Our File: 9506

**Re: Letter - Response to Burnside Review of Summary of Drilling and Testing of New Well M15 at Hidden Quarry Site (Burnside Response April 8, 2014)  
Harden Response to Burnside Review of Hydrogeological Summary Report (Burnside Response April 9, 2014)  
Hidden Quarry Site for Township of Guelph/Eramosa  
Burnside File No.: 300032475.0000**

Part of Lot 1, Concession 6  
Township of Guelph/Eramosa, County of Wellington

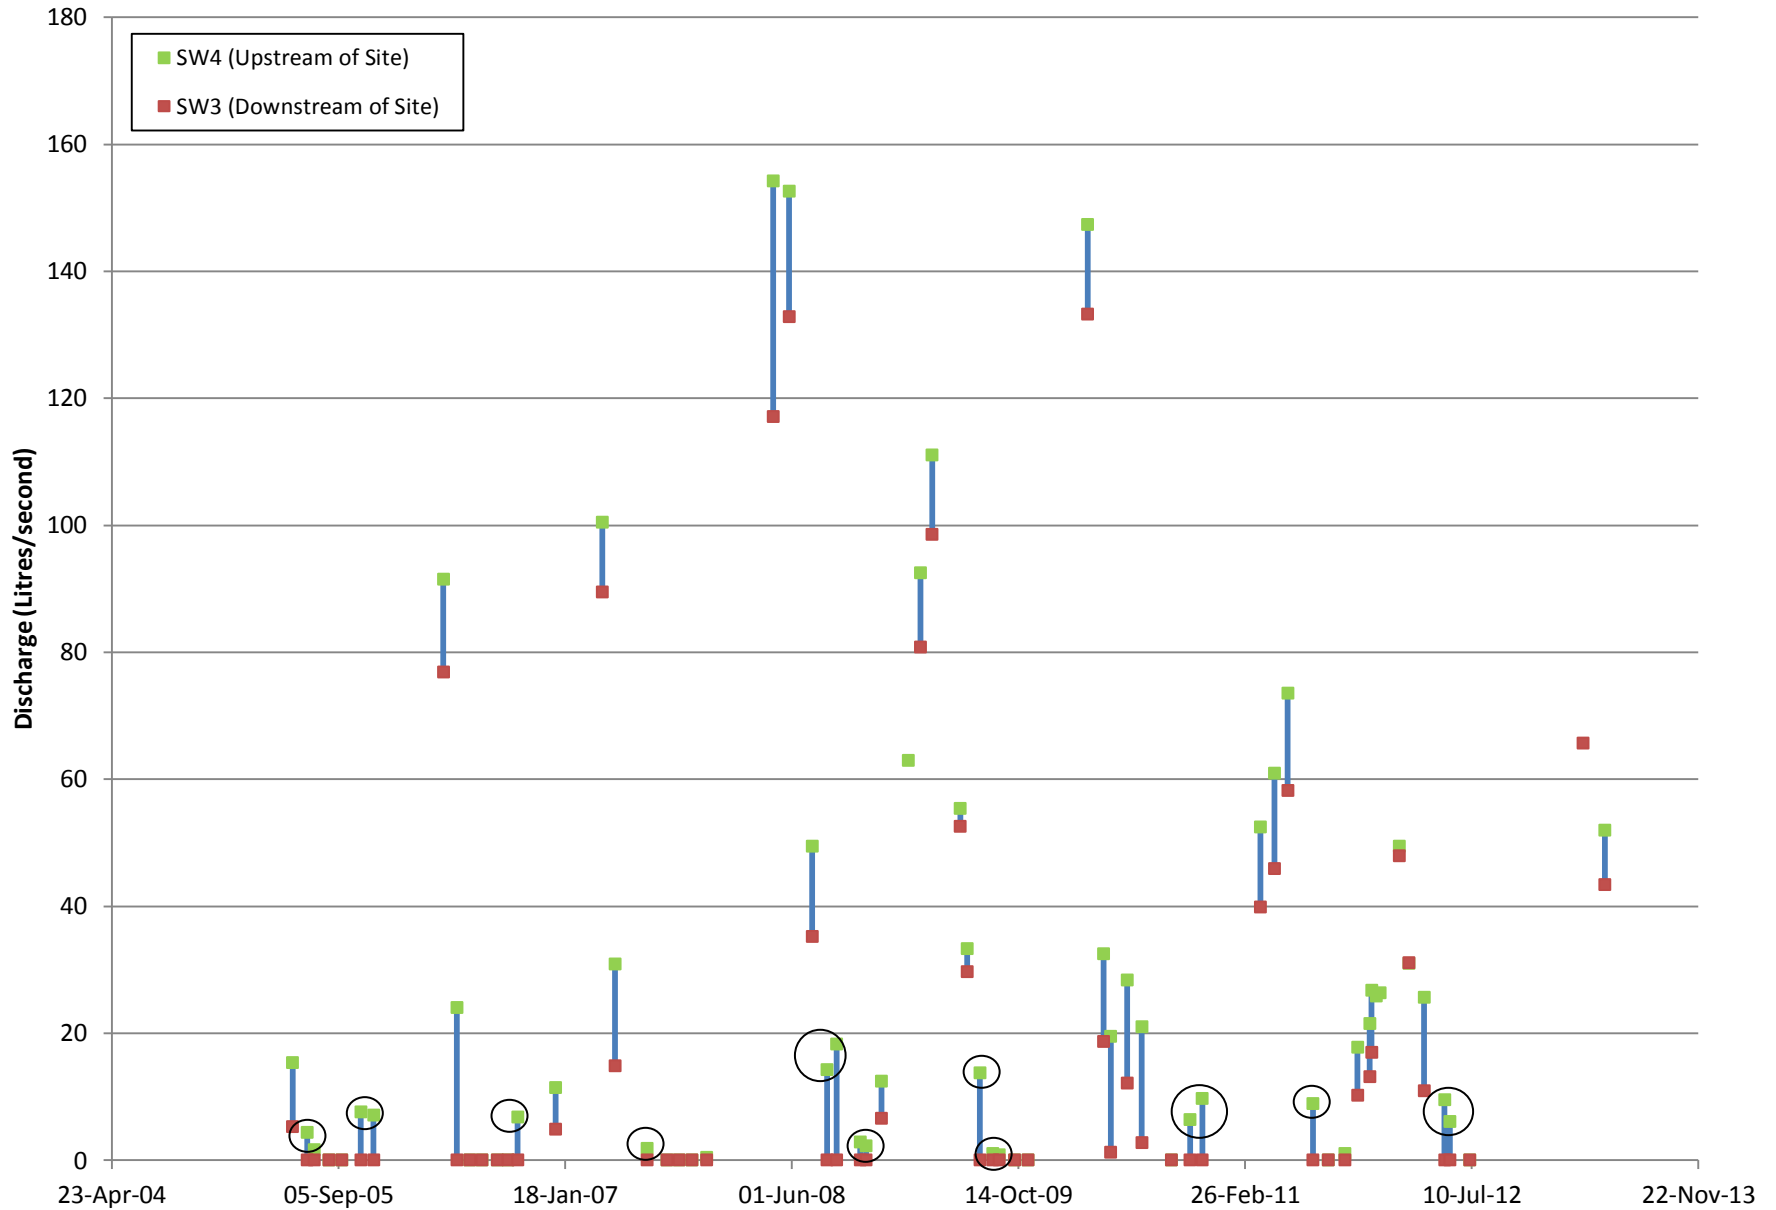
**Figure 1: Streamflow Stations SW3 vs SW4**

Streamflow measurements have been obtained regularly since 2005. As shown on Figure 1, Tributary B only loses all of its water (no flow at SW3) when the incoming flow at SW4 is less than approximately 20 L/s. With flows of greater than 20 L/s, flow is found in all on-site reaches of Tributary B. Table 1 summarizes observations of flow conditions where streamflow has been observed to cease within different reaches of Tributary B. The surface water station locations are shown on Figure 2. Our observations are that the stream will cease to flow in various reaches within the proposed quarry boundaries depending on the incoming flow at SW4. This gradual loss of water supports the

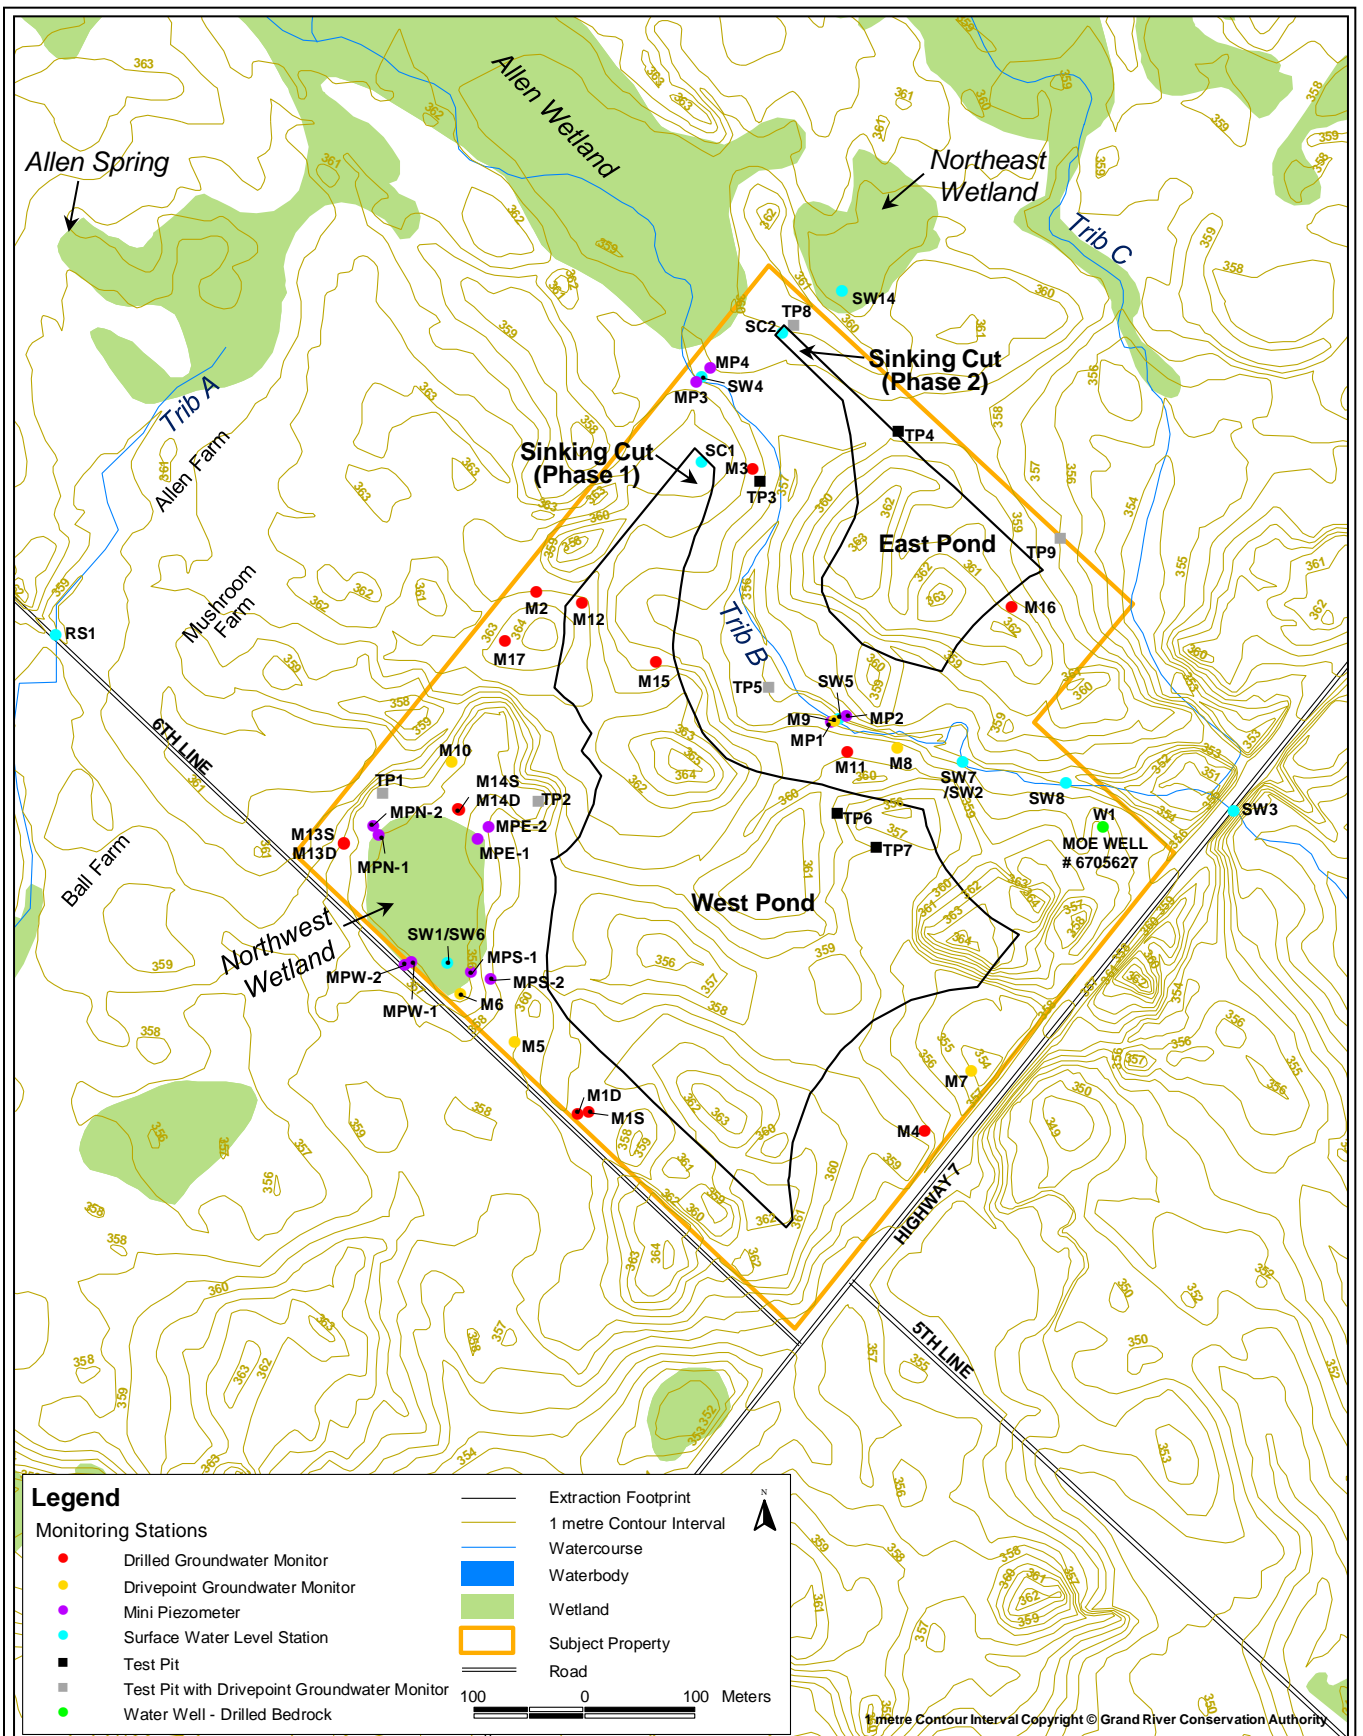
**Monitoring Locations**

As suggested by Burnside and Associates, a dedicated monitoring well completed as an open hole to 327 m AMSL will be installed within the quarry limits. This well will be installed as M17 at the location shown on Figure 2. M17 will be installed upon approval of the quarry. This monitor has been added to the monitoring program.

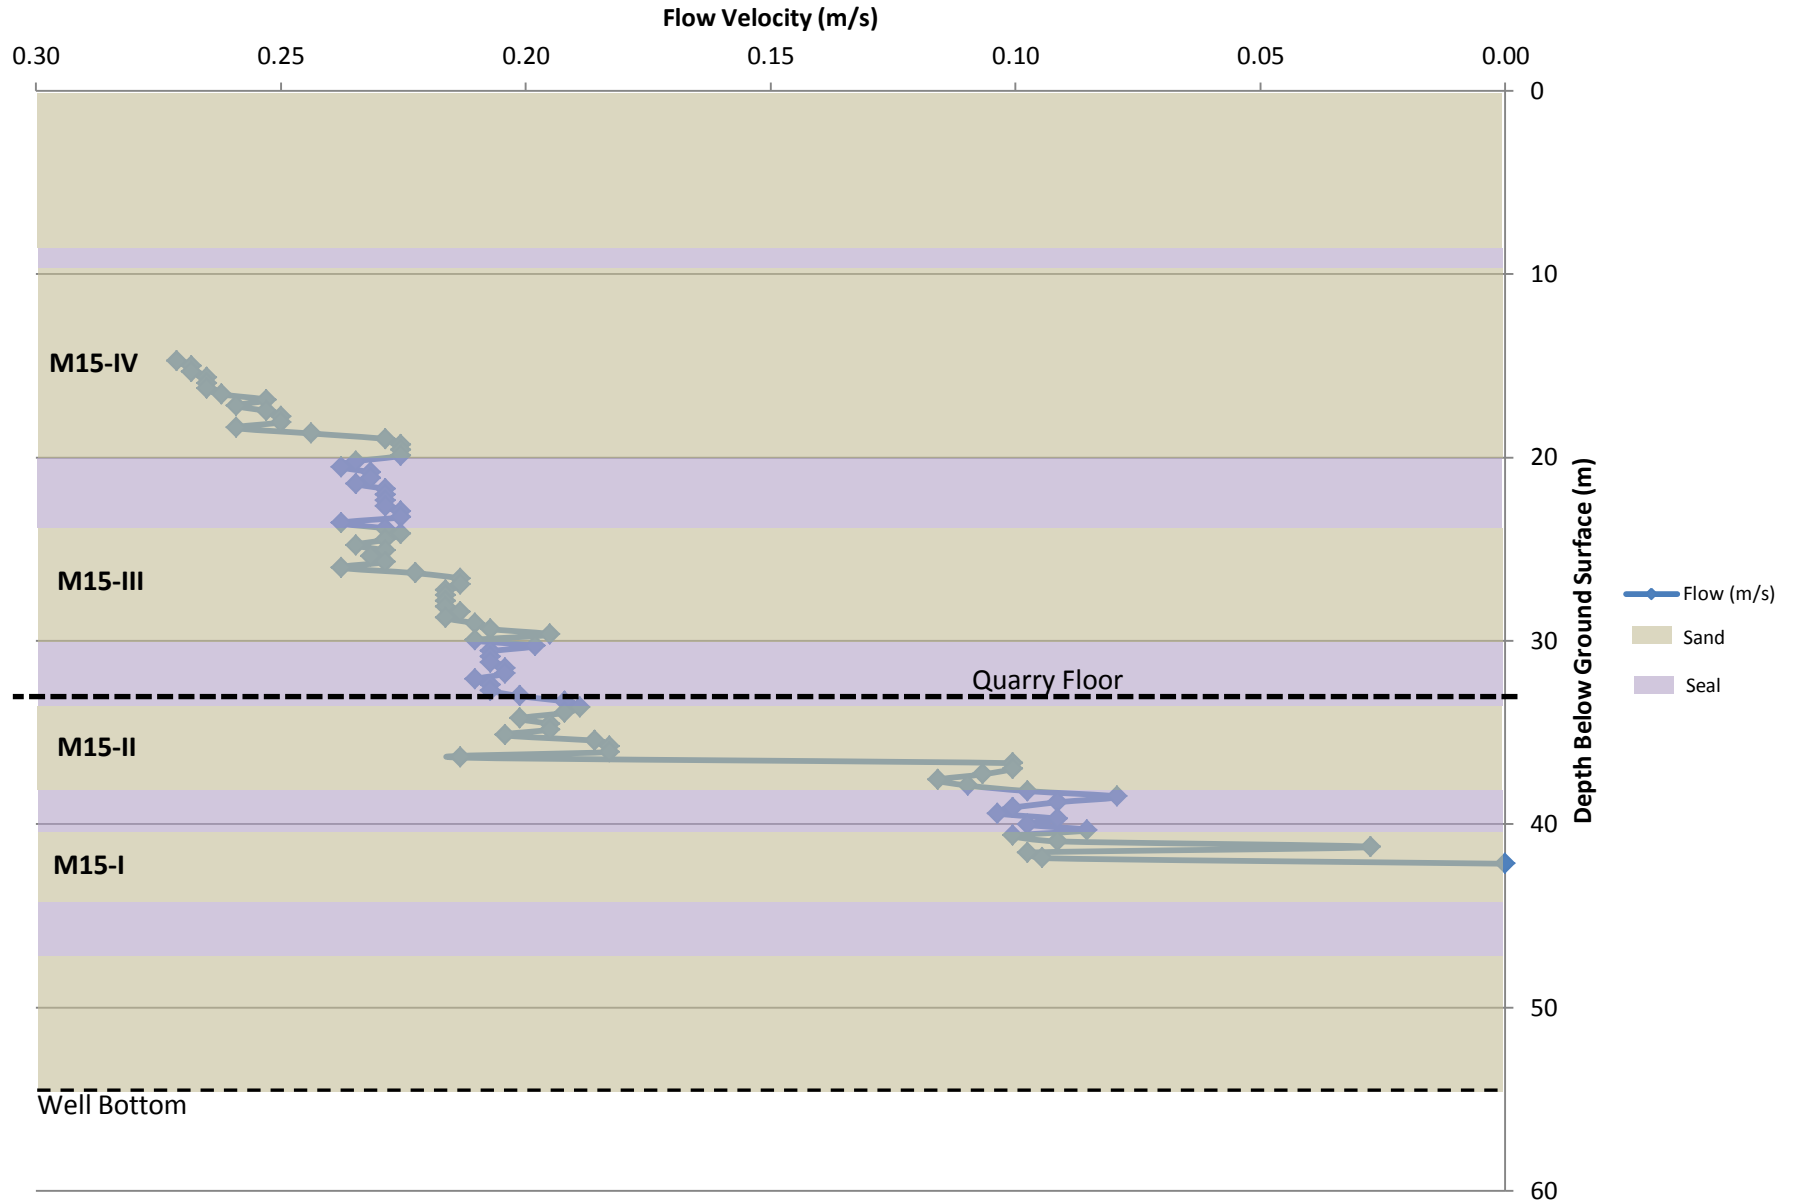
**Figure 3: Installation of M15 versus Results of Flow Test**

As shown on Figure 3, the test intervals were designed to isolate major fractures and water producing sections of the aquifer identified in the video log and flow test.

The greater value hydraulic conductivity intervals M15-I and M15-II correspond with the greater flow velocities as observed in the flow test as shown on Figure 3. Approximately 75% of the flow to the well comes from the aquifer represented by test intervals M15-I

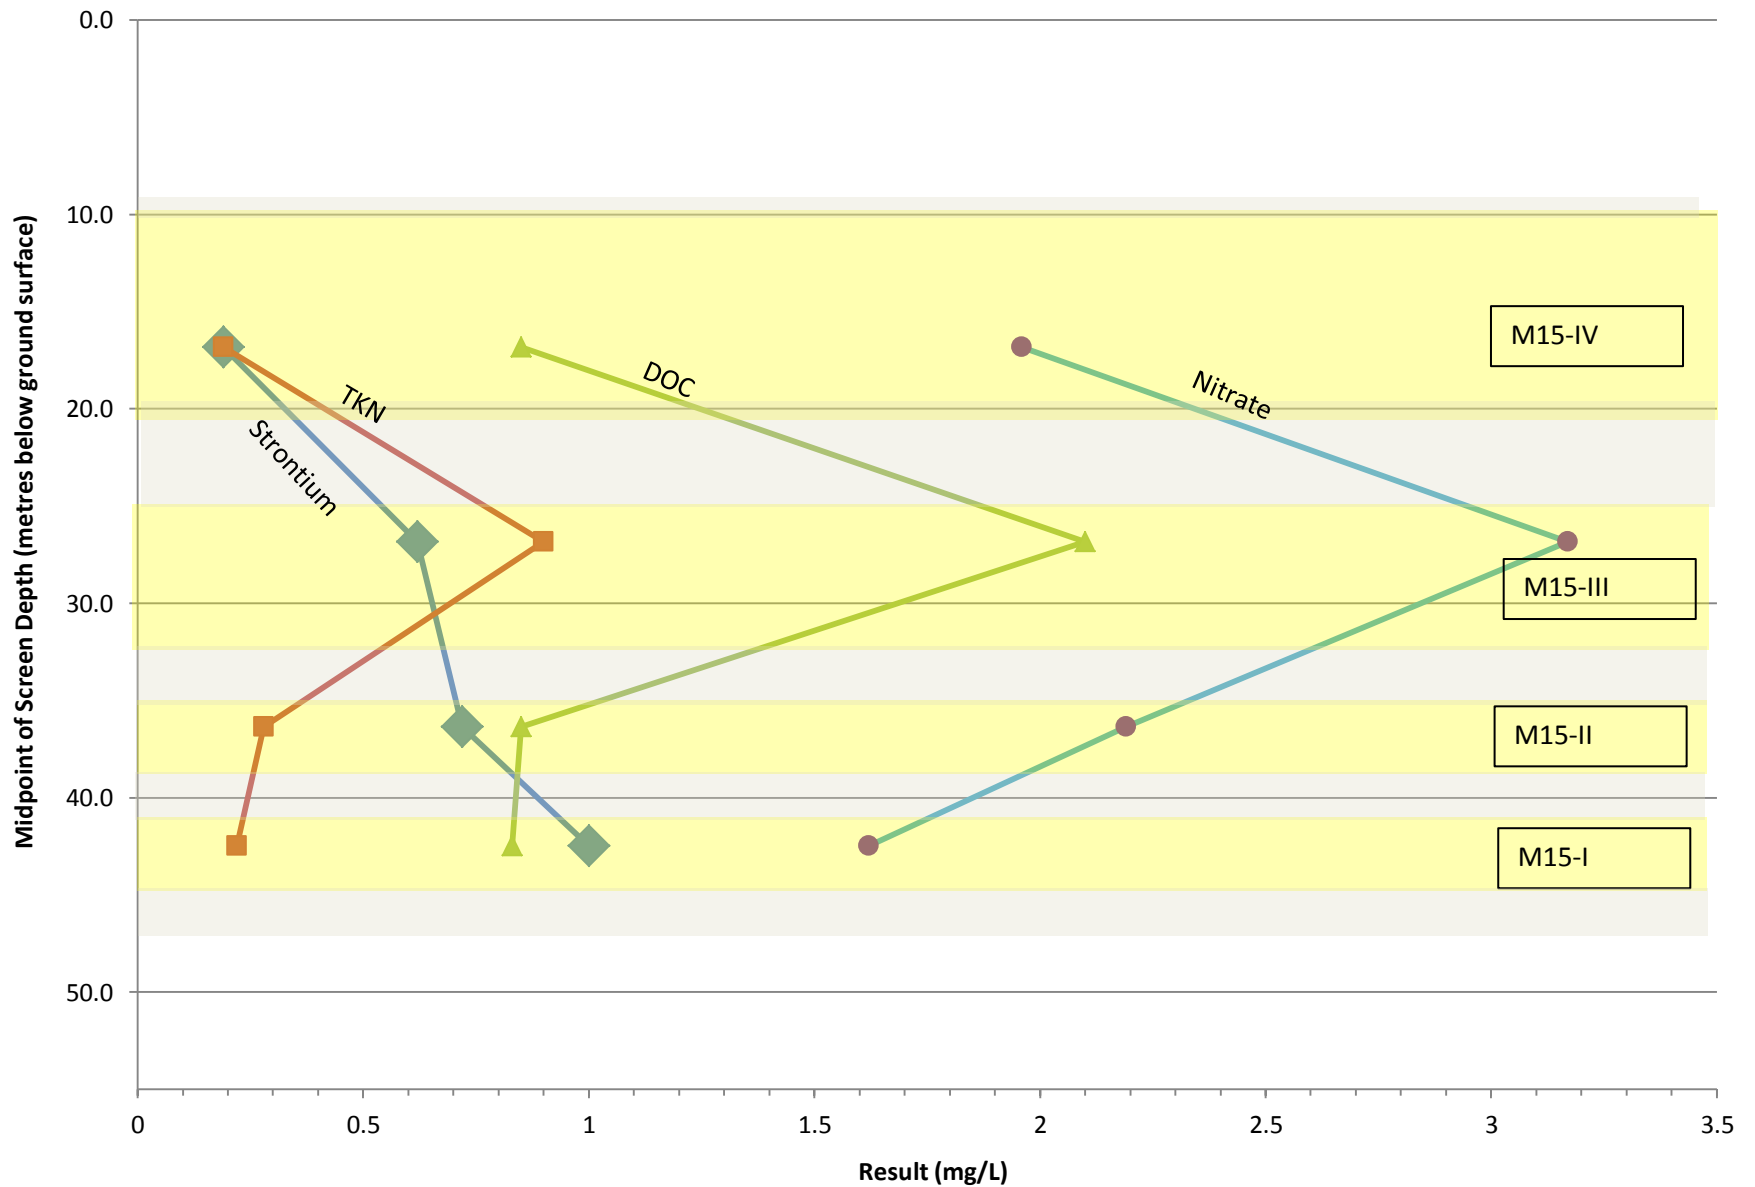
**Figure 6: M15 Water Quality Results**

The test results are found in Appendix C. Graphs of TKN, DOC, nitrate, strontium and sulphate are shown on Figures 6 and 7. The strontium concentration increases with depth, a confirmation that sufficient water was removed from the test sections for water samples to be representative of the aquifer water at the interval depths sampled. Typical of the lower Gasport Formation, the strontium value is elevated in the lower elevations.

The highest TKN, DOC and nitrate concentrations occur in test interval M15-III. This indicates that this intermediate depth fracture set interacts with shallow fracture sets resulting in the movement of chemicals lower within the aquifer. The lower fracture sets represented by intervals M15-II and M15-I have lower nitrate, DOC and TKN concentrations than the M15-III interval. The sharp contrast in chemical concentrations with the lower fracture sets indicates some degree of isolation between the fracture sets, whereas the mere presence of these chemicals in the lower aquifer suggests interconnectivity between the lower and upper fracture sets.

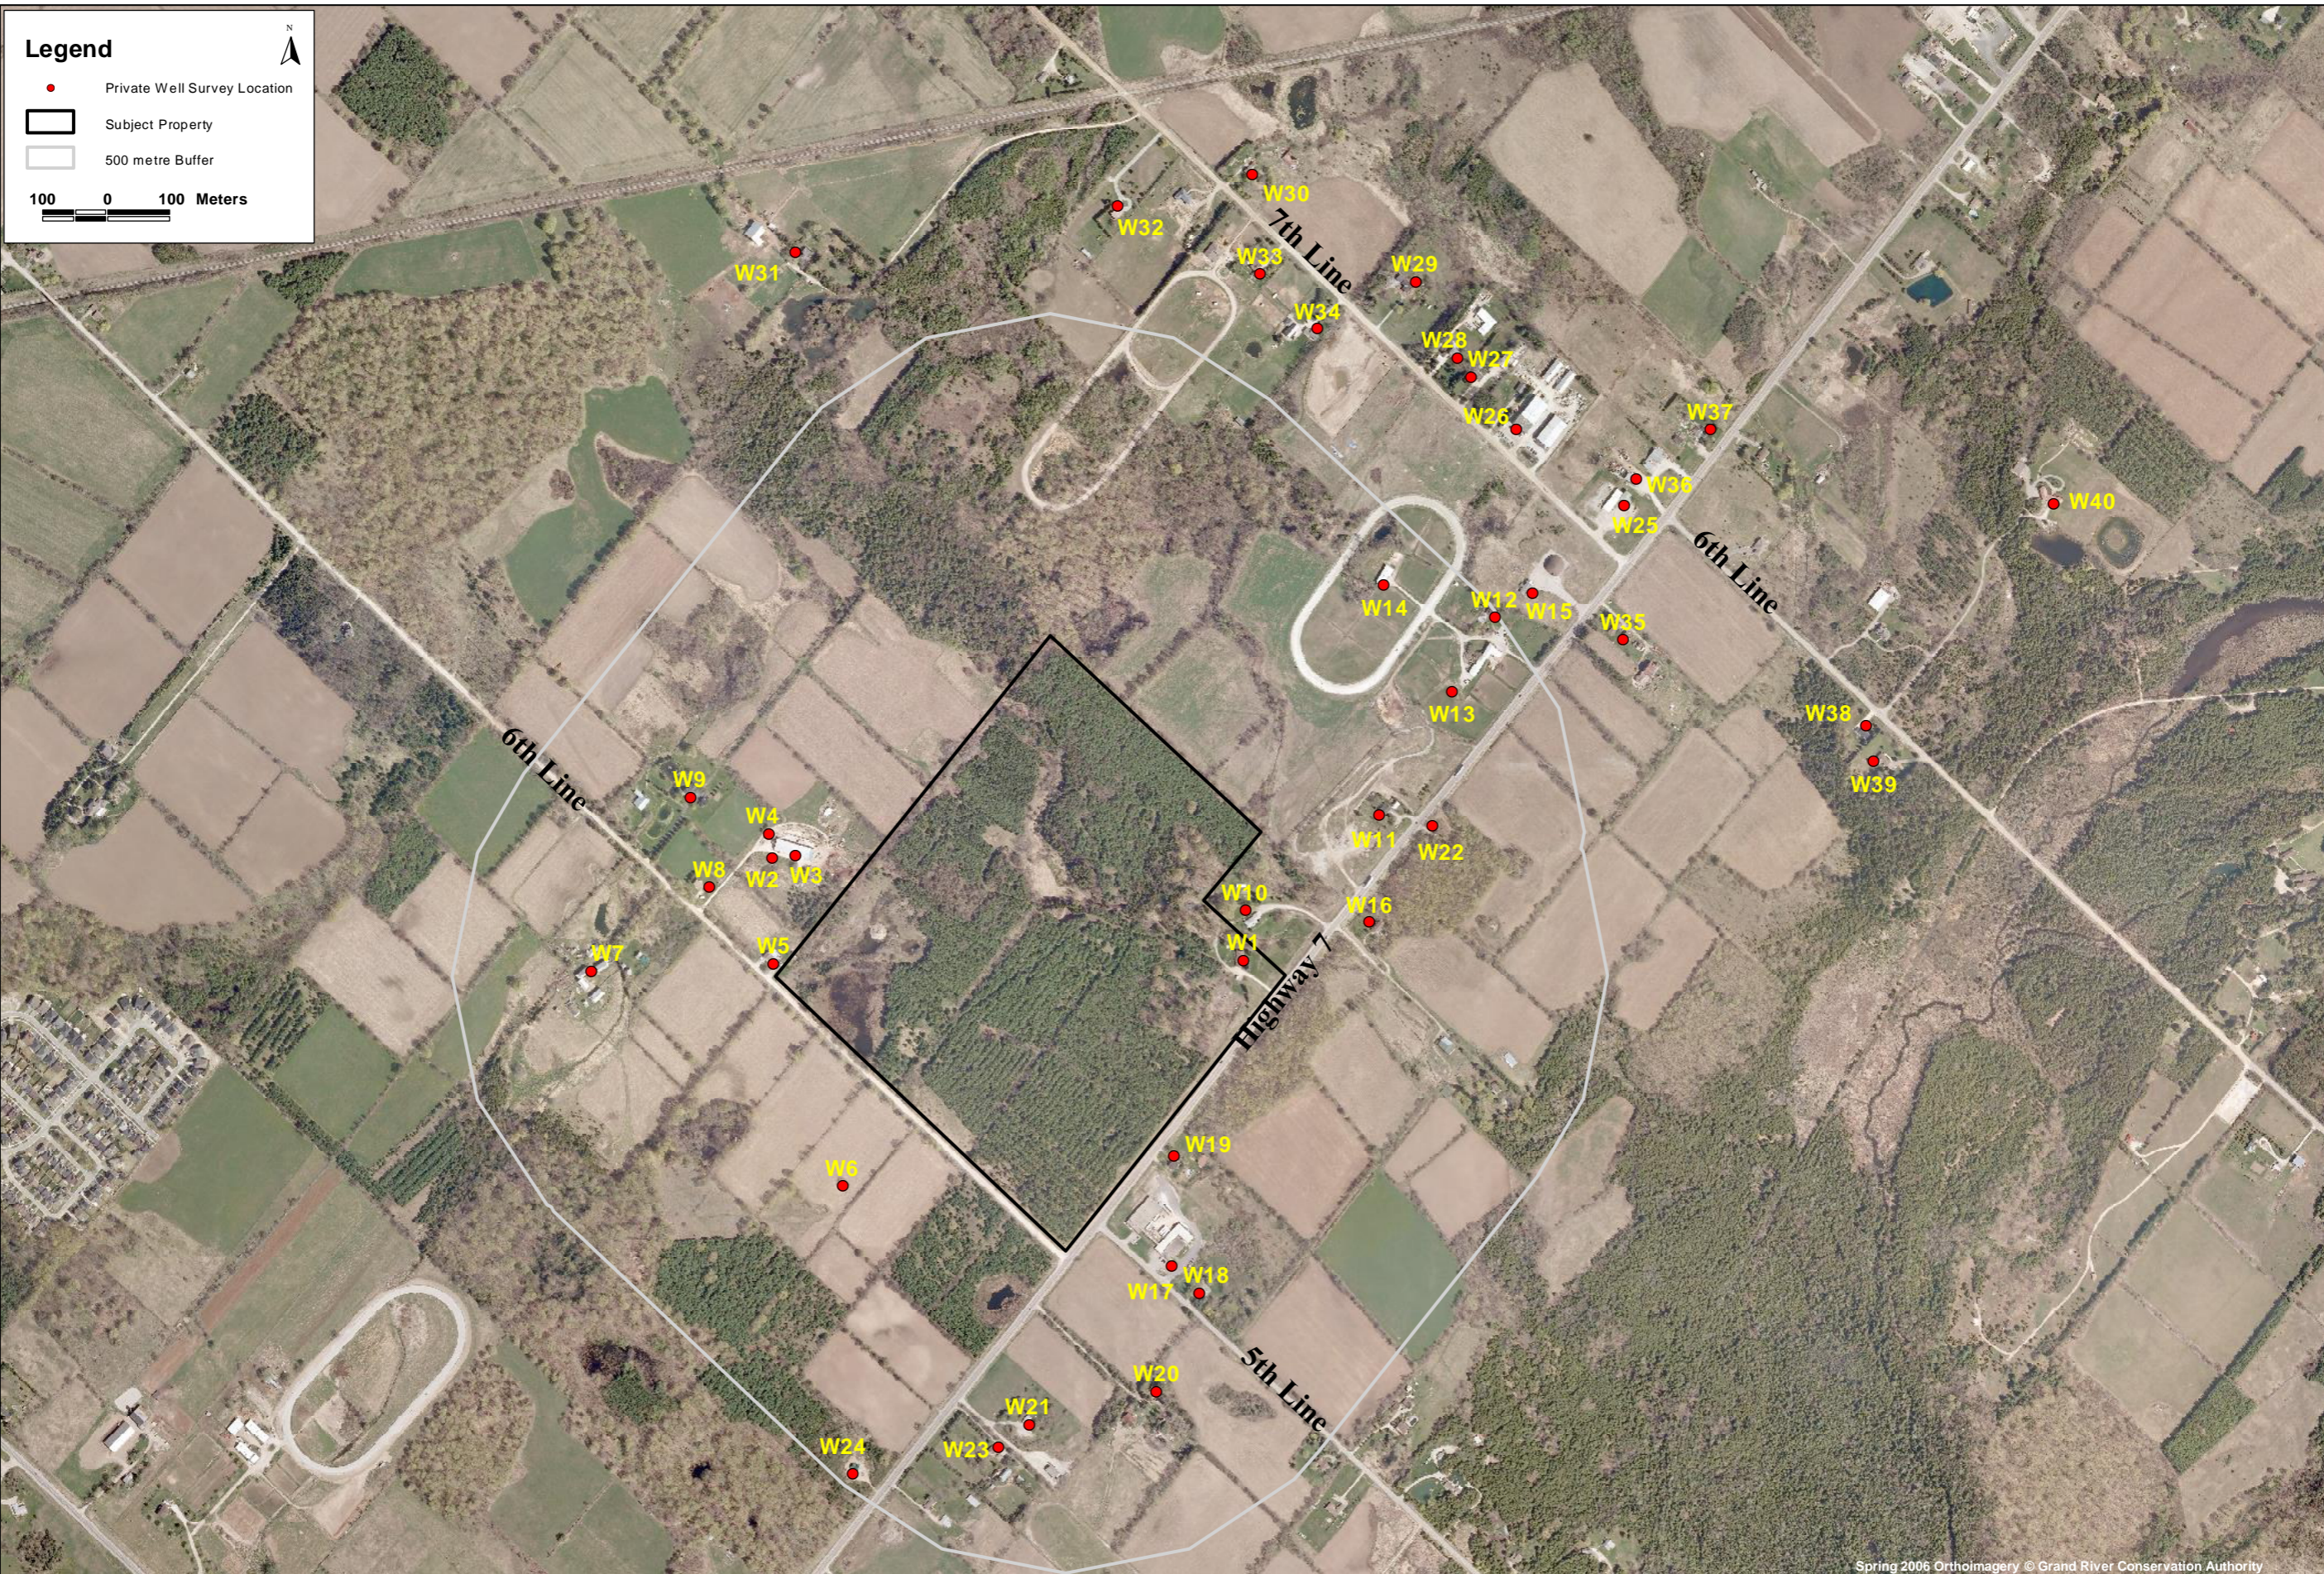
<b>HARDEN</b> Harden Environmental Services Ltd.	Project No: 9506	Hydrogeologic Impact Assessment Proposed Aggregate Extraction	Figure 10:  <b>Private Water Well Locations</b>
	Date: Apr 2014		
	Drawn By: AR

James Dick Construction Ltd. has agreed to undertake a voluntary detailed well inventory and water quality assessment of wells within 500 m of the quarry. This will be conducted to establish baseline water quality and quantity conditions. Harden Environmental has already undertaken three such studies as summarized in Table 9 and Figure 10. Since

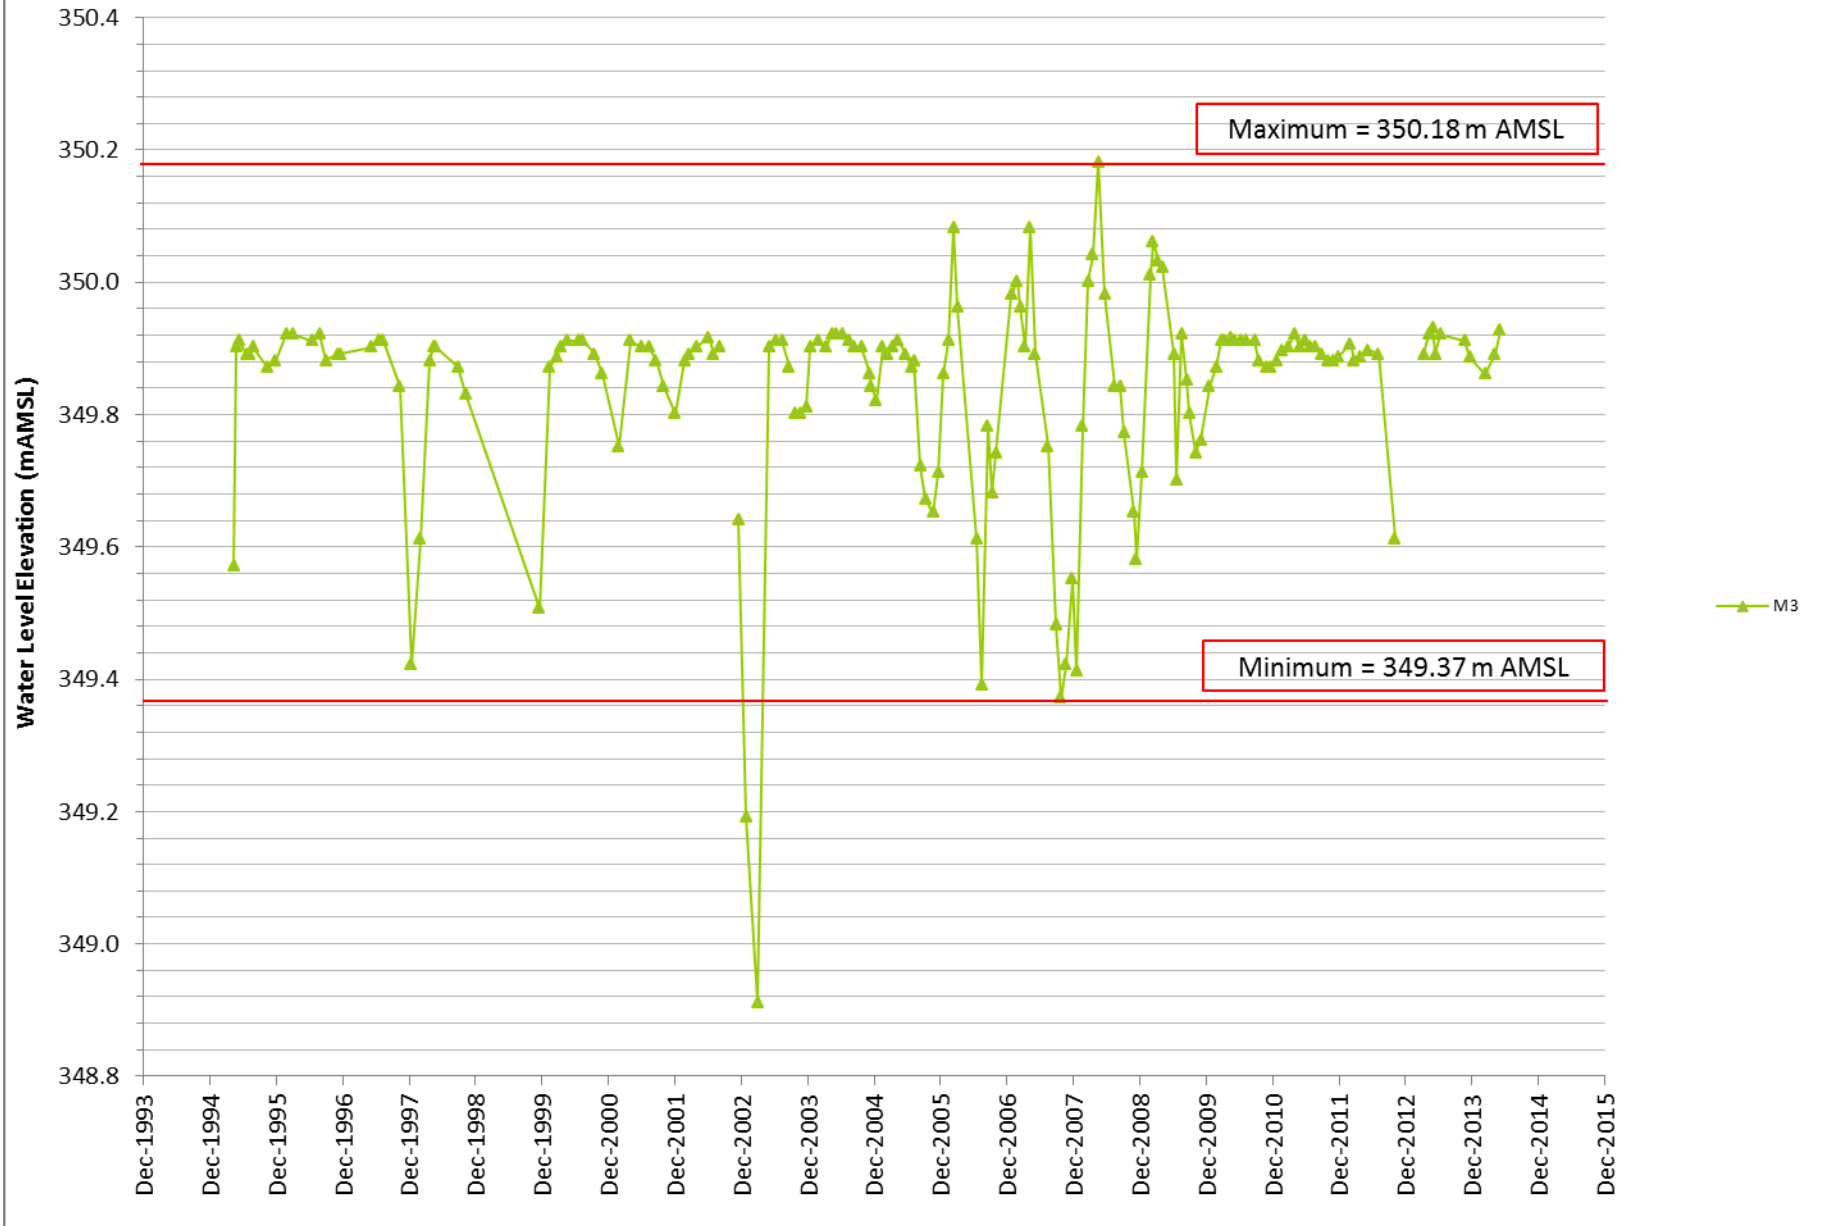
The nearest groundwater monitor to the sinking cut is M3. The hydrograph of M3 is found attached as Figure 11. The low water level in M3 is 349.37 m AMSL. We propose to use this as the reference elevation resulting in a minimum allowable water elevation in the sinking cut of  $349.37 - 2.54 = 346.83$  m AMSL. JDCL proposes to hang a buoy from a tether with the buoy floating in the water until the water level falls below an elevation of 346.83 m AMSL. The buoy will be a visual indicator of the minimum allowable water level to the operator. Once the extraction face has been established, a level logger will be used to verify that water levels in the sinking cut do not fall below 346.83 m AMSL.

### M3 Hydrograph

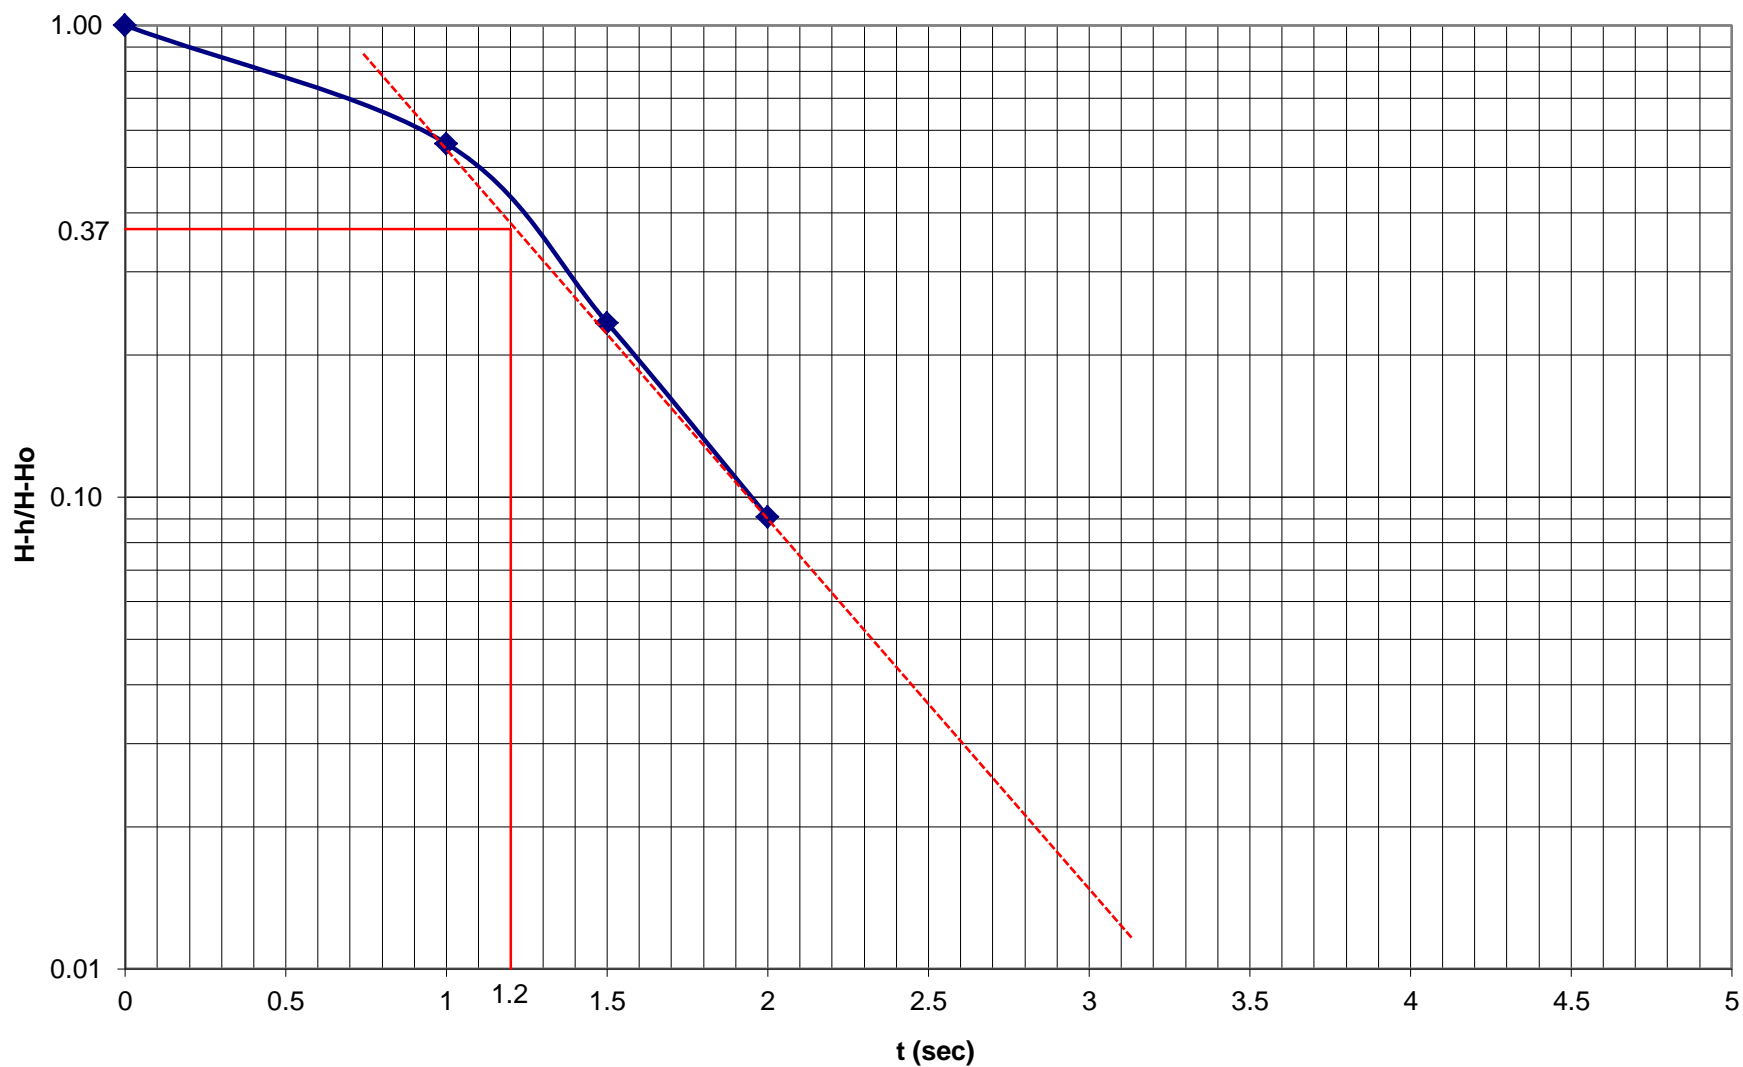
**M15-I Rising Head Test**

**M15-I Rising Head Test (Hvorslev Method)**  
 $K = 6.7 \times 10^{-5} \text{ m/sec}$

The hydraulic testing of M15 was conducted on May 6, 2014. The testing was conducted both by adding a slug of water to the test interval (falling head test) and recording the response and by removing a physical slug from the test interval (rising head test) and recording the response. Graphs showing the response to this testing are found in Appendix B.

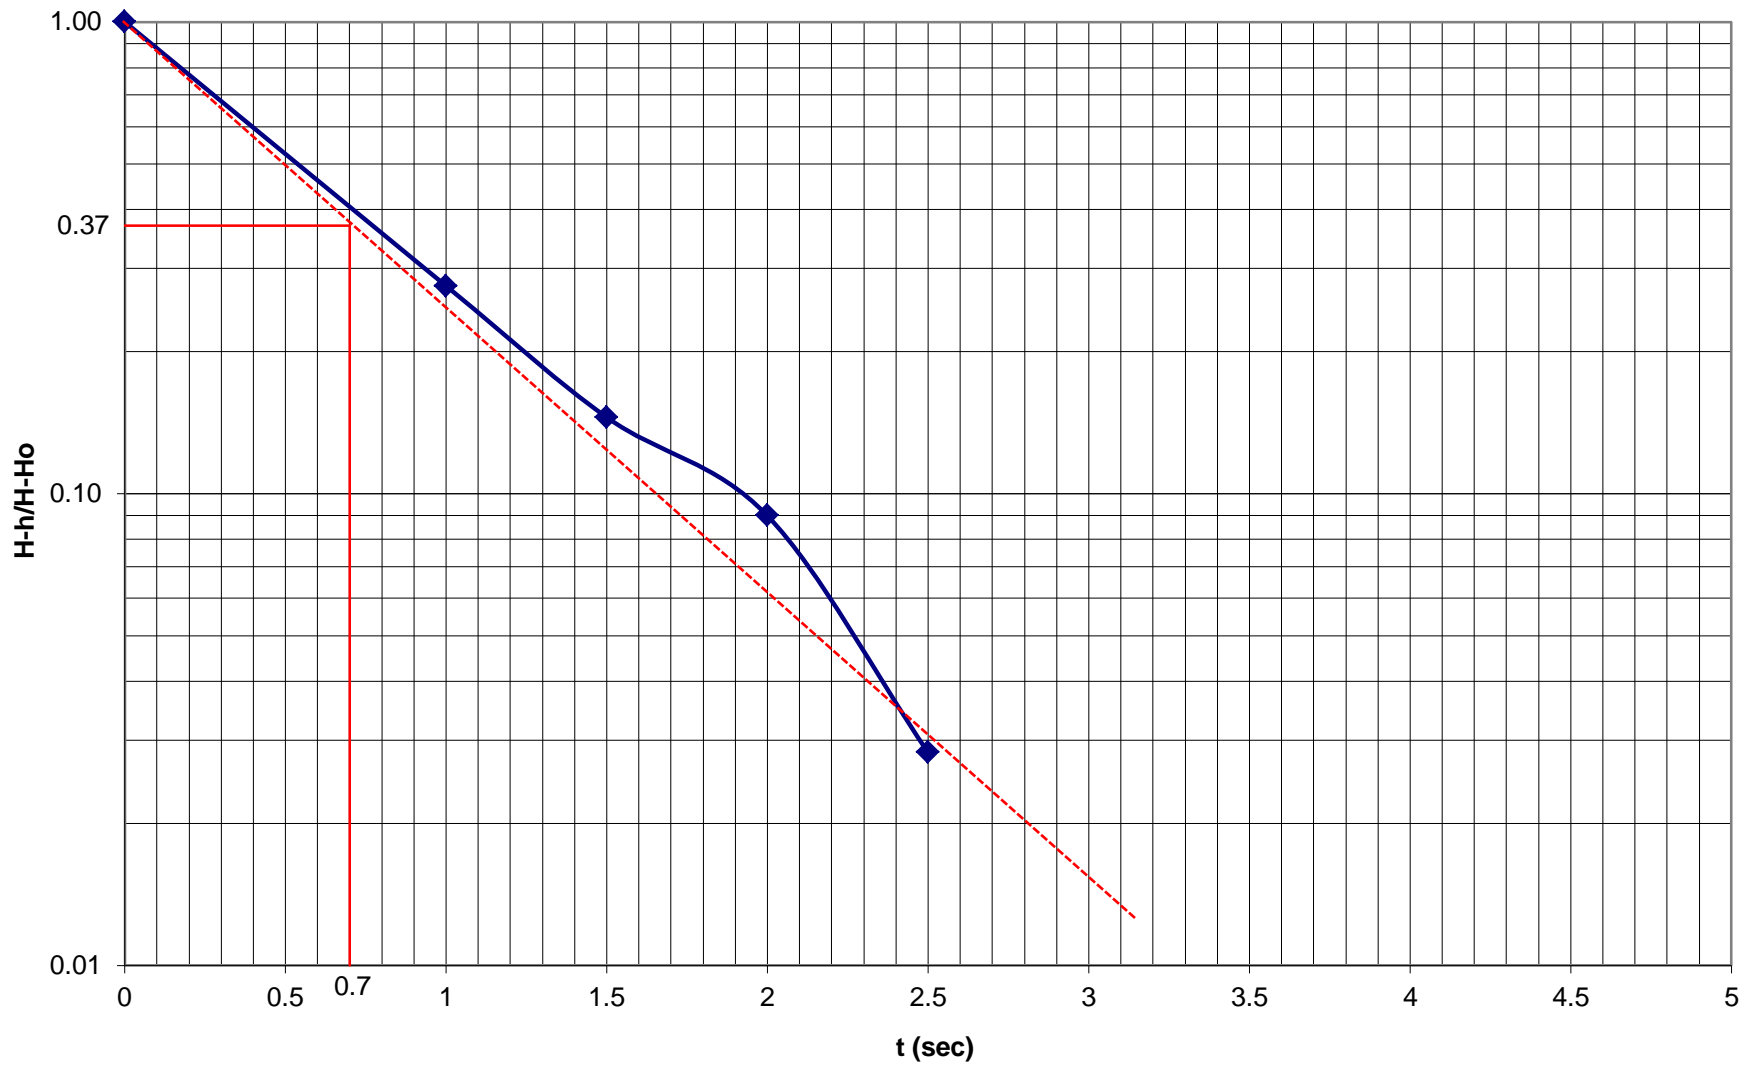
**M15-II Rising Head Test**

**M15-II Rising Head Test (Hvorslev Method)**  
 **$K = 1.0 \times 10^{-4}$  m/sec**

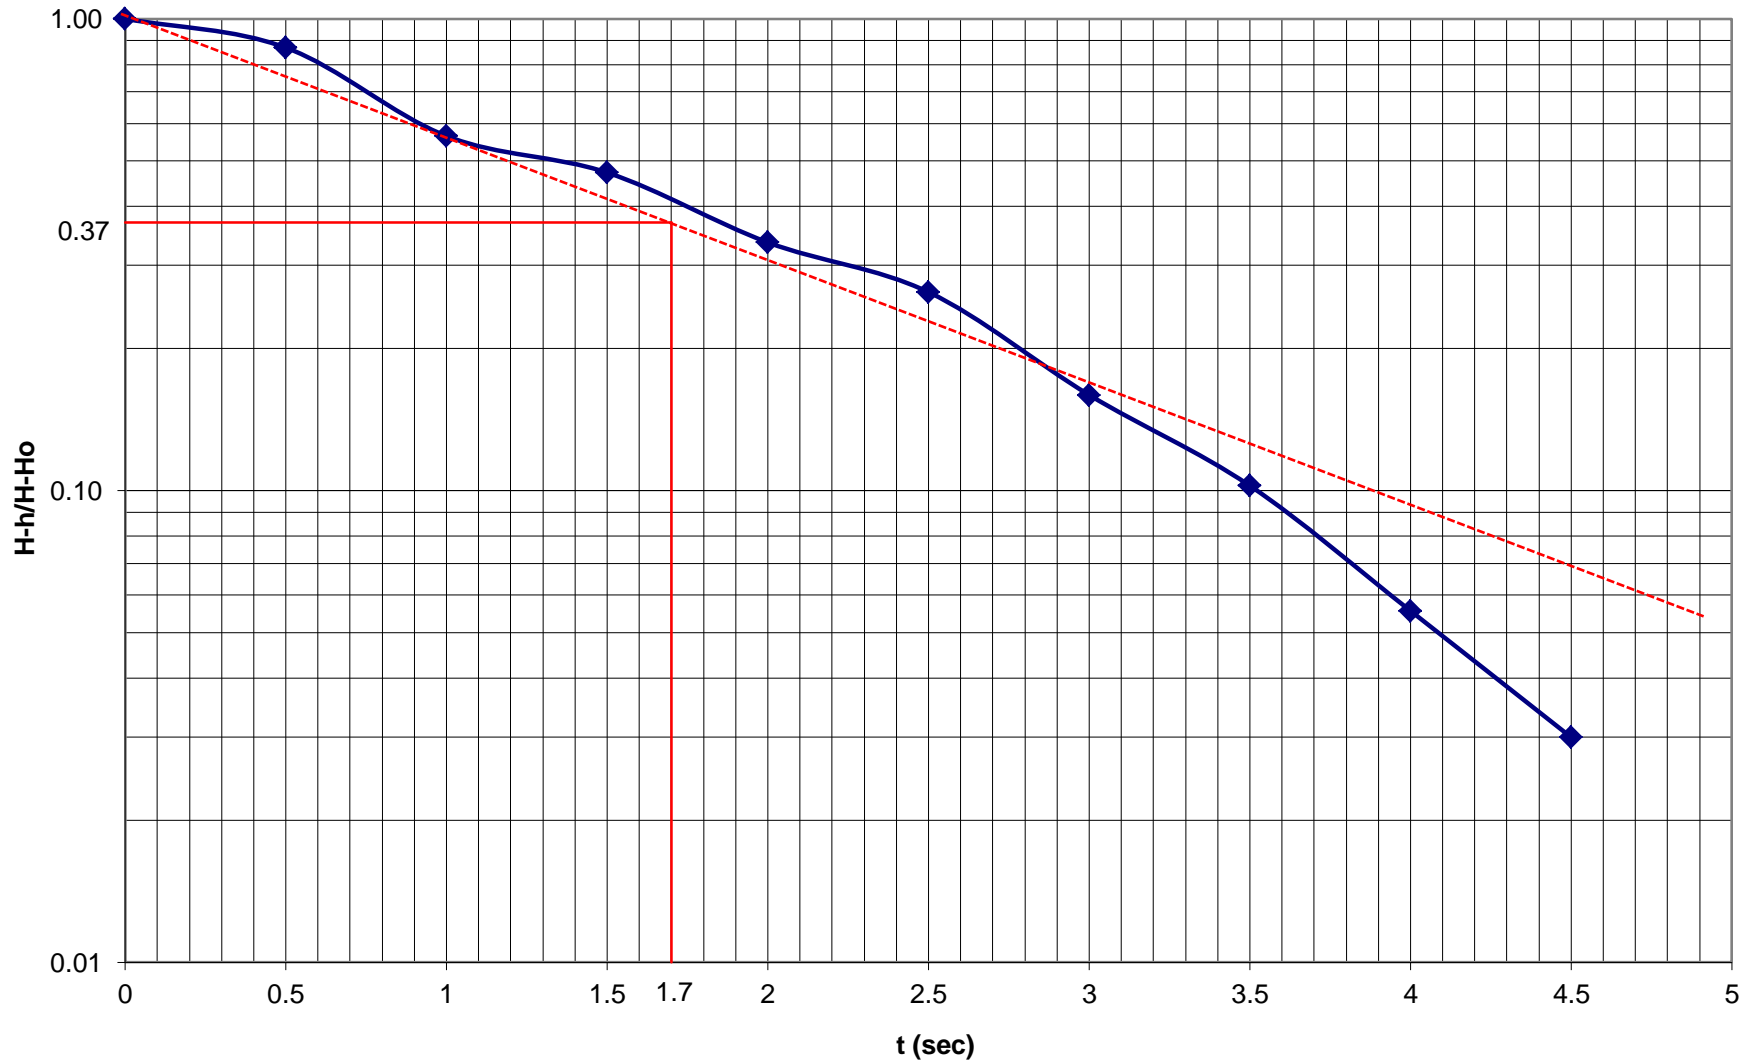
**M15-III Rising Head Test**

**M15-III Rising Head Test (Hvorslev Method)**  
 $K = 3.4 \times 10^{-5} \text{ m/sec}$
