Our File: 9506

**Re: Letter - Response to Burnside Review of Summary of Drilling and Testing of New Well M15 at Hidden Quarry Site (Burnside Response April 8, 2014)  
Harden Response to Burnside Review of Hydrogeological Summary Report (Burnside Response April 9, 2014)  
Hidden Quarry Site for Township of Guelph/Eramosa  
Burnside File No.: 300032475.0000**

Part of Lot 1, Concession 6  
Township of Guelph/Eramosa, County of Wellington

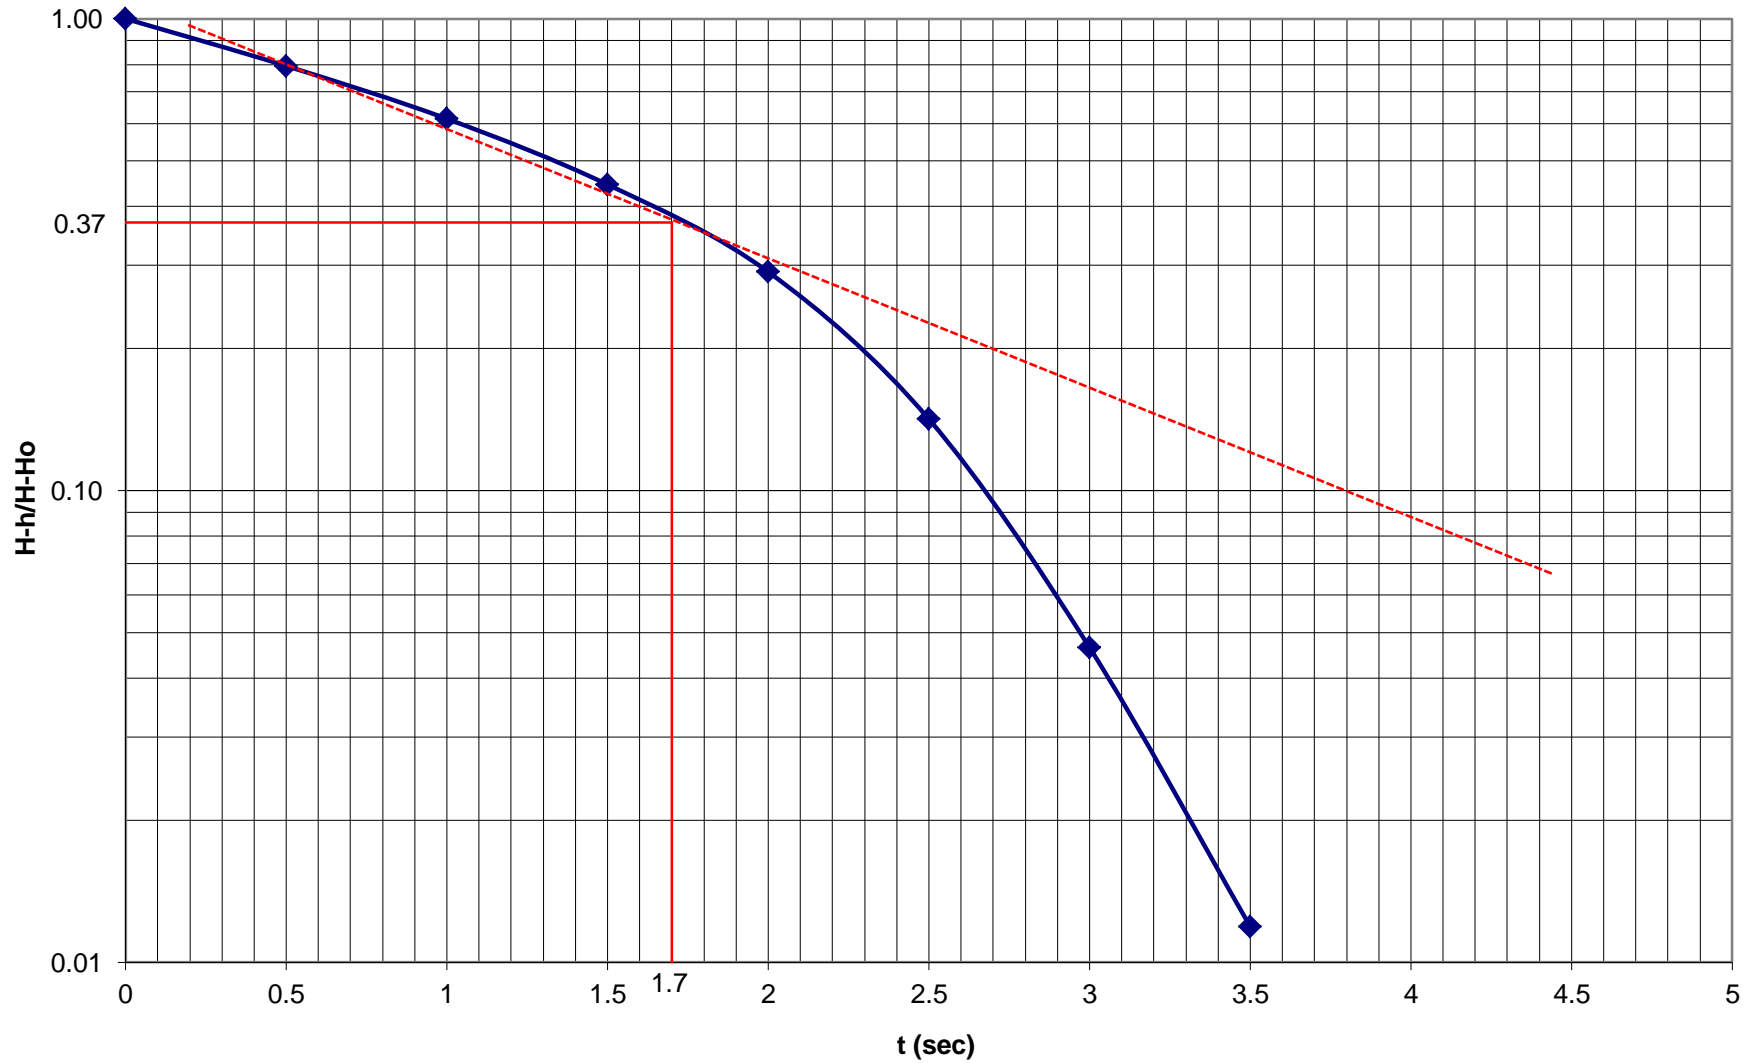
**M15-IV Rising Head Test**

**M15-IV Rising Head Test (Hvorslev Method)**  
 $K = 2.2 \times 10^{-5} \text{ m/sec}$

The hydraulic testing of M15 was conducted on May 6, 2014. The testing was conducted both by adding a slug of water to the test interval (falling head test) and recording the response and by removing a physical slug from the test interval (rising head test) and recording the response. Graphs showing the response to this testing are found in Appendix B.
