# Evidence Book 15

## Township of Guelph/Eramosa Visual Impact Review Document Book

# Visual Information Package

## HIDDEN QUARRY

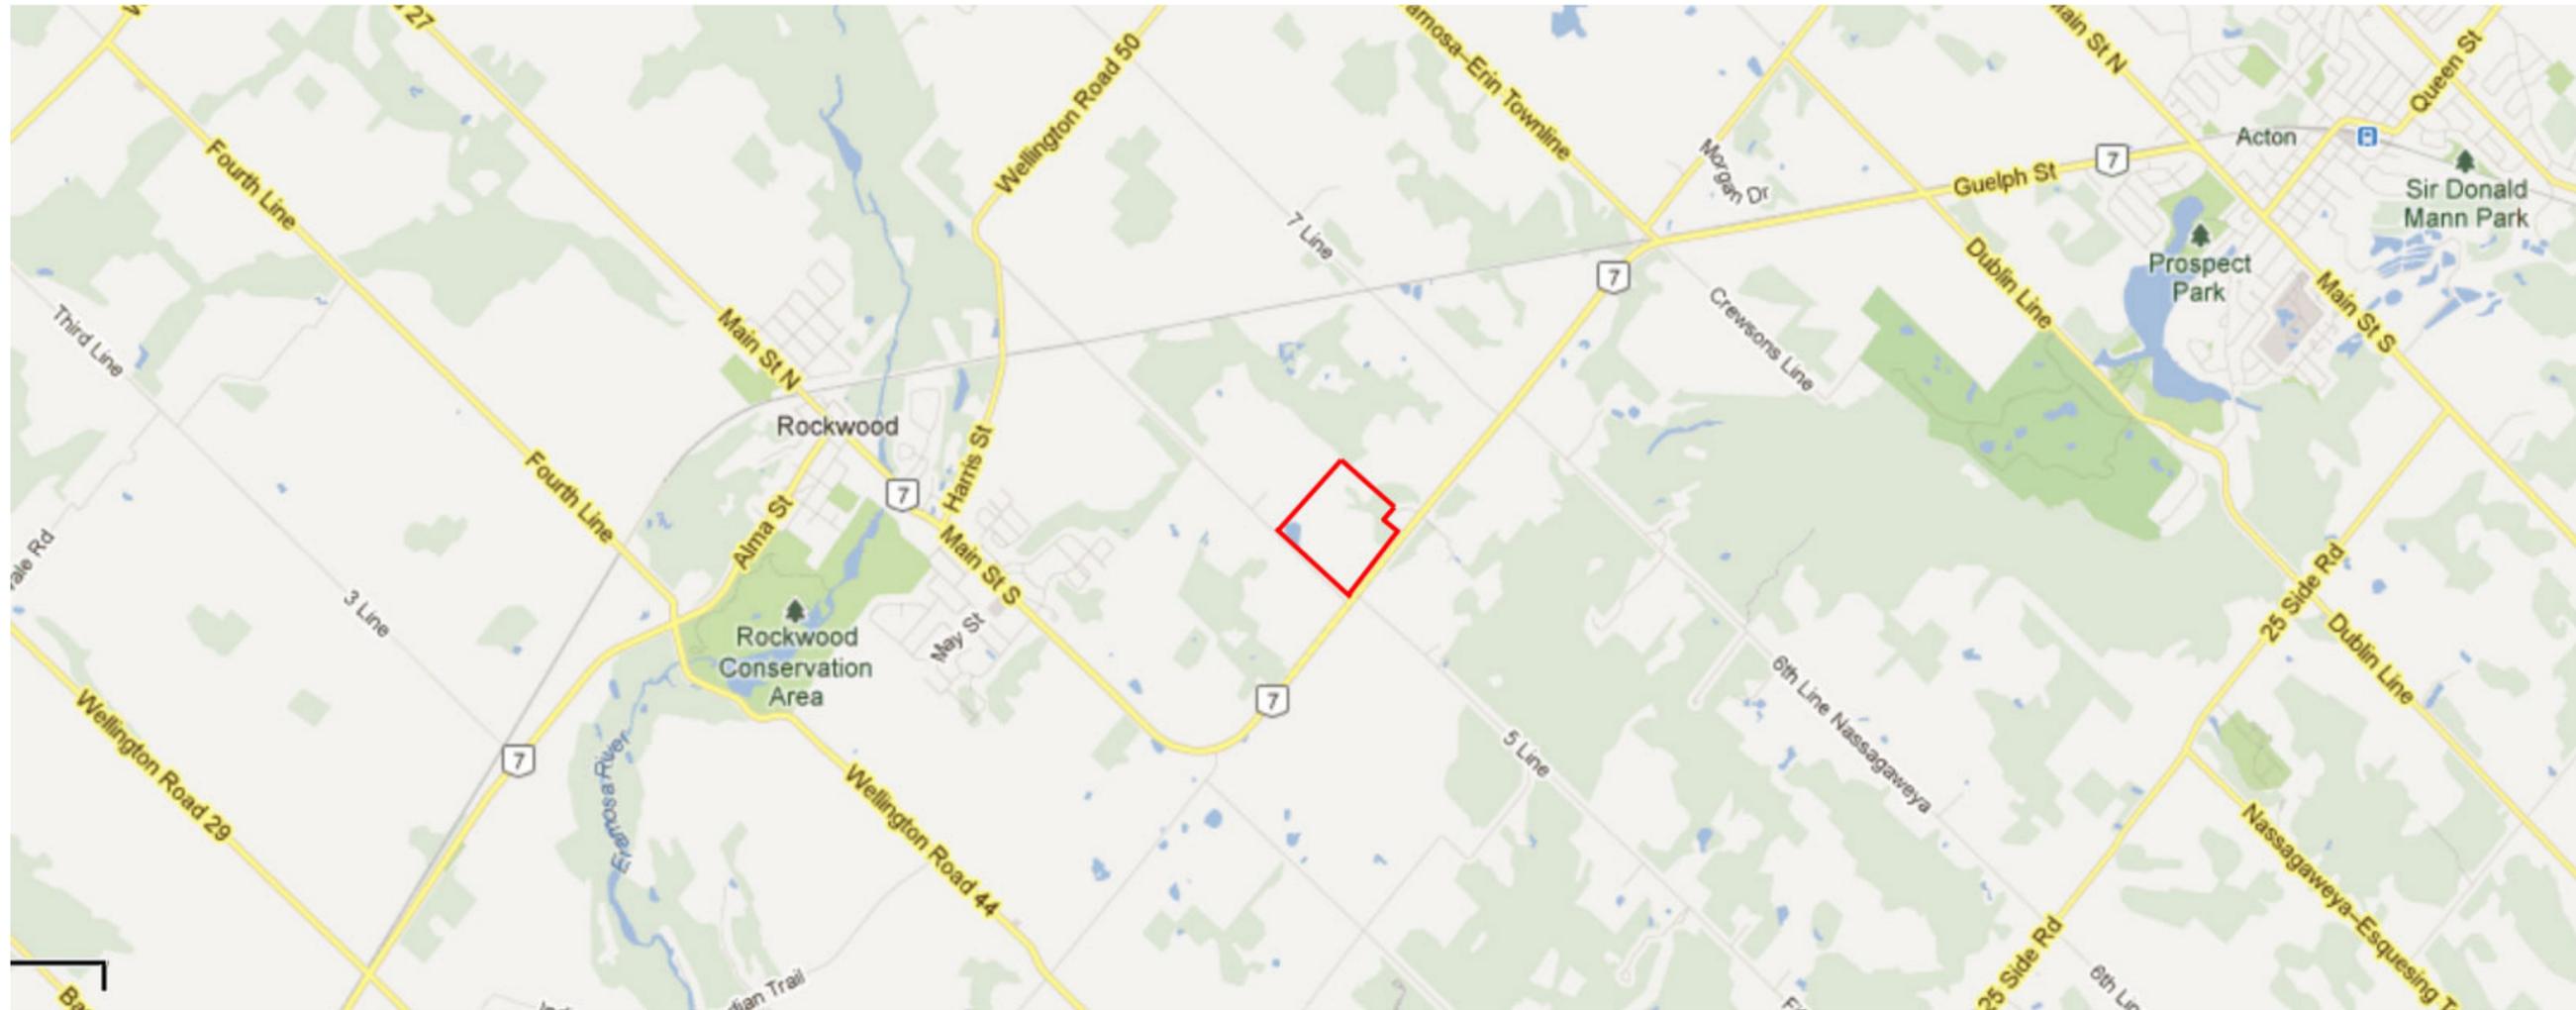
Figure 1- Site Location

James Dick Construction Limited has made a Zoning Bylaw amendment application and an Aggregate Resources Act application on lands described as Part of the West Half Lot 1 Concession 6 Eramosa. The property fronts on Highway 7 and the Sixth Line. The location of the proposed area to be licensed is shown in Figure 1.

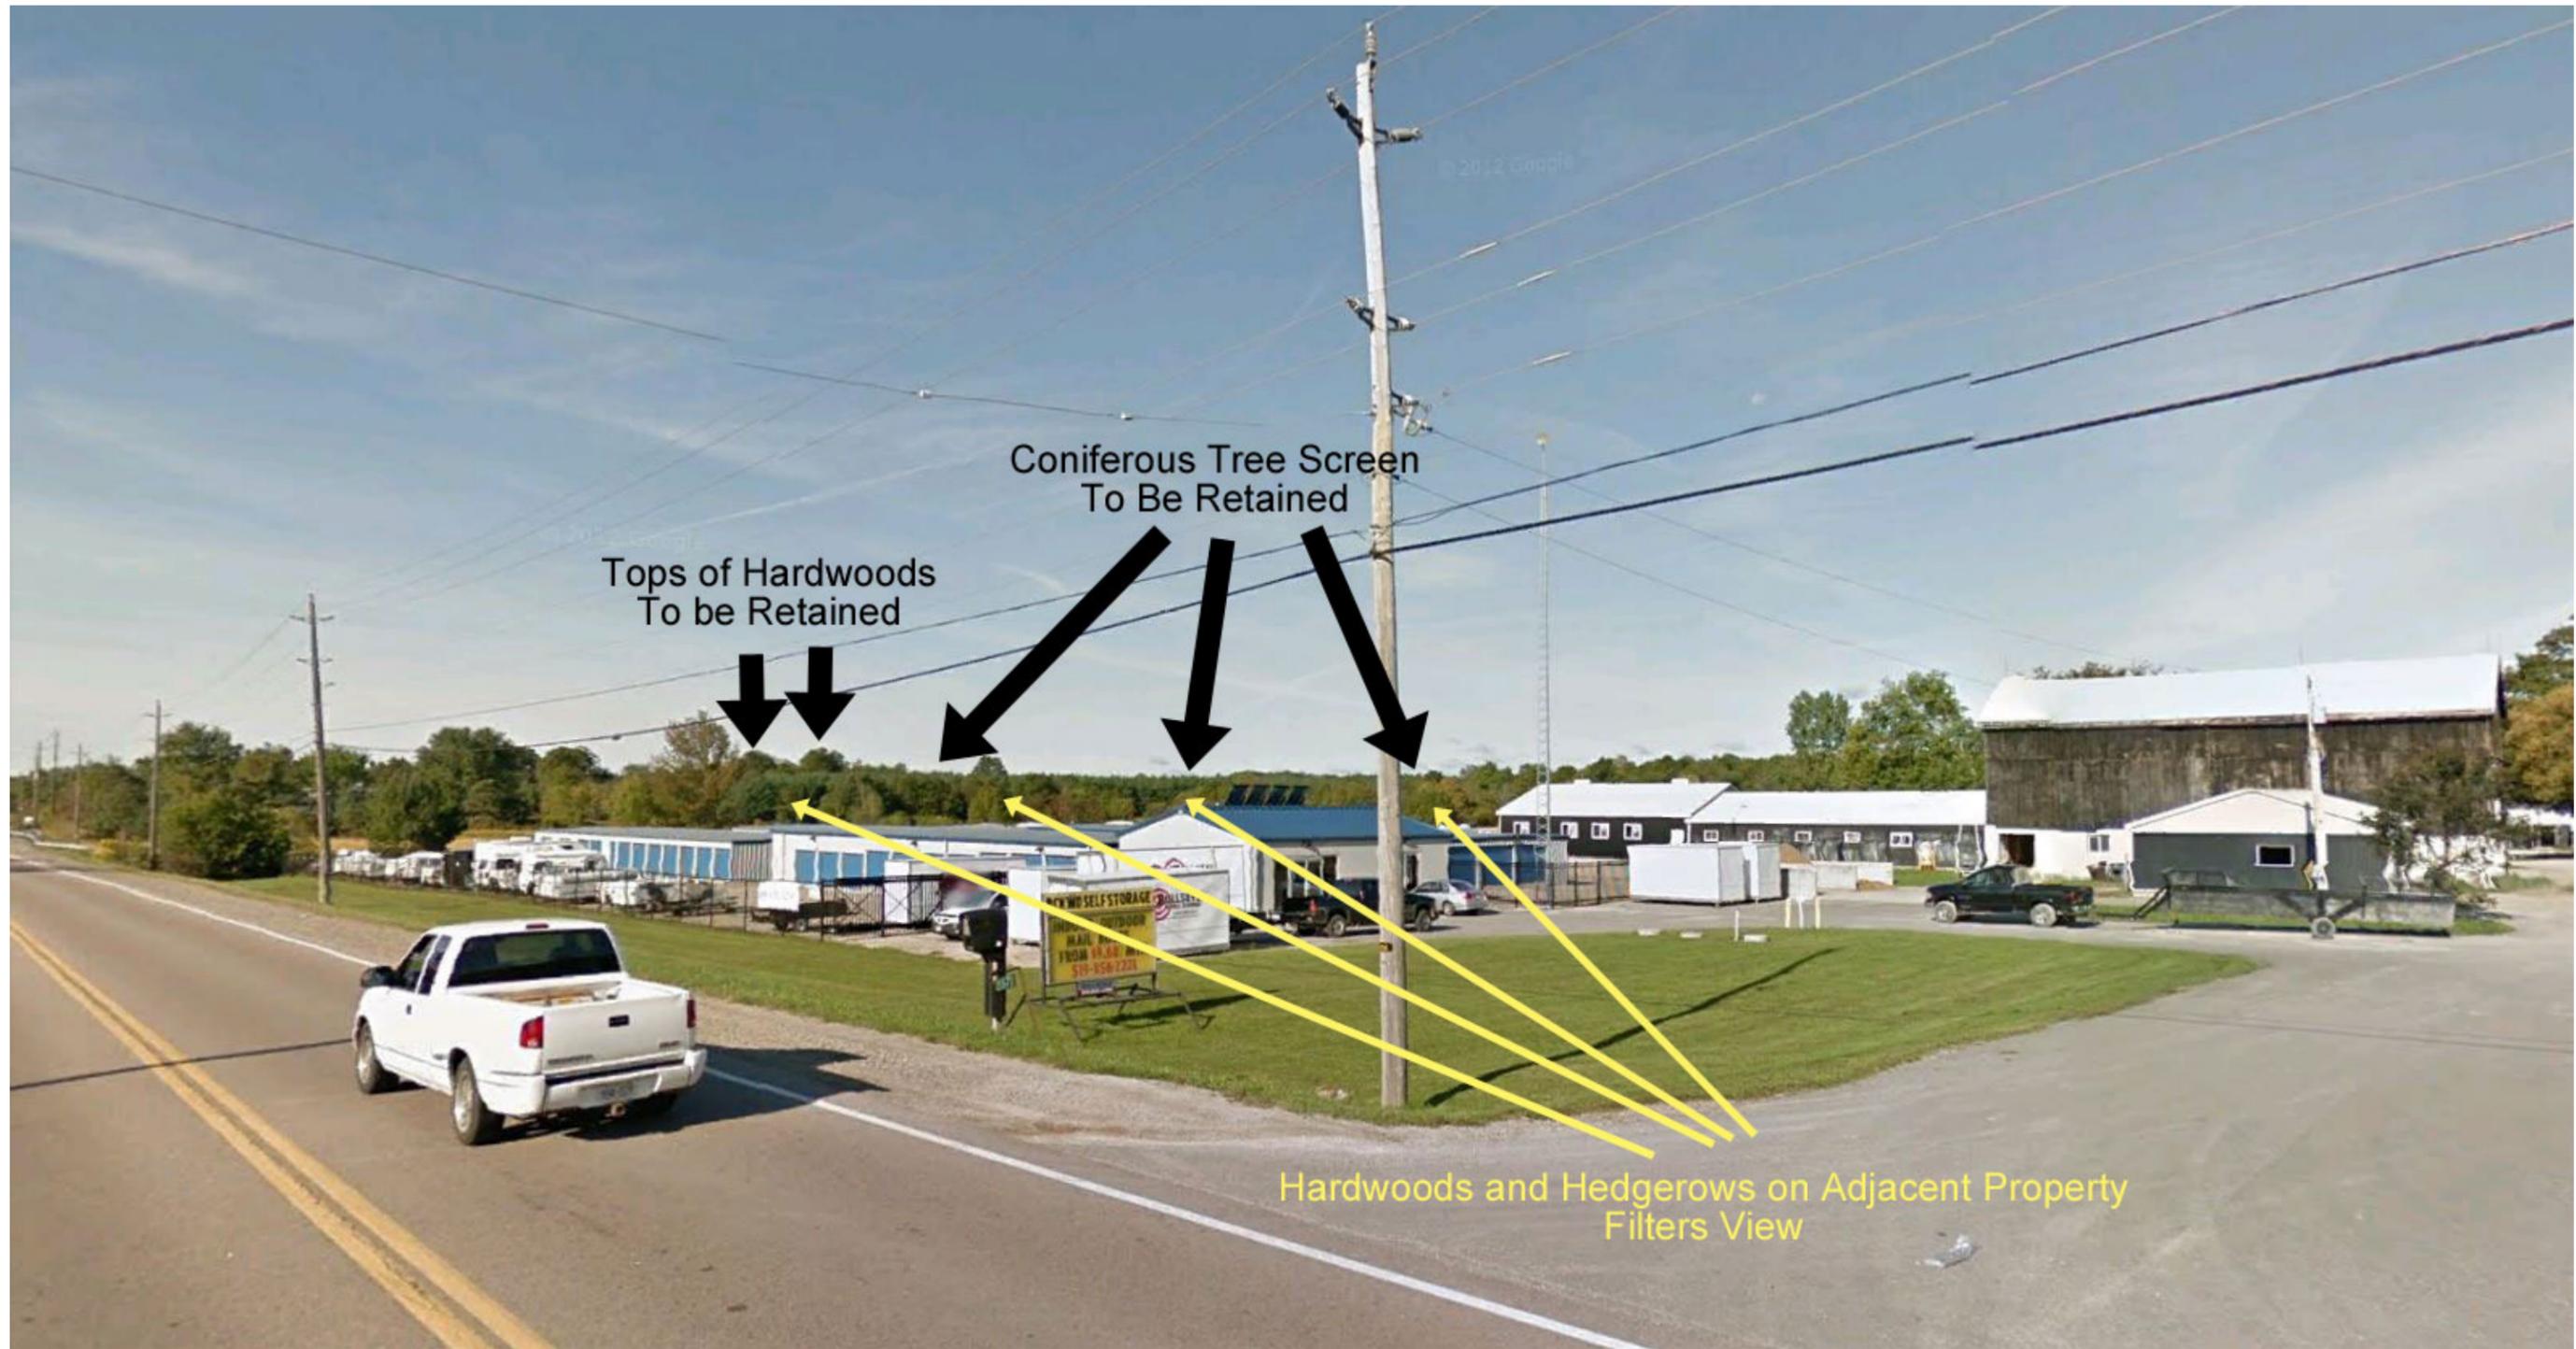
Photo 1- Looking over Rockwood Self Storage- Quarry not Visible

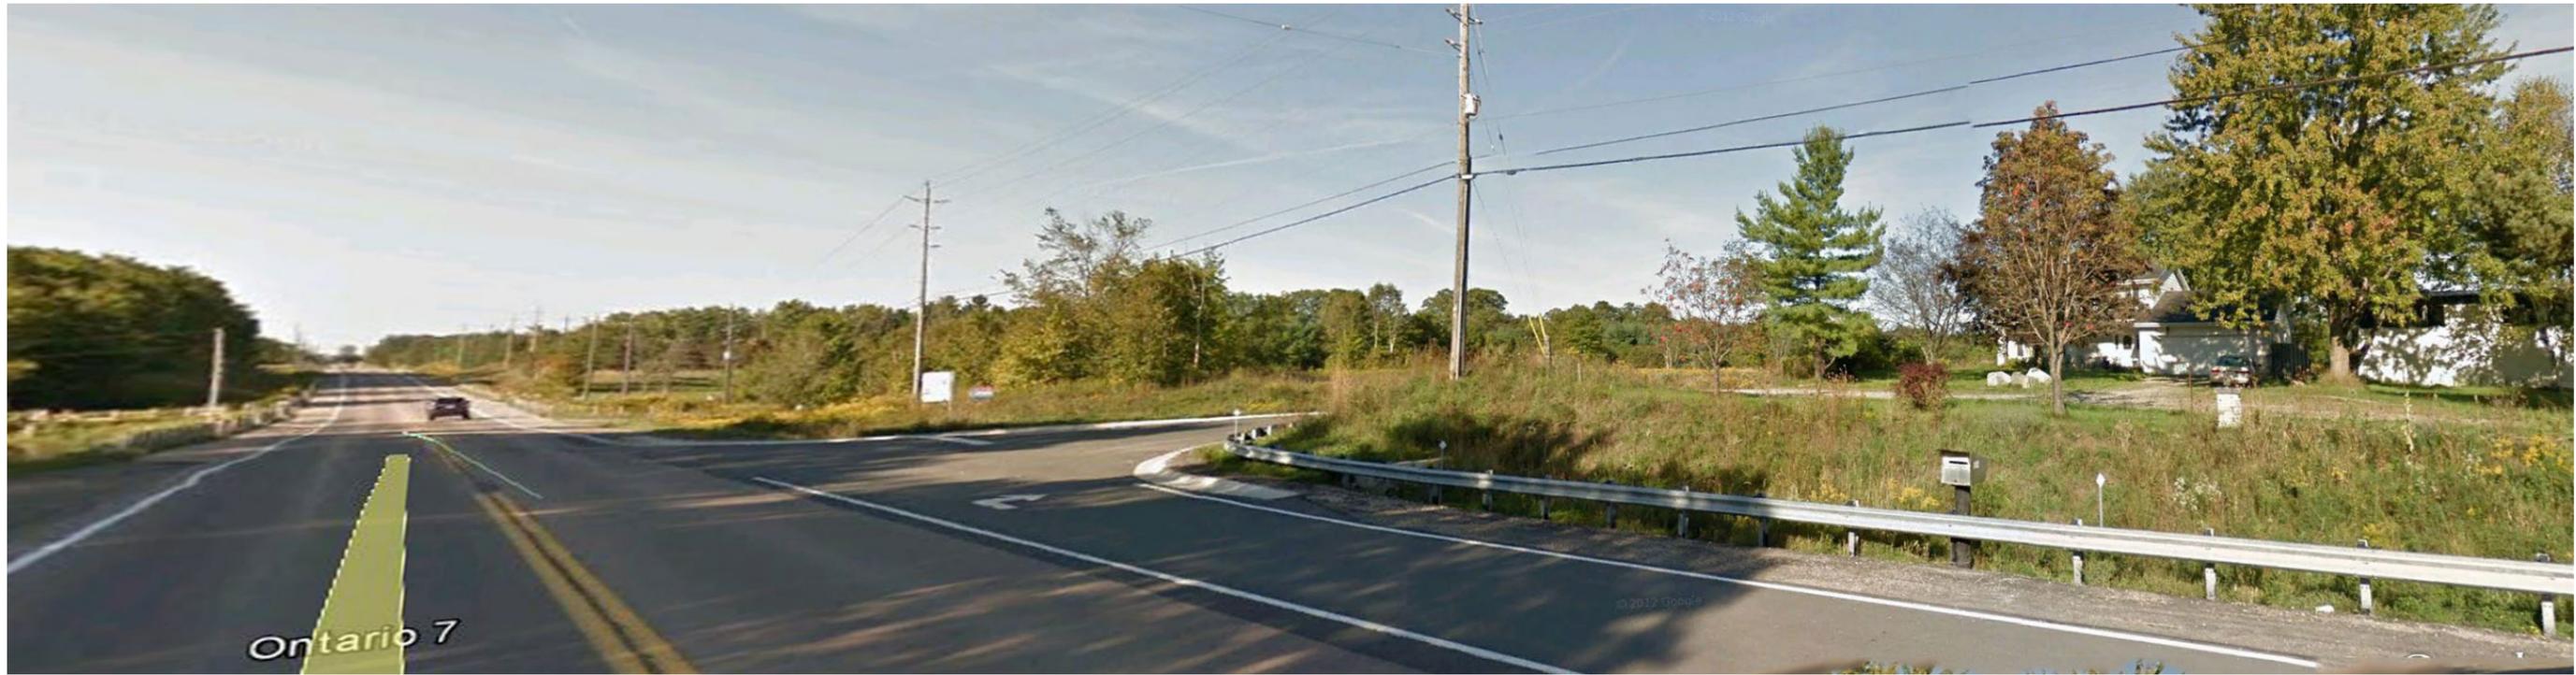
Photo 3- Panorama at Receptor 14 (below) Driveway- Quarry not Visible

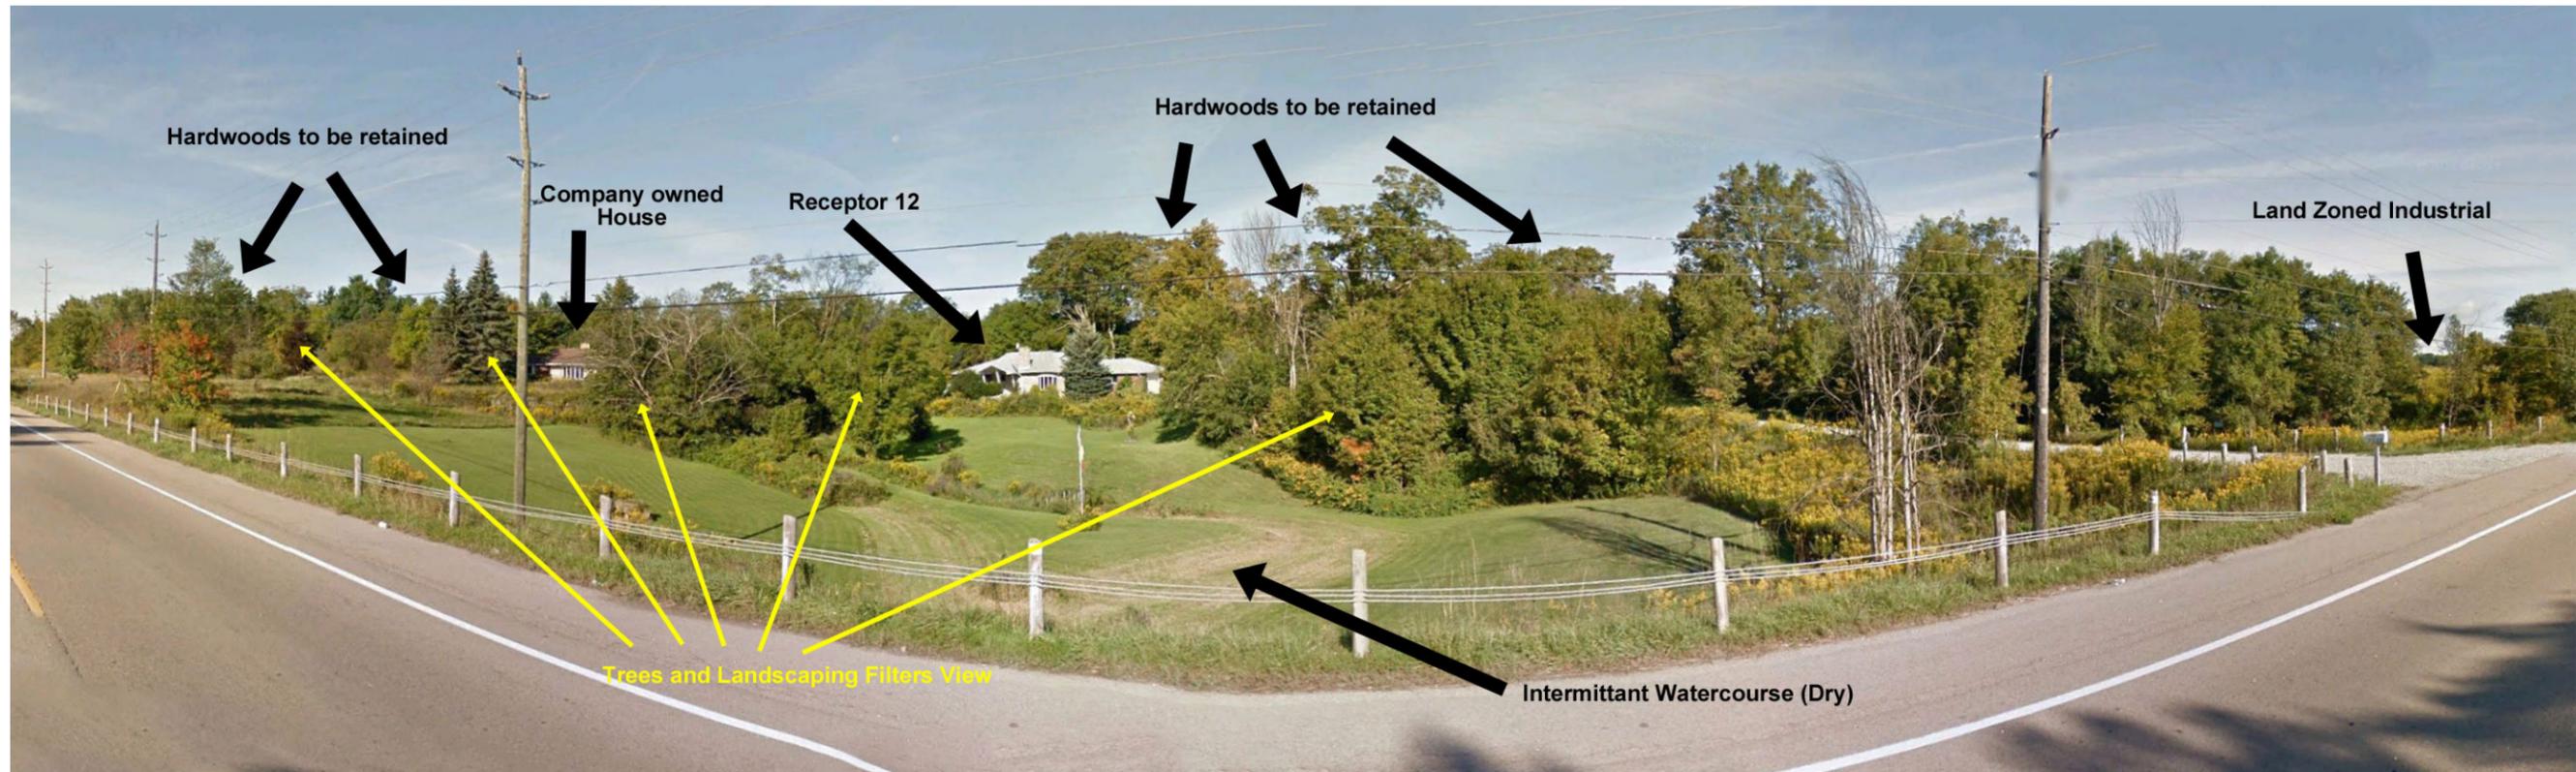
Photo 5- Panorama near Receptor 12- Quarry not Visible

Figure 13- Cross Section V3-V3' Analysis- Quarry not visible from any receptor. Heavy existing tree cover in existing bush and large setbacks completely hide quarry. See Photo 5.

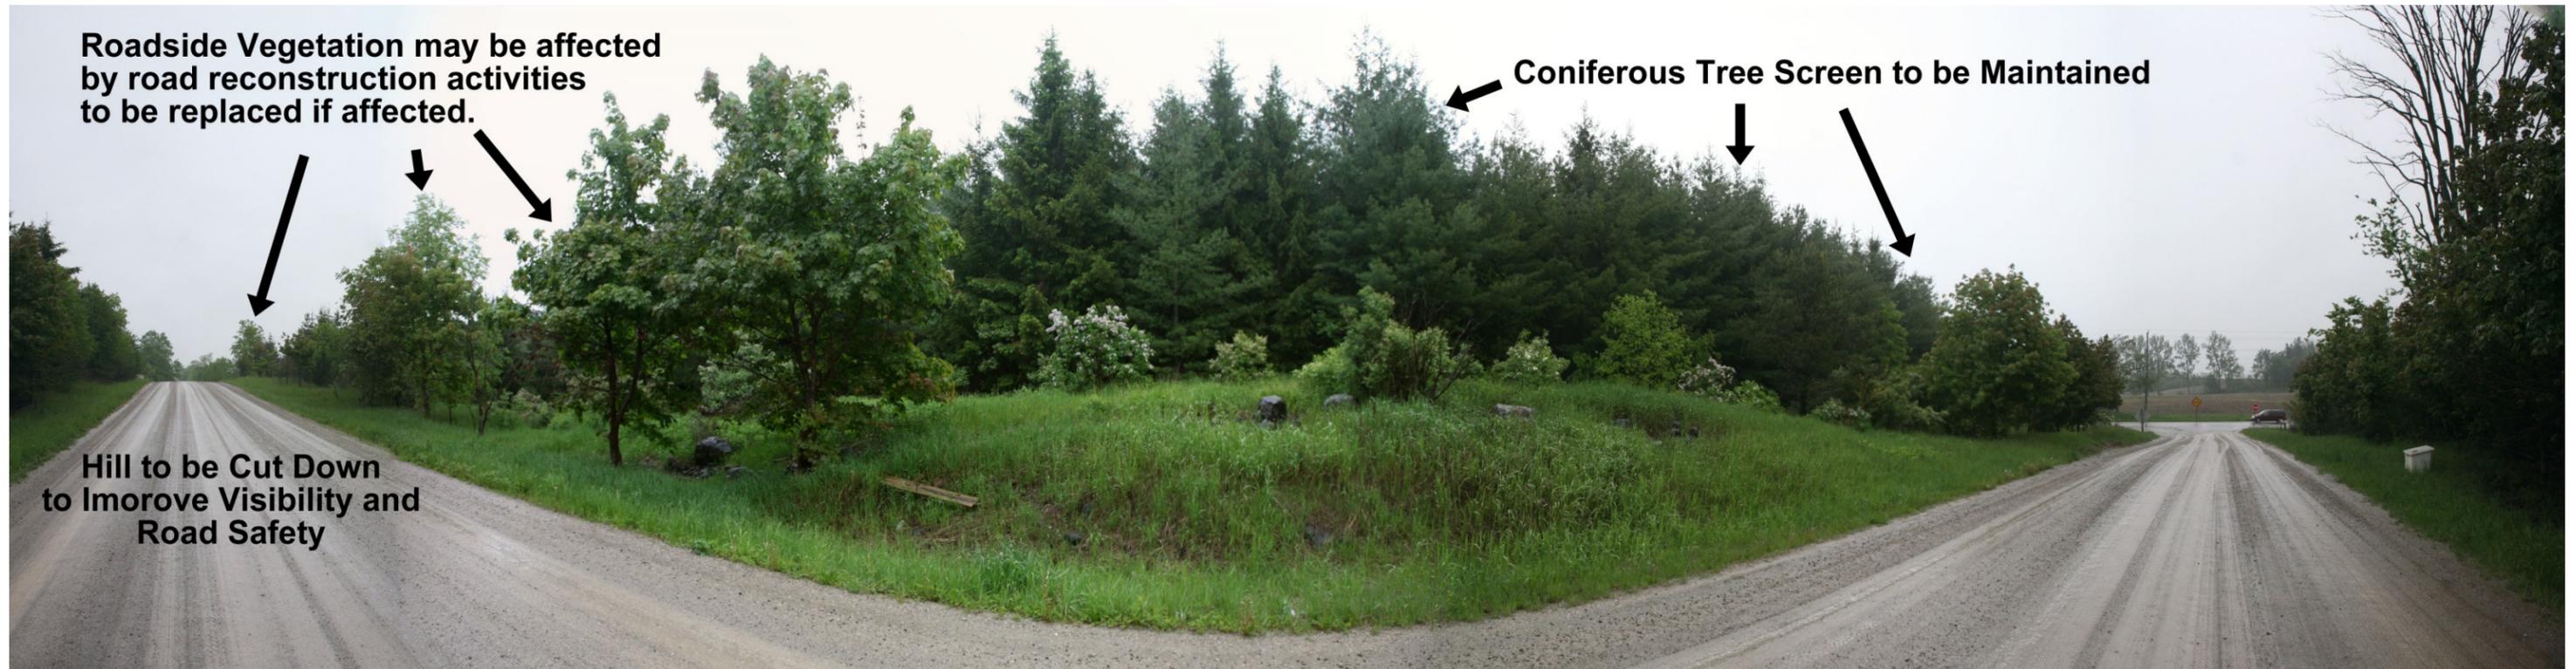
Photo 10- Panorama of the Sixth Line section that is to be the haul route between the Site and Highway 7- Quarry not visible.

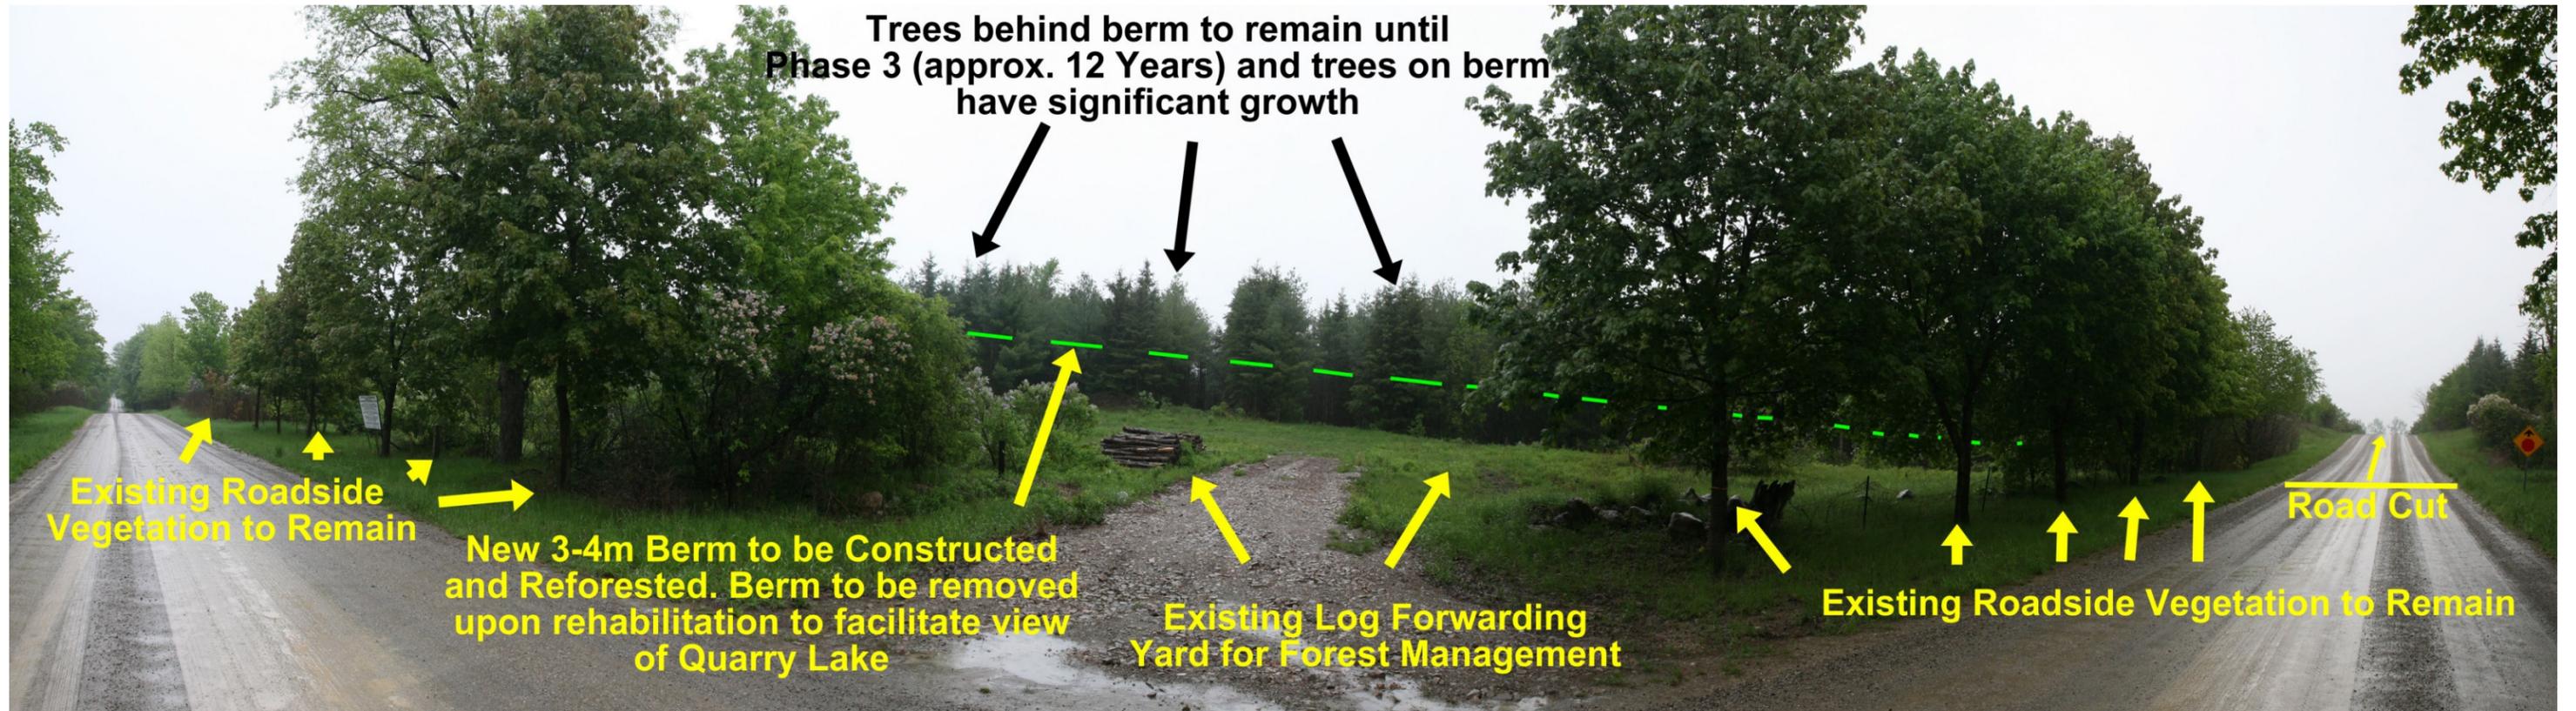
Photo 12- Current Log Forwarding Yard. Reforested berm will be visible in this area. Quarry not visible.

Figure 12- Cross Section V2-V2' Analysis- The quarry is not visible. The berm is visible through gaps in the roadside vegetation screen. The berm itself is to be reforested. See photos 12 and 13. The coniferous plantation is not to be removed until Phase 3 (approximately year 12 of the operation), at which time the reforestation on the berm will have achieved some size.

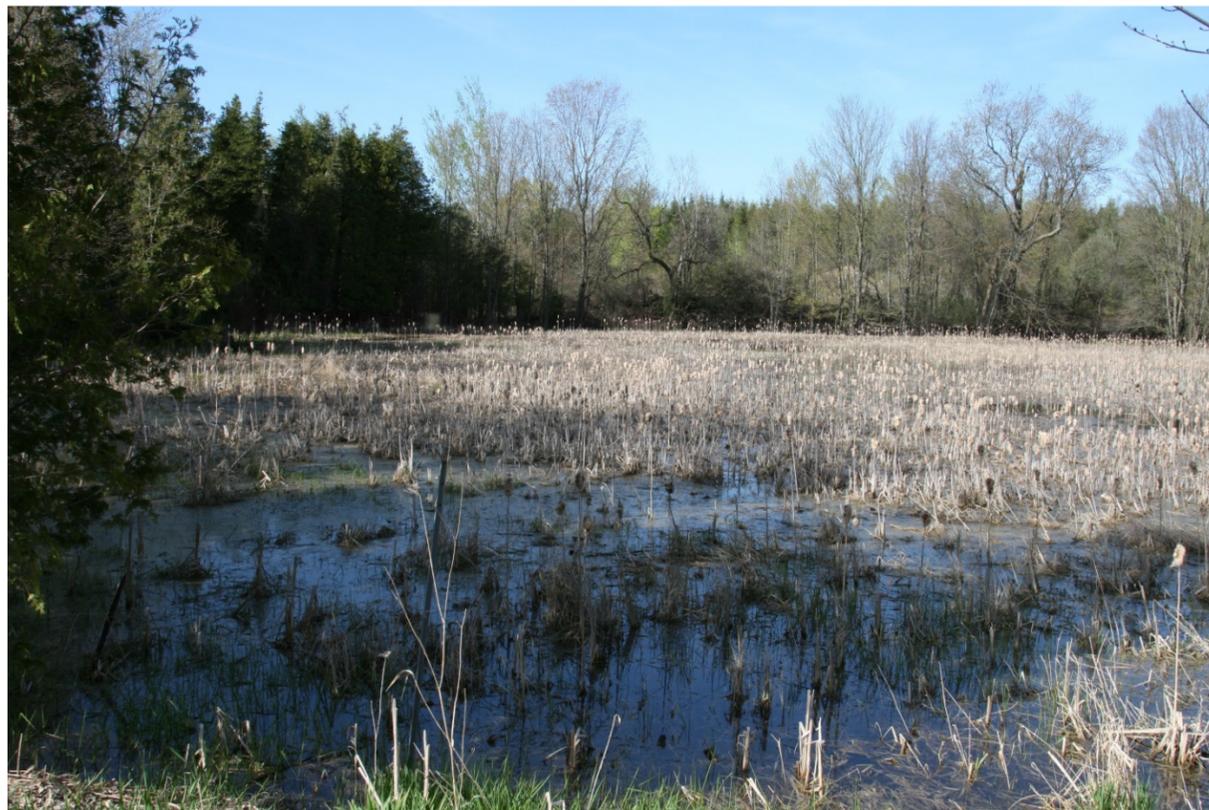
Photo 15a- Same view above in Spring before Leaf Out. Note Gravel Stockpile just visible in Old Pit.

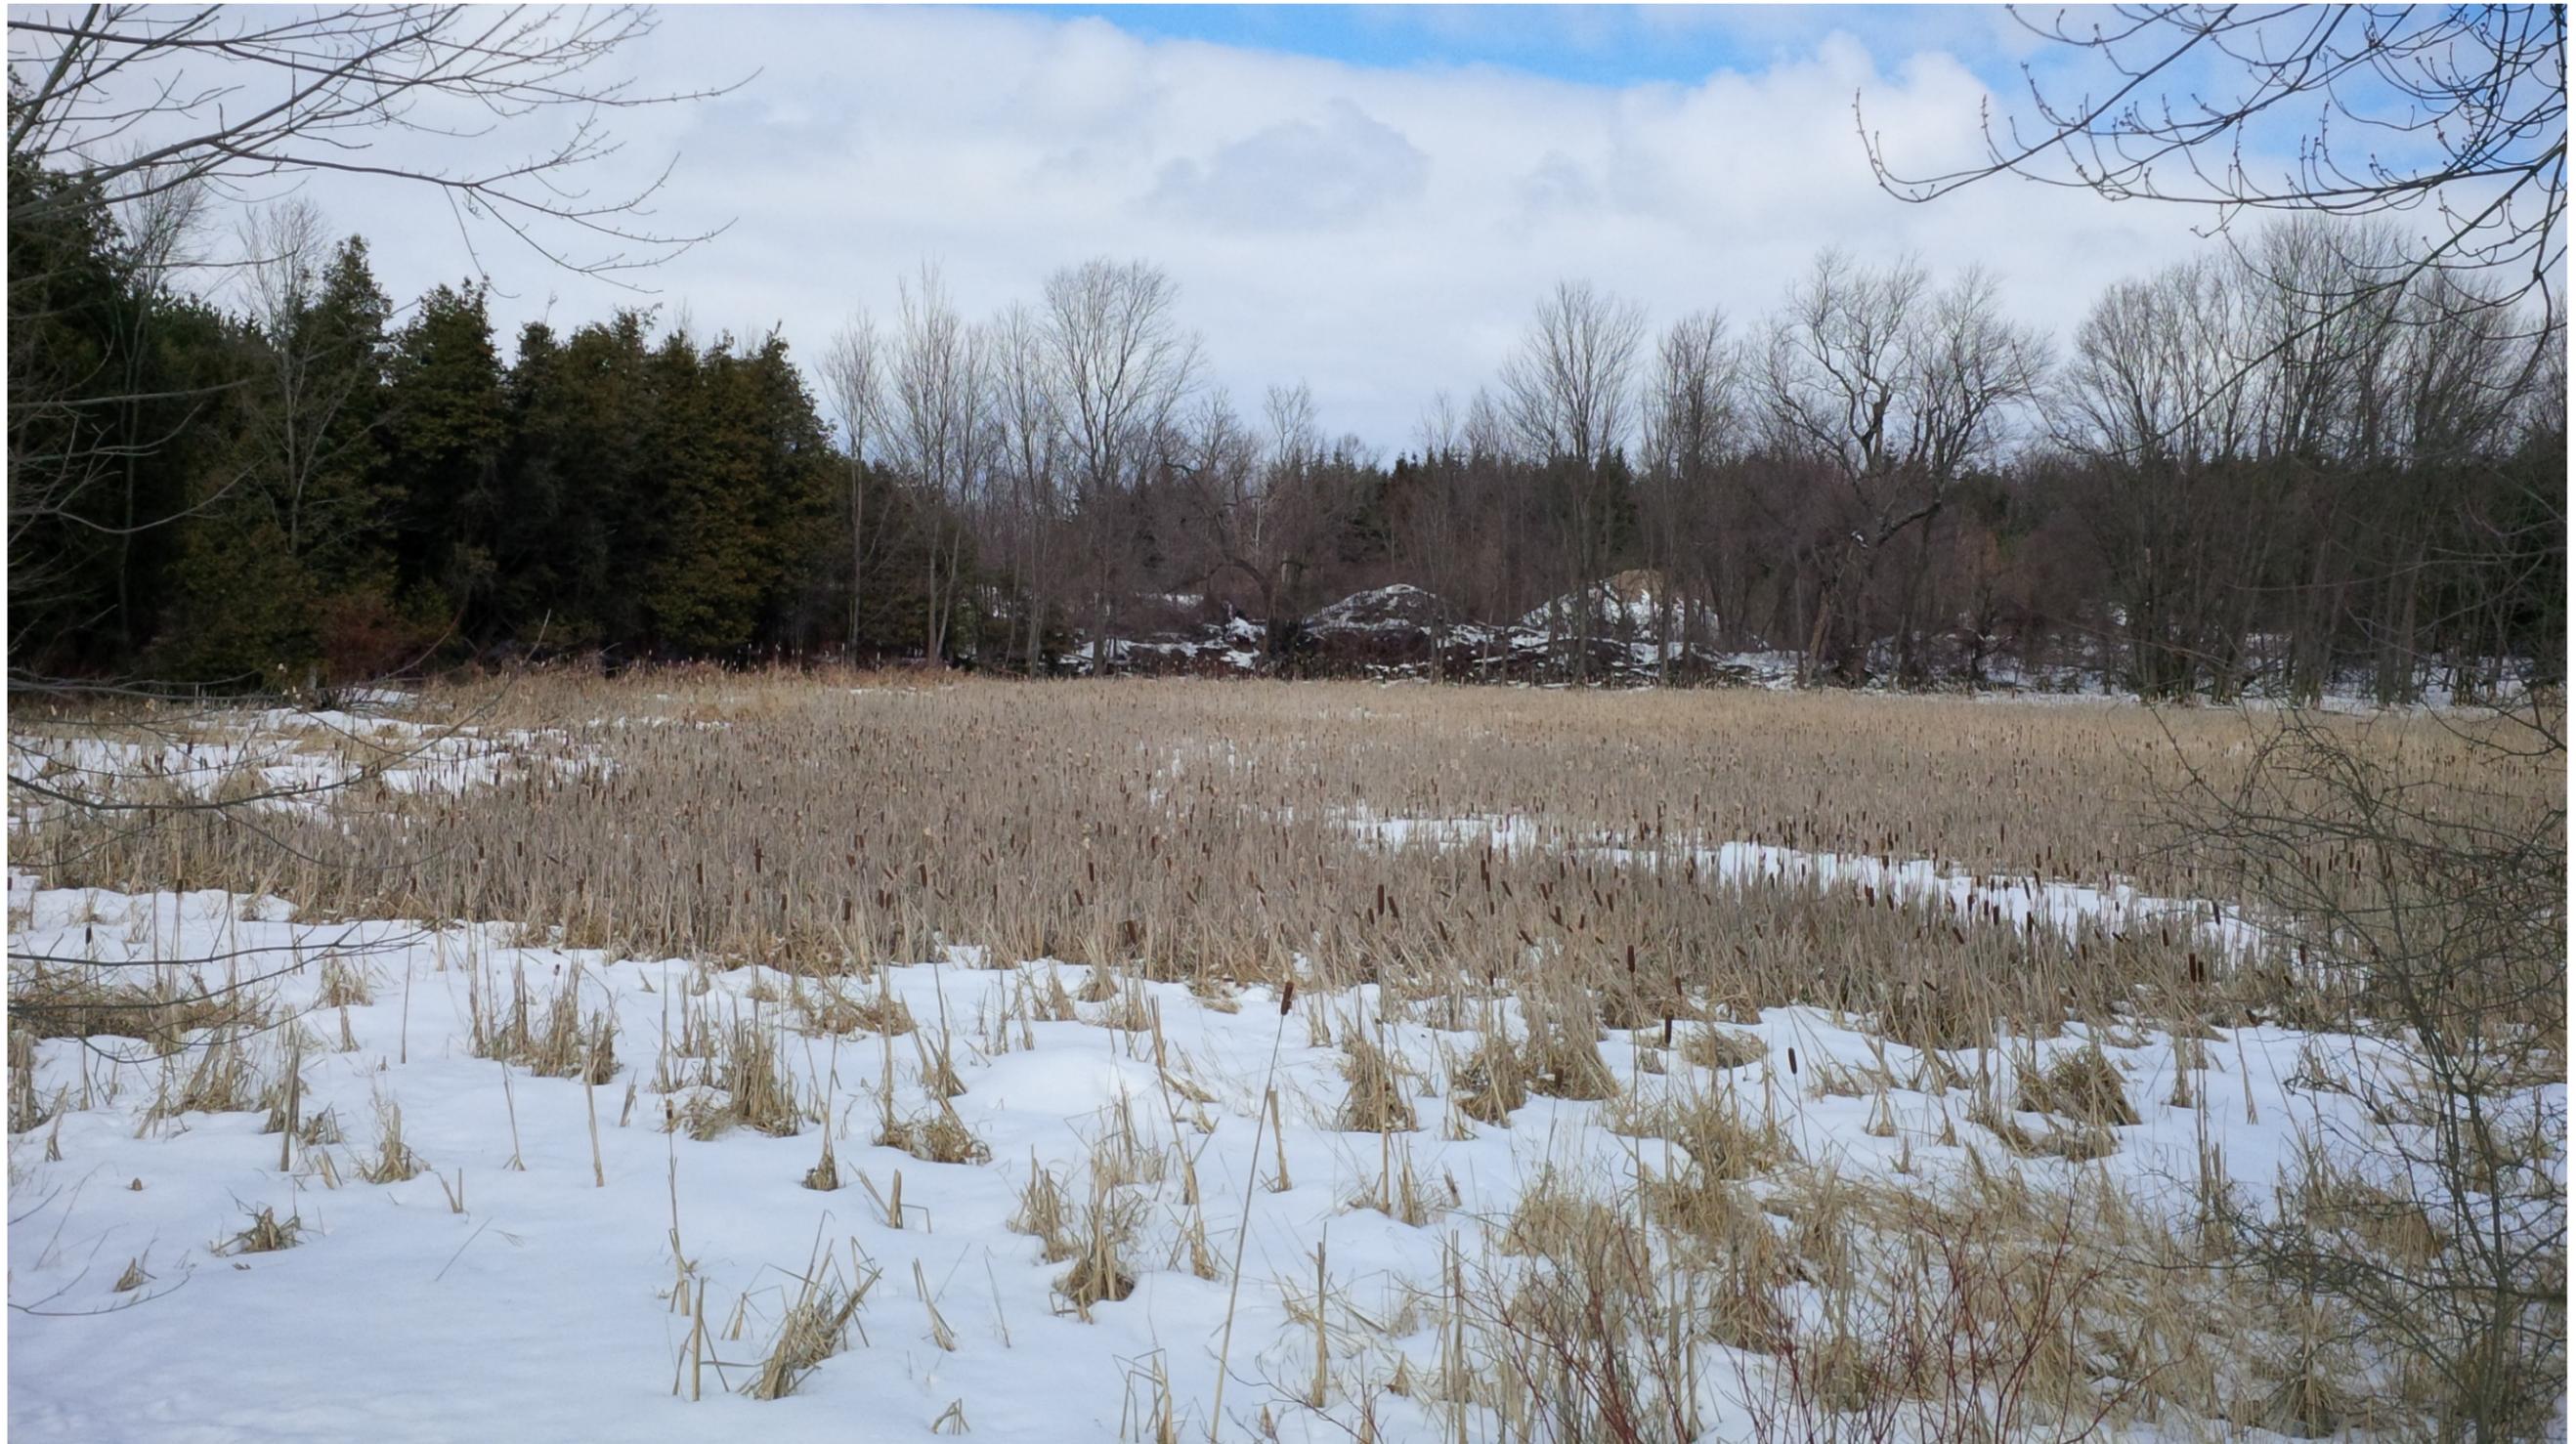
Photo 15b. Same view in winter. With no leaf cover the existing Gravel Stockpiles and Vegetated Berm are visible on the far side of the Wetland. Note that the new berm will be a similar elevation to the large gravel stockpile. It will be seeded and reforested. The conifers in the distance will be removed in Phase One. All Conifers on the left side of the wetland will be retained.

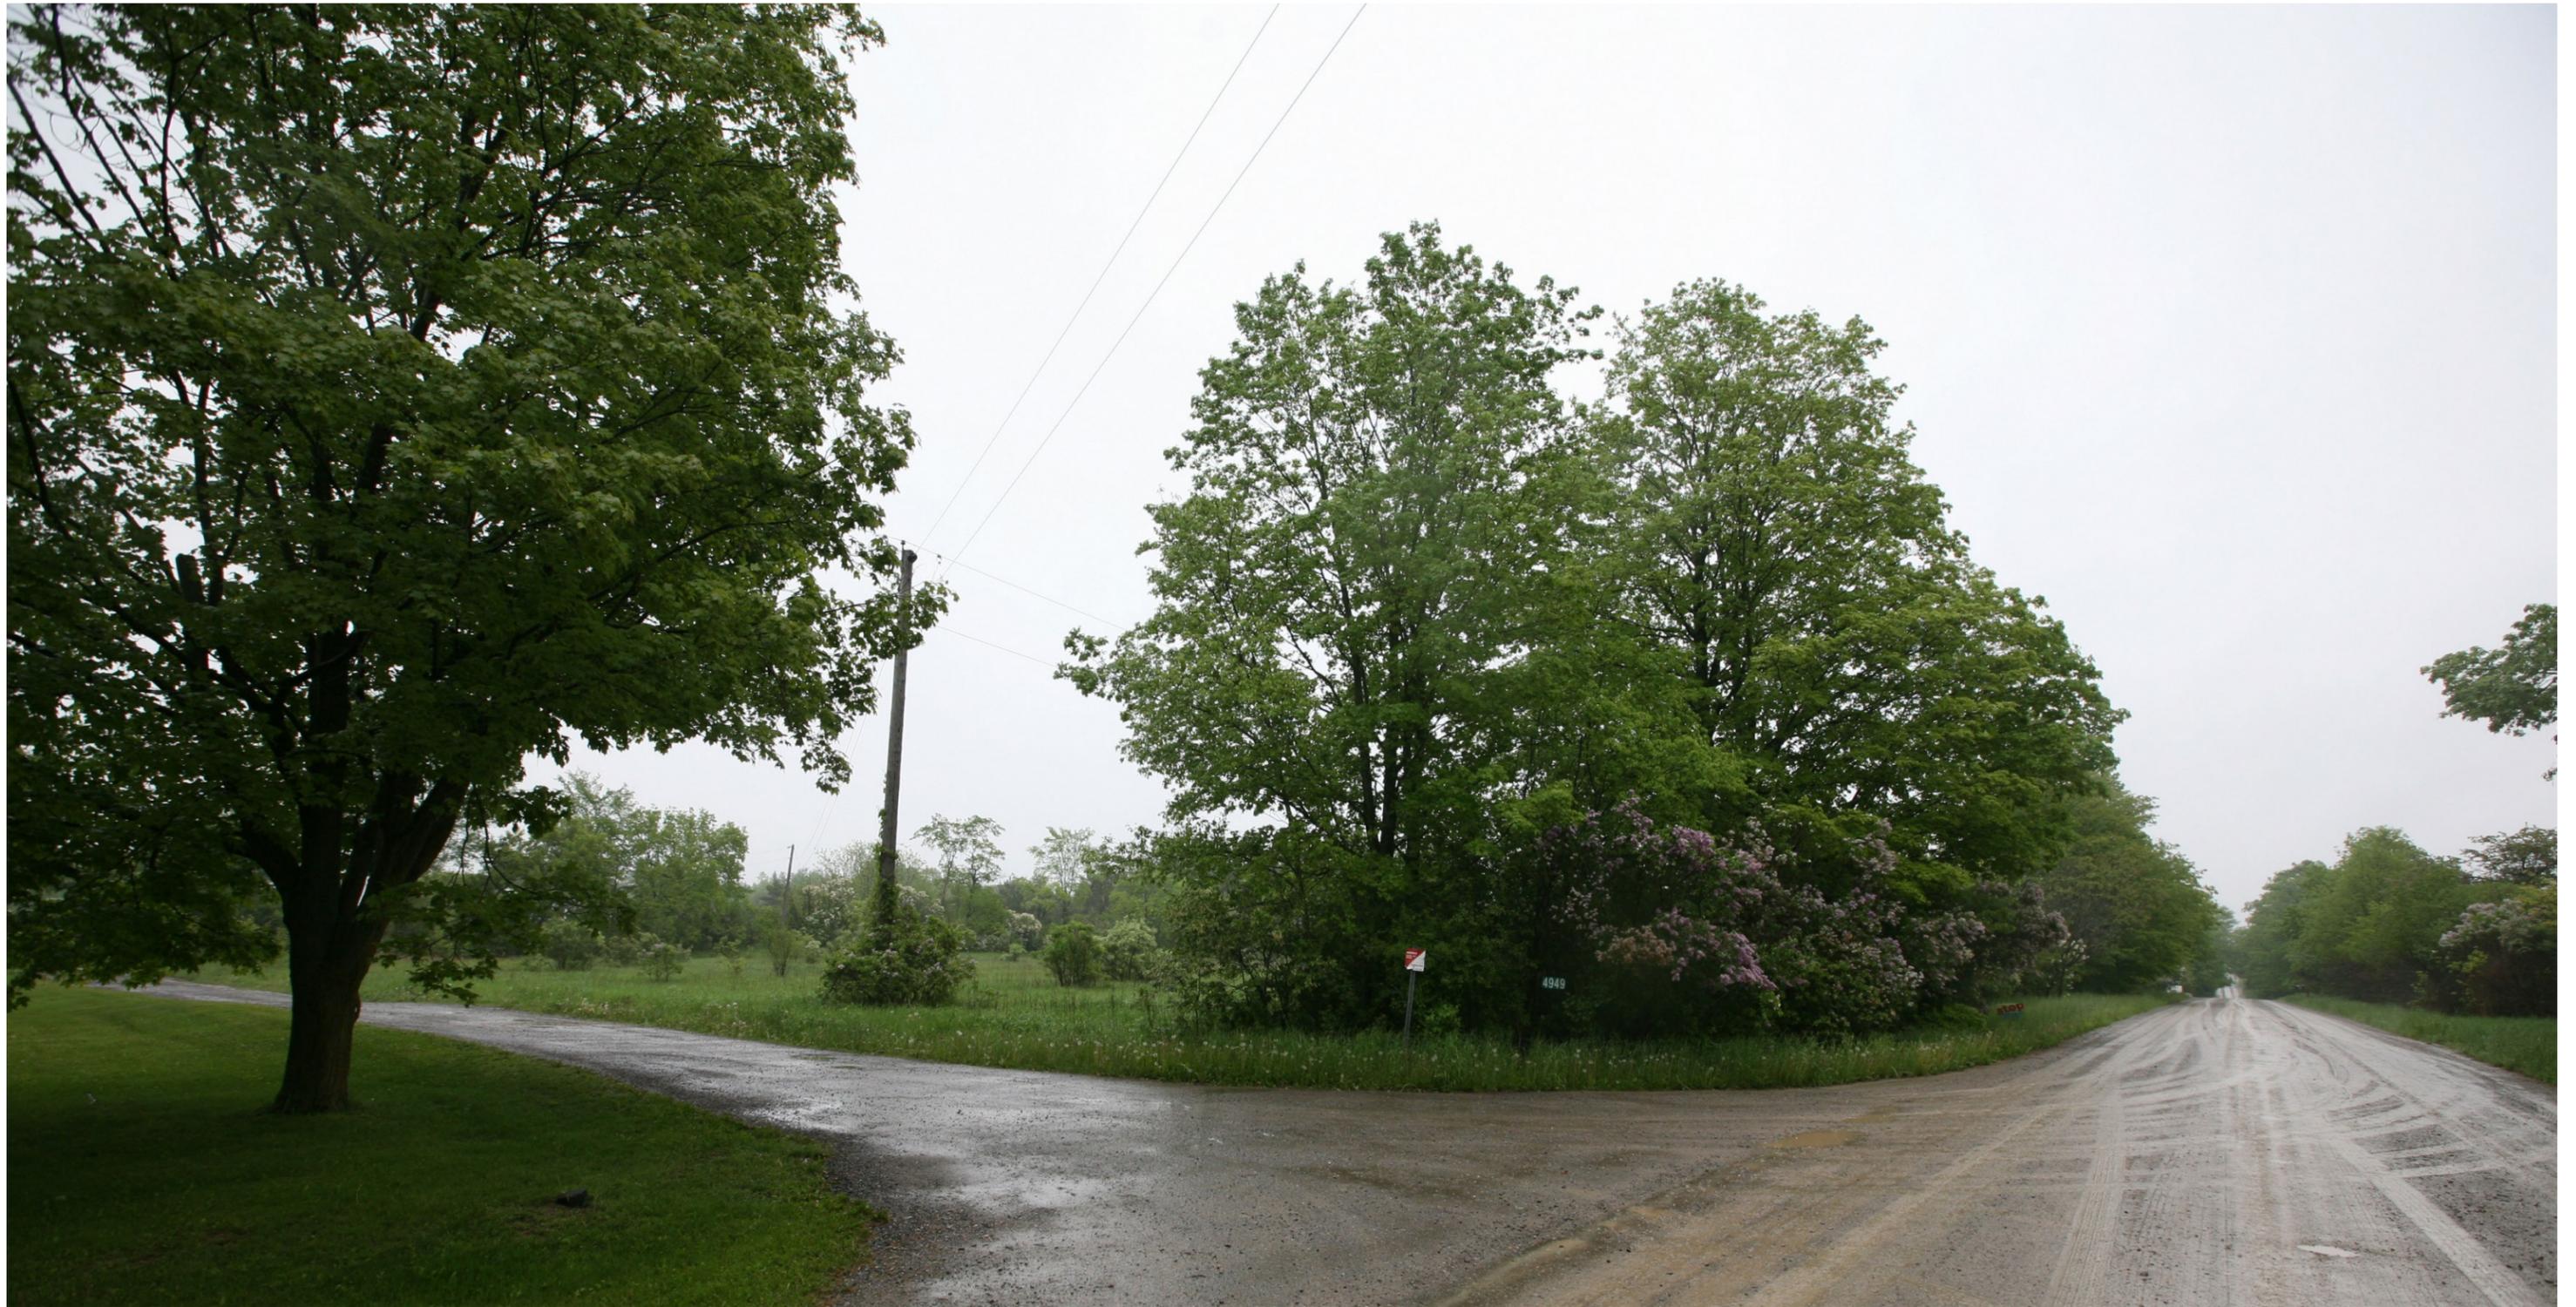
Photo 17- View to the South looking from the driveway on the sixth line beside Receptor 11. Various vegetation in small woodlots and hedgerows screens views of the quarry.
