# Evidence Book 15

## Township of Guelph/Eramosa Visual Impact Review Document Book

# Visual Information Package

## HIDDEN QUARRY

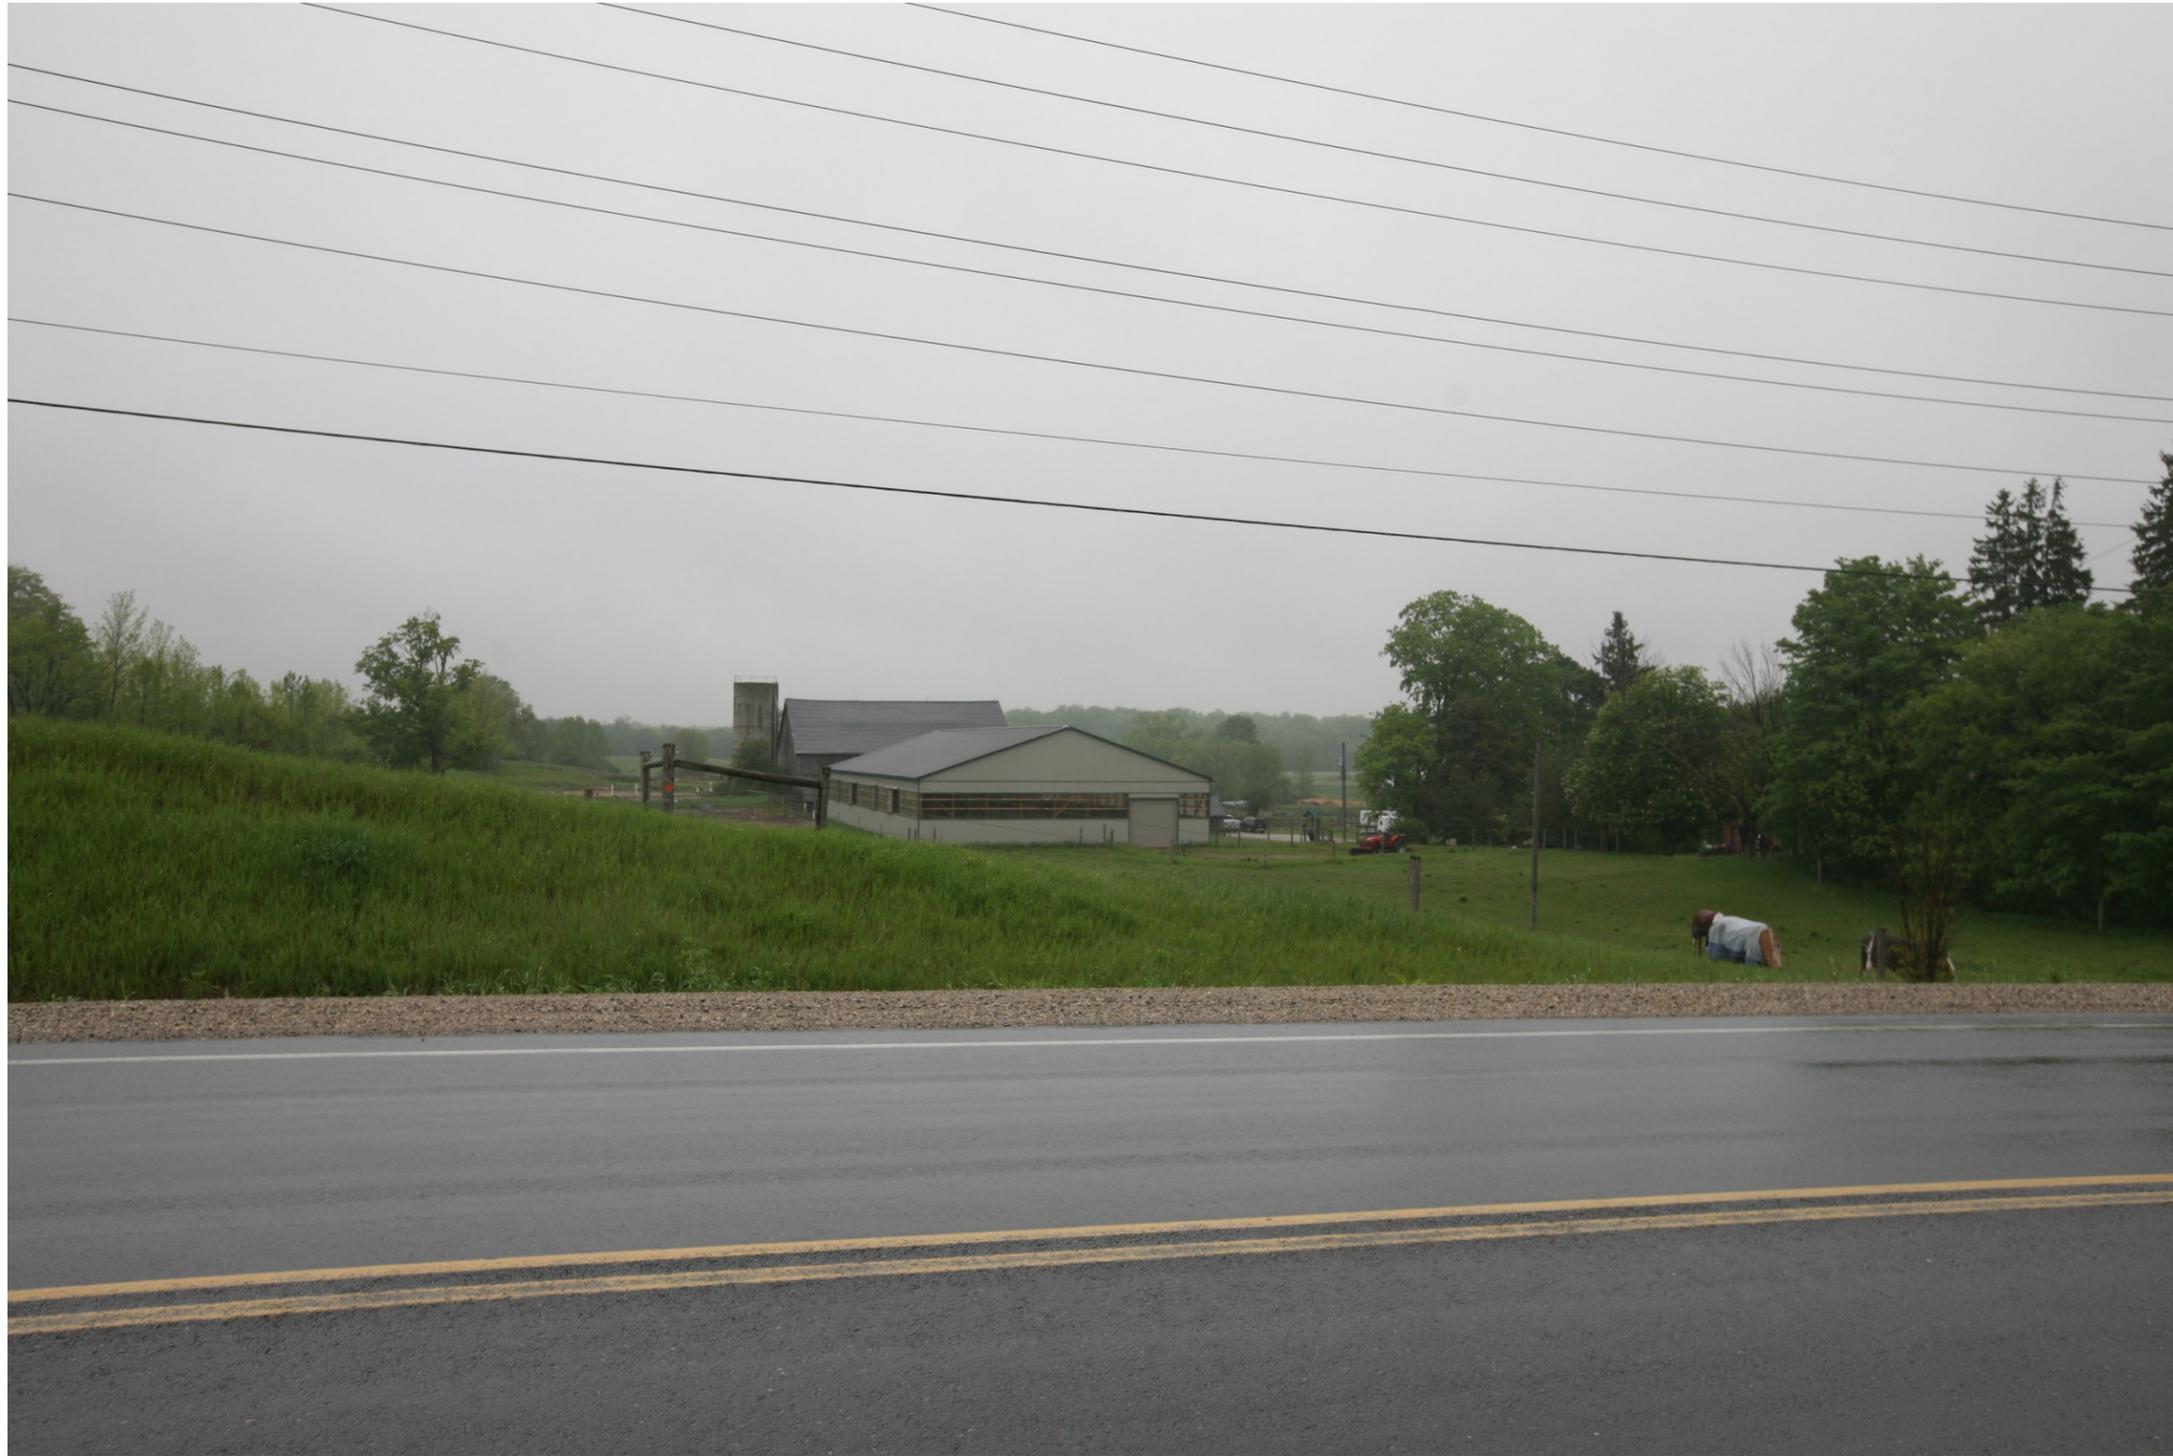
Photo 22-Taken from rise on Highway 7 just south of Rockwood- Quarry not visible behind distant hardwood bush. Distance to quarry approximately 1.6 km.

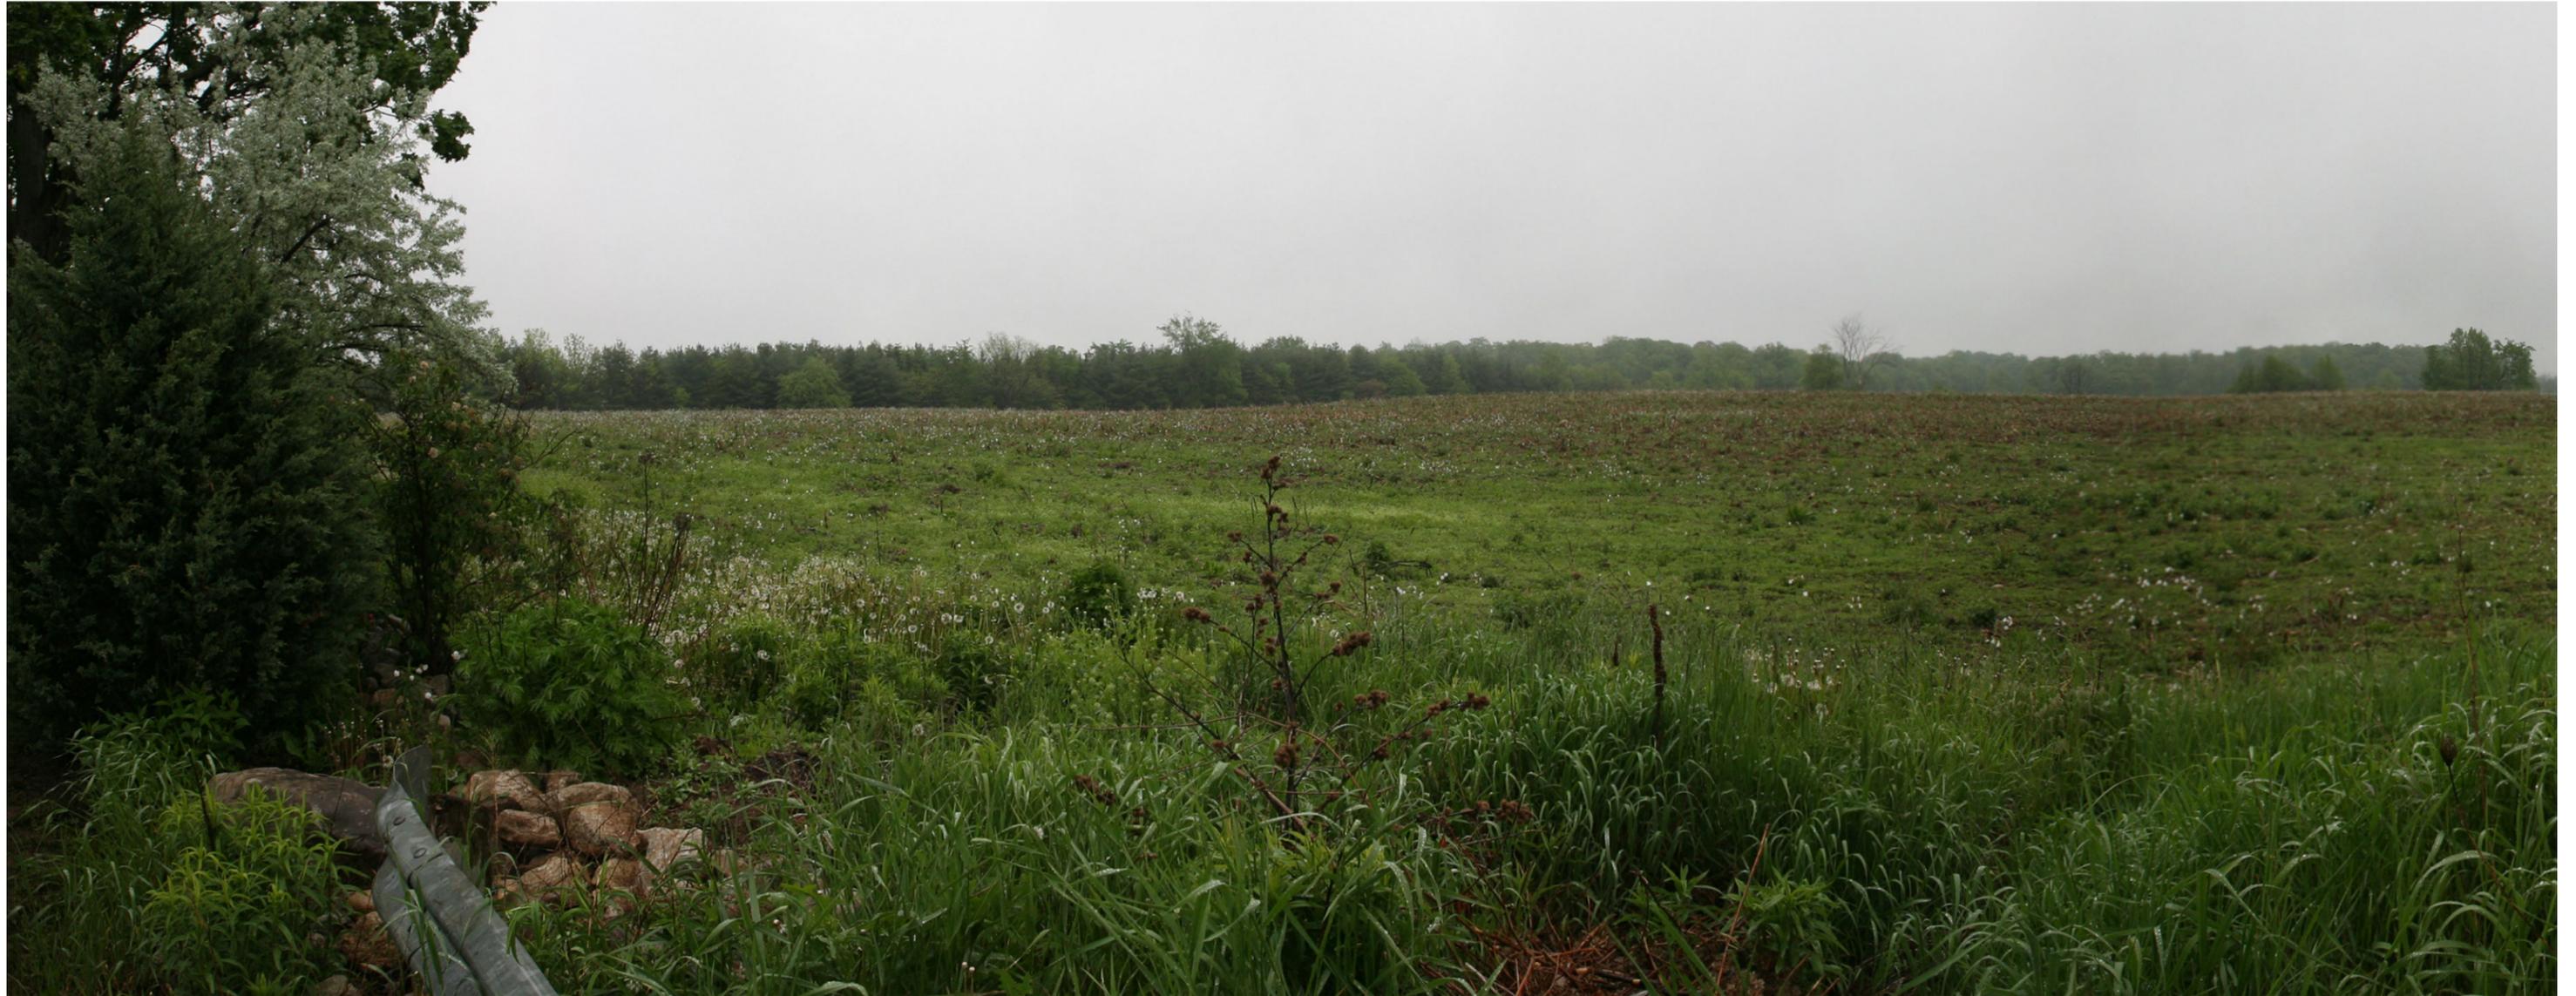
Photo 23- View from stub end of Ridge Road near intersection with Milne Place- Quarry not visible behind mixed forest block in distance. Distance to quarry approximately 1.1 km.

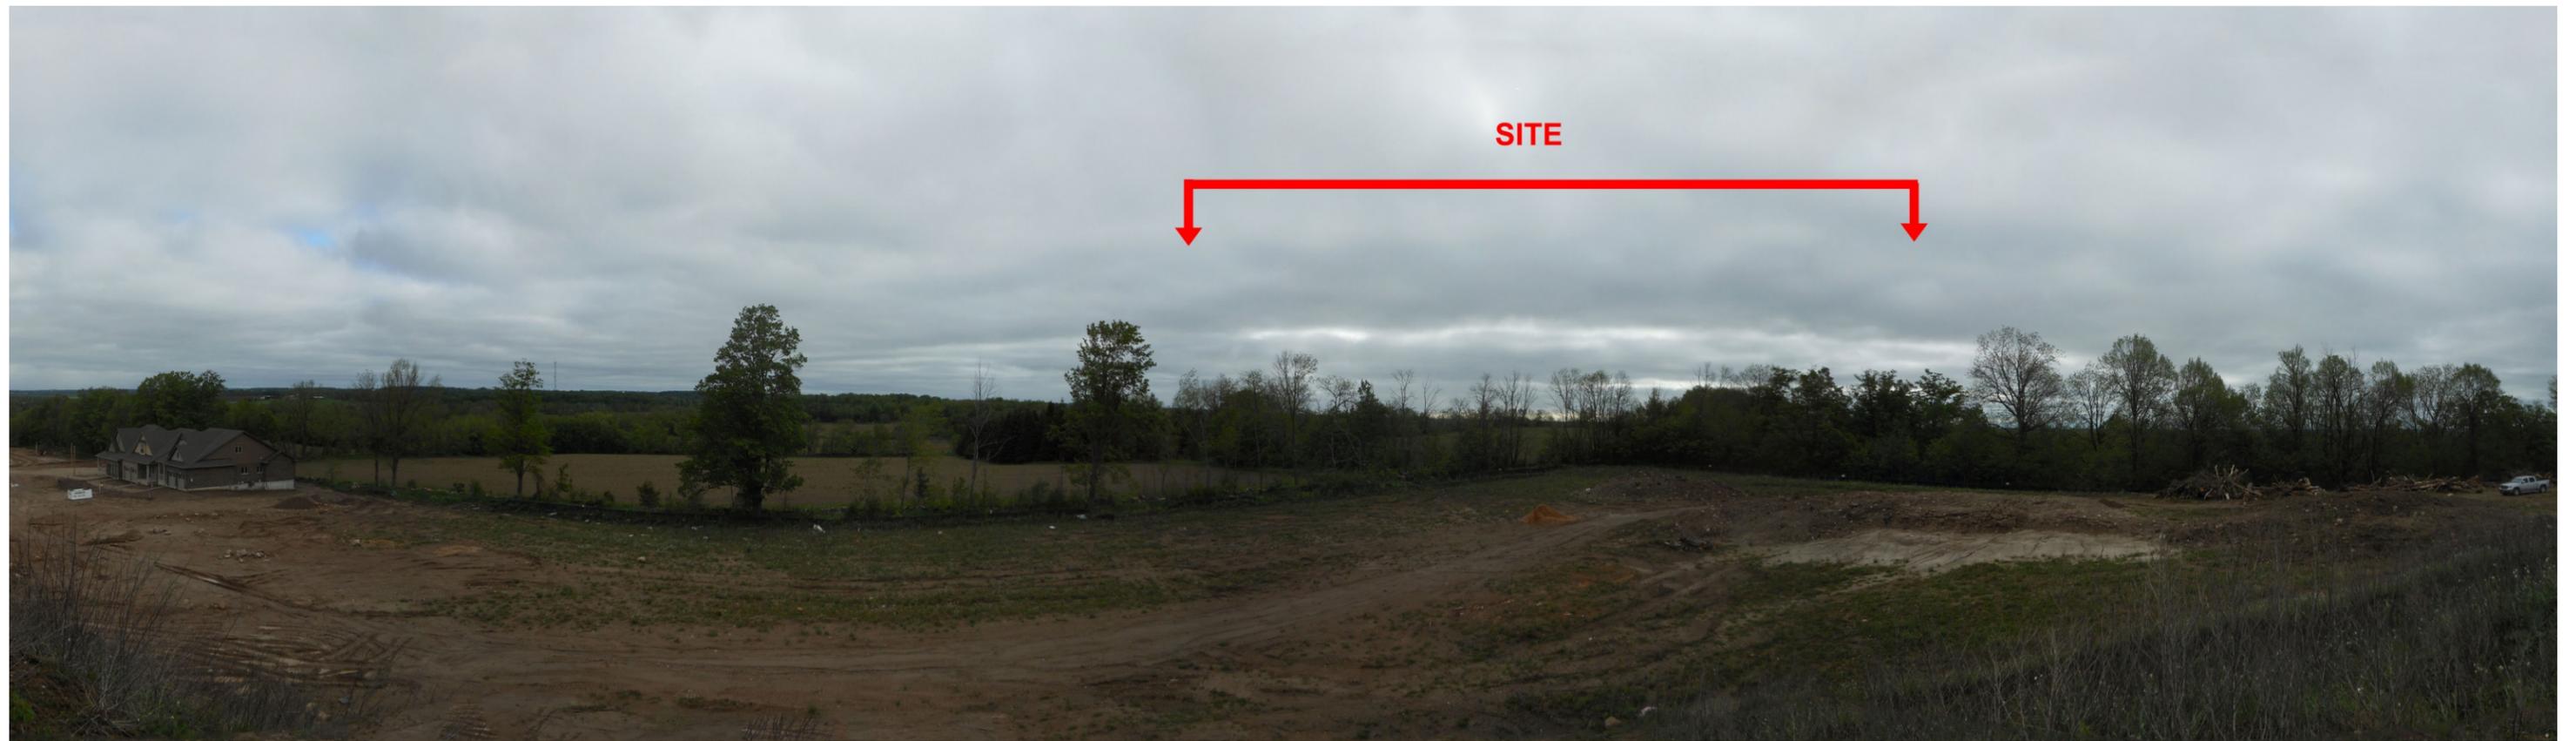
Photo 24- Panoramic photo taken from the top of a topsoil stockpile in the new housing development at approximately 30 feet above grade (ie top of roof height). The rise of land, the mixed wooded blocks and the hedgerow screening completely block any view of the quarry. Distance to Quarry approximately 1.5 km. Note the model homes on the left.

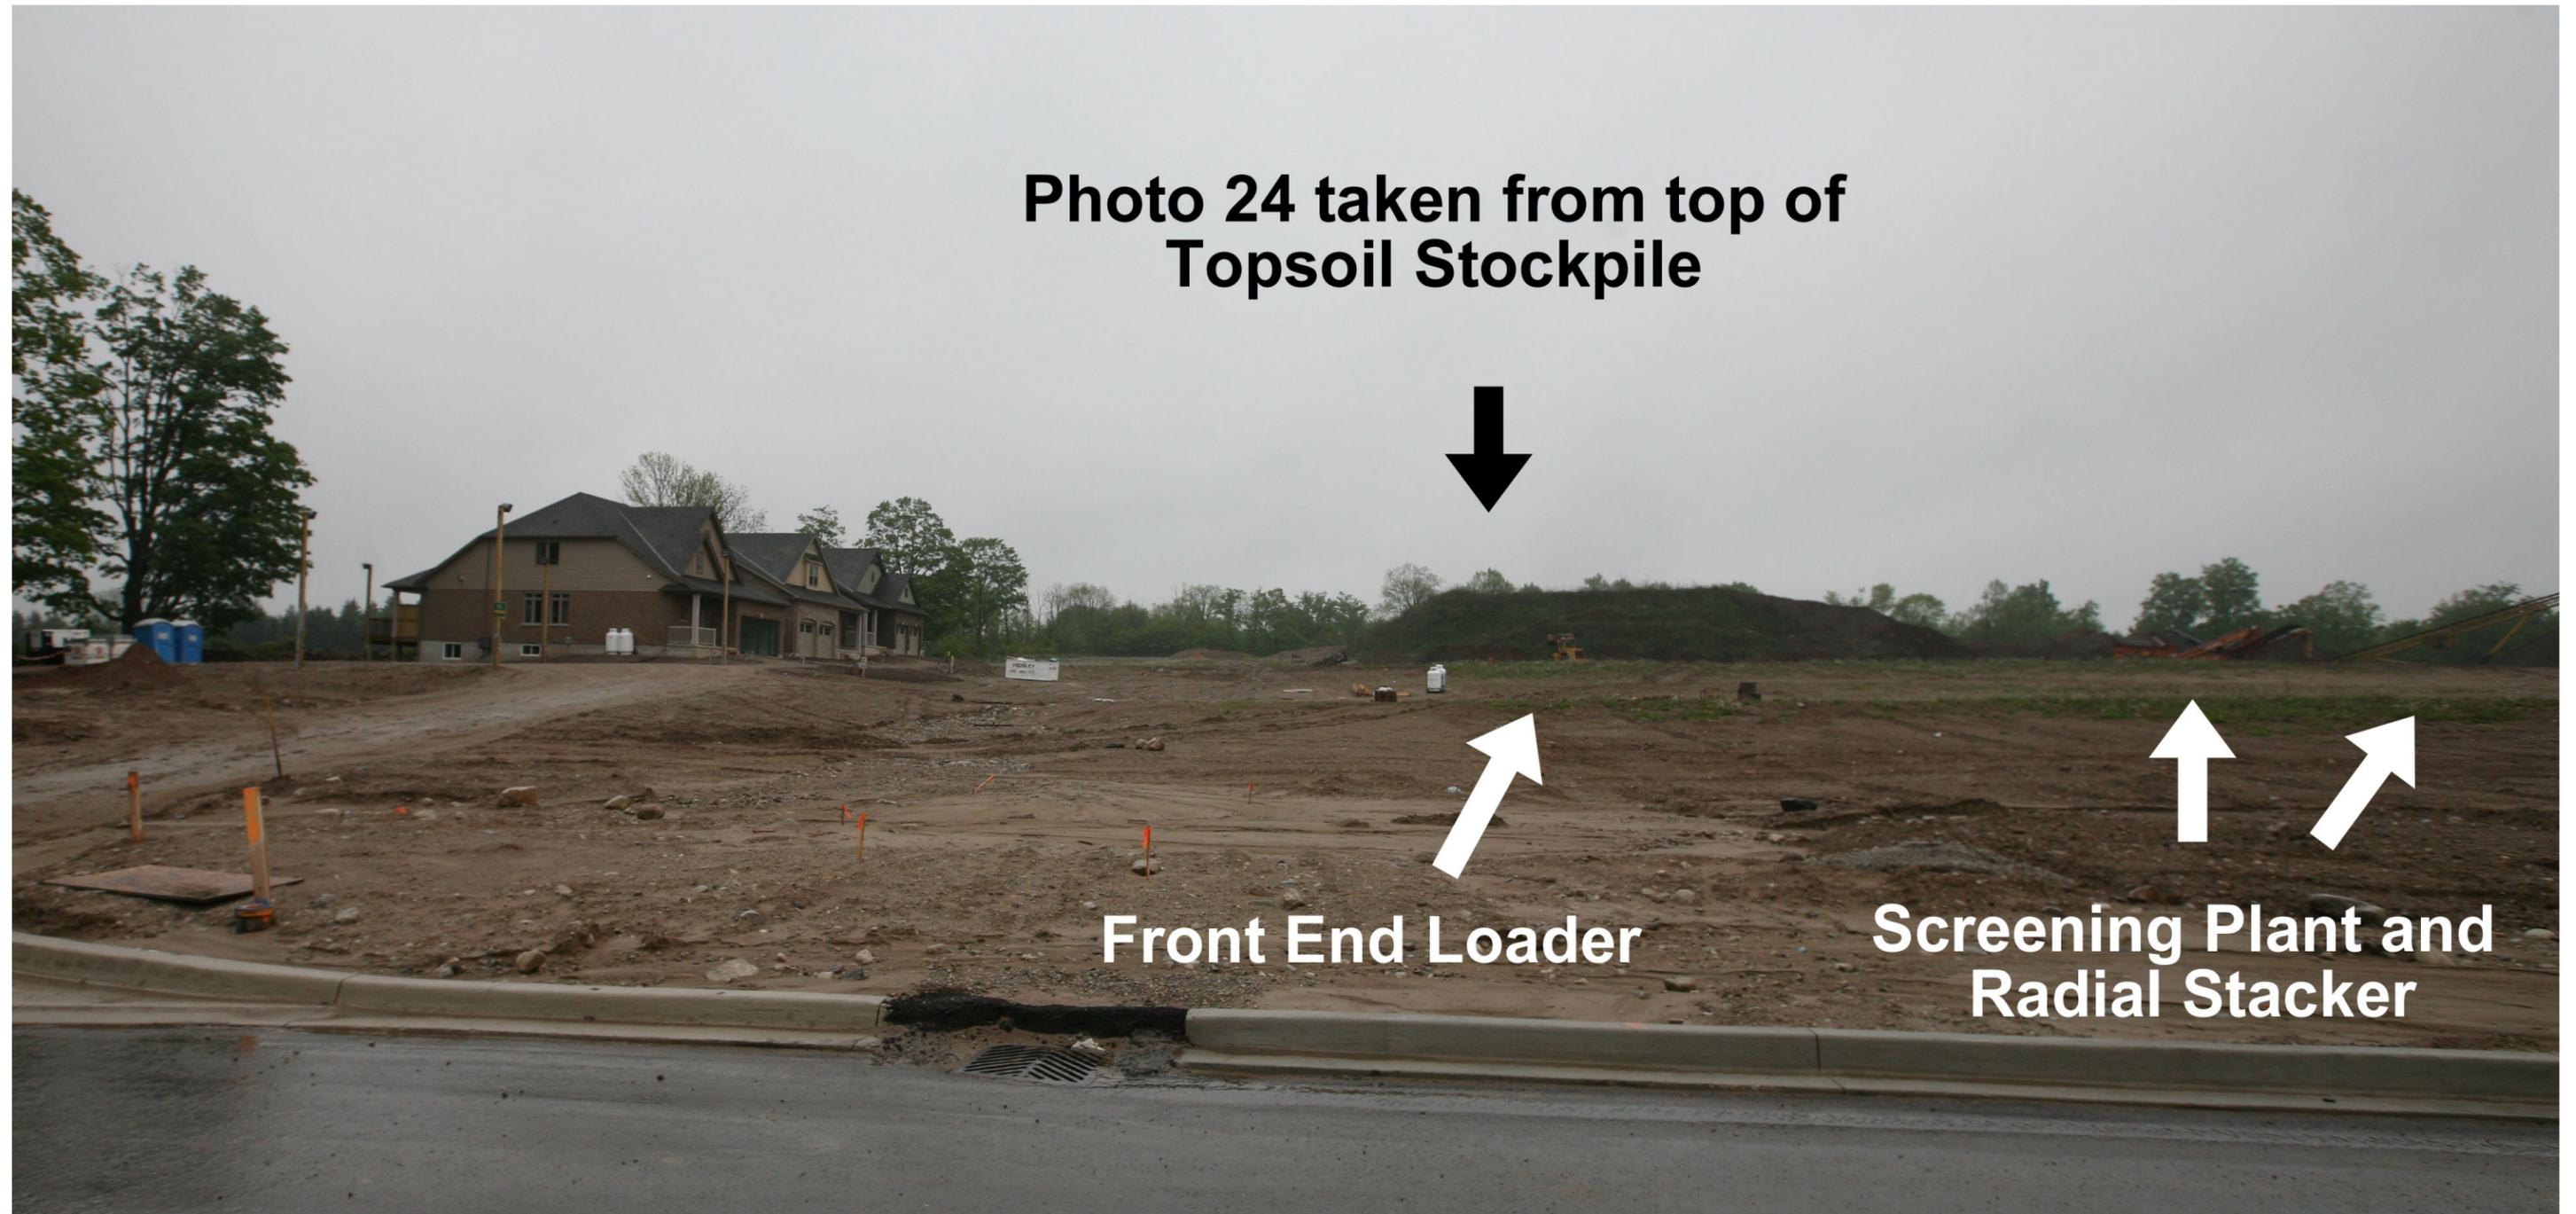
Photo 24a- Photo of stockpile where Photo 24 was taken. Screening plant and stacking conveyor similar to quarry equipment.

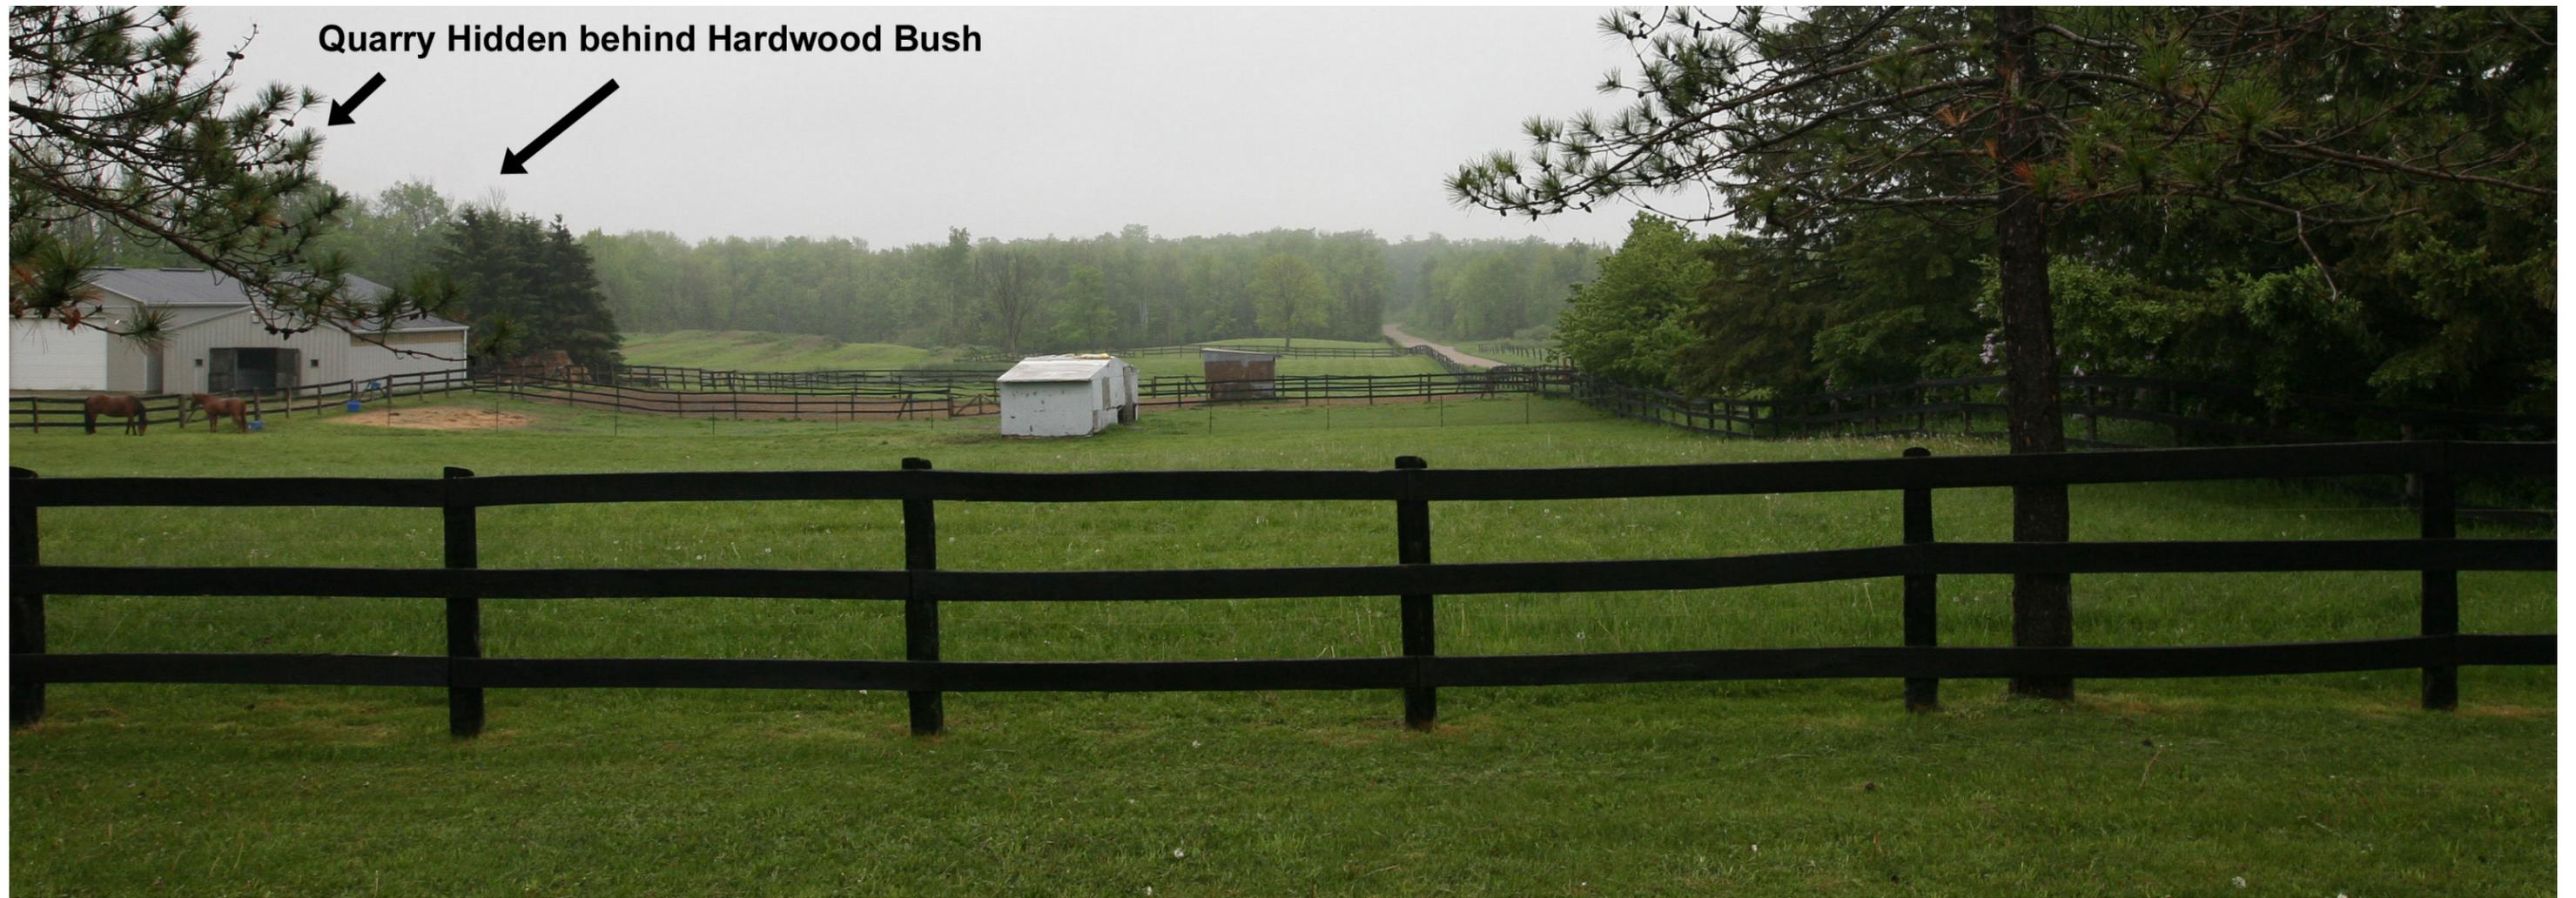
Photo 27- Quarry not Visible.

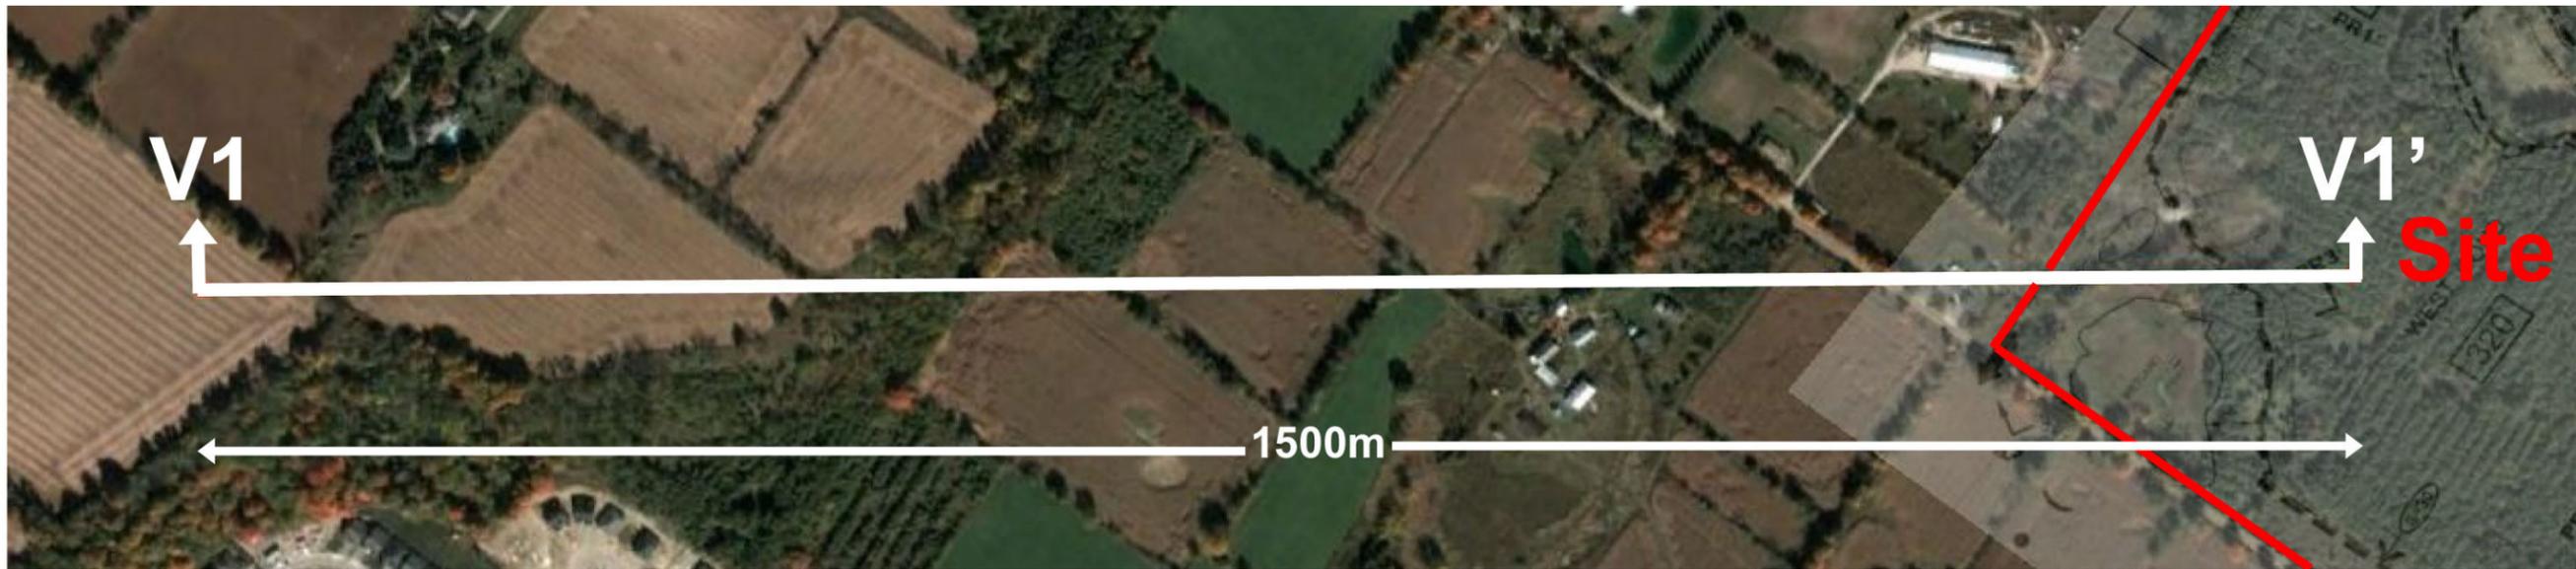
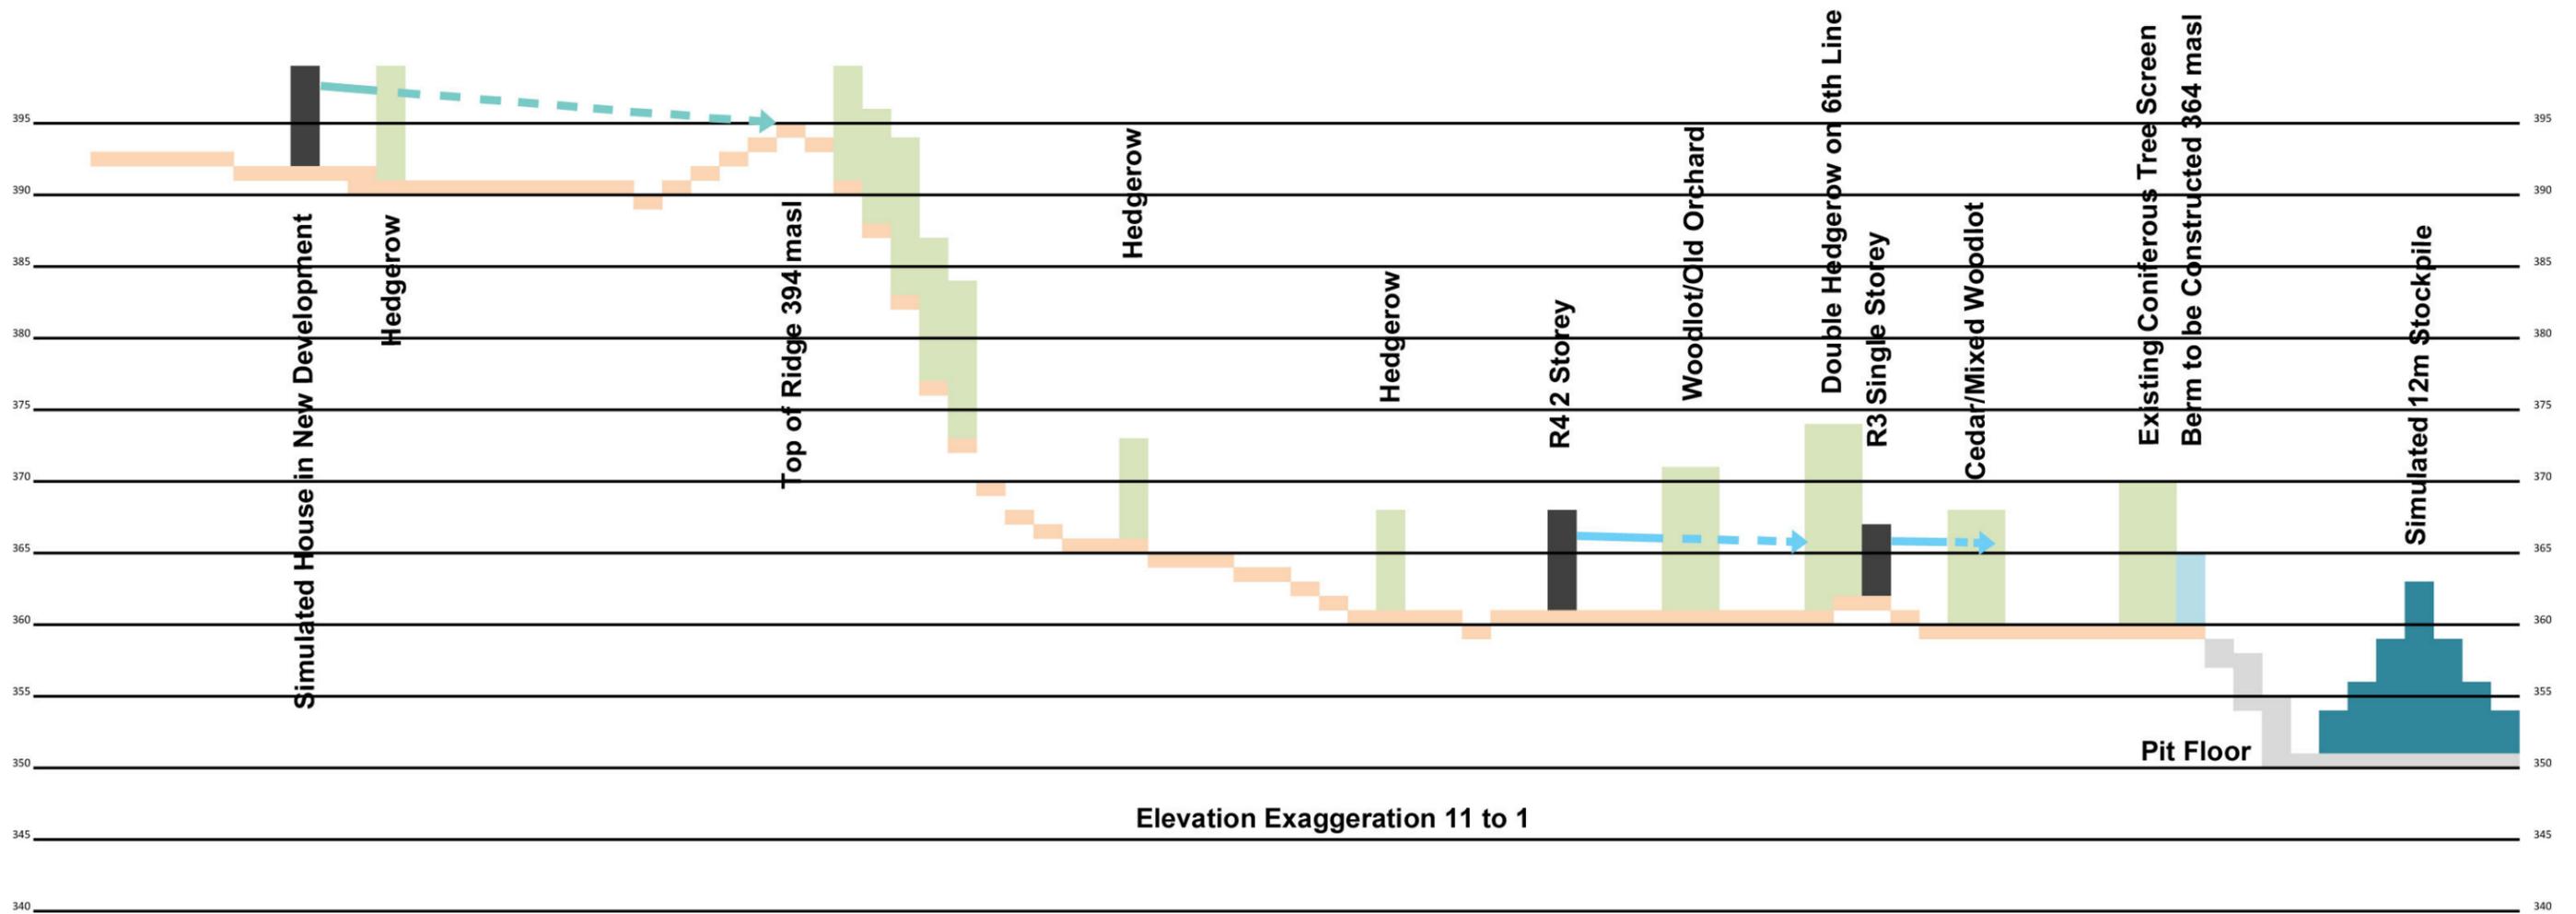
Figure 11- Cross Section V1-V1' Analysis- Quarry not visible from any receptors. Trees to be planted on Berm not shown.

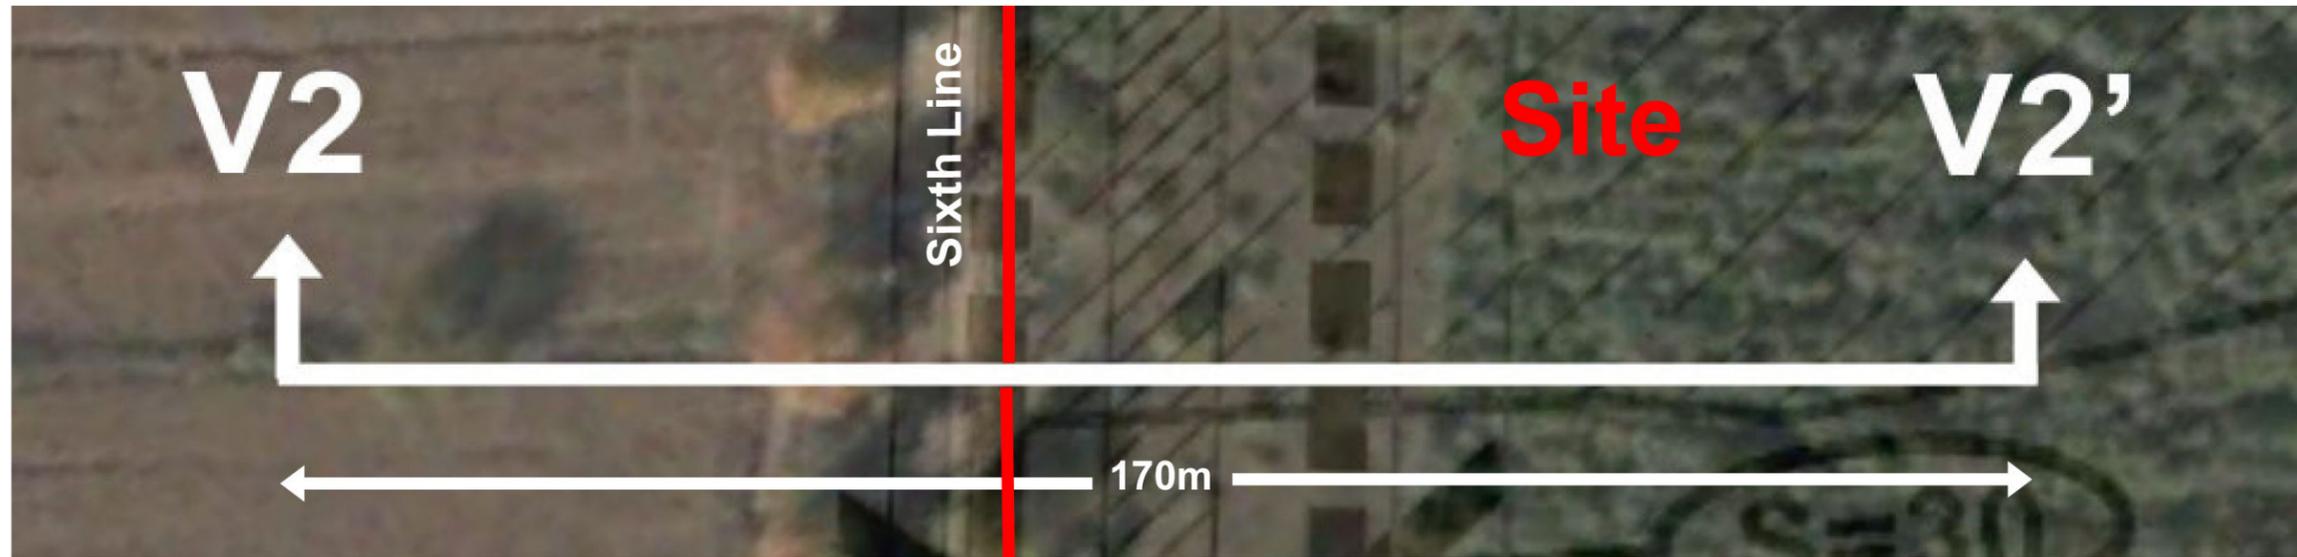
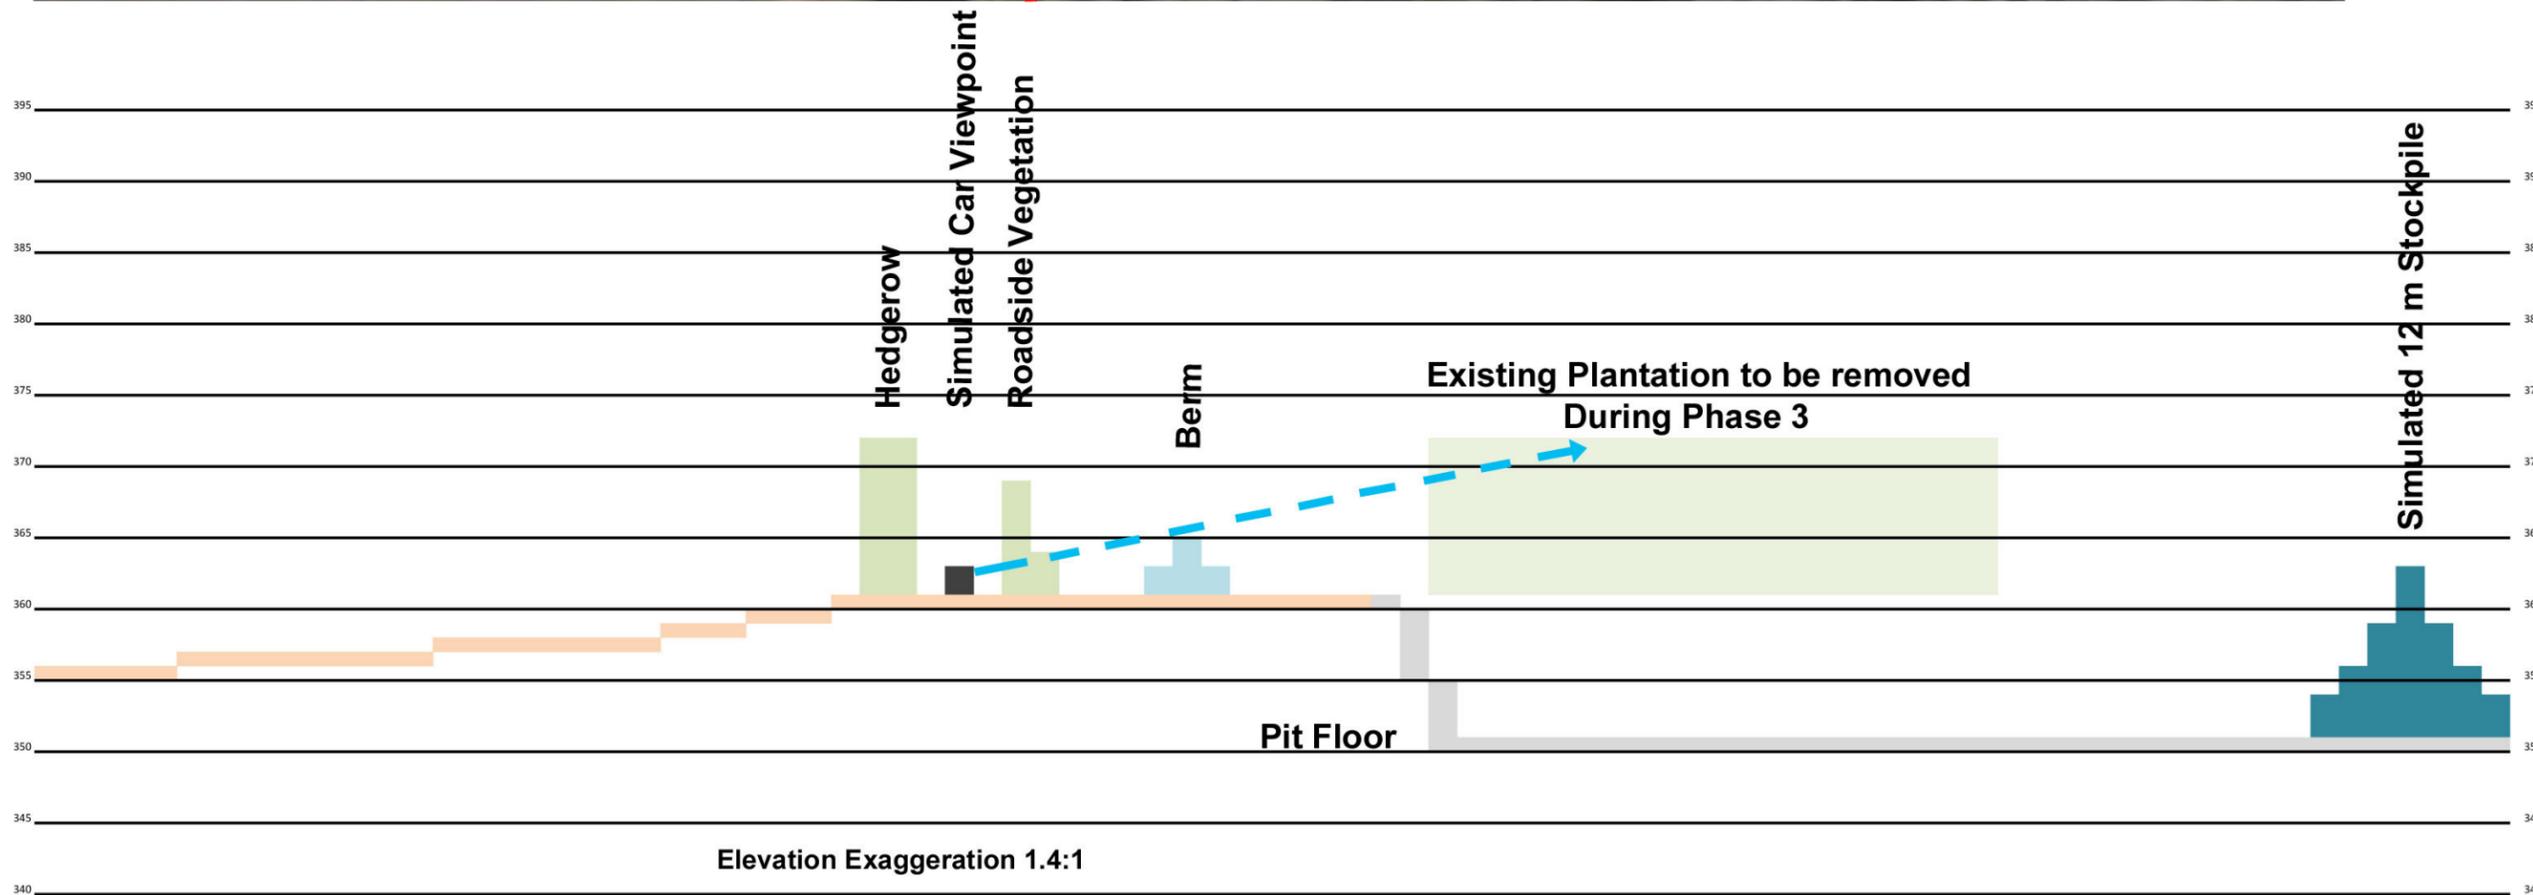
Figure 12- Cross Section V2-V2' Analysis- The quarry is not visible. The berm is visible through gaps in the roadside vegetation screen. The berm itself is to be reforested. See photos 12 and 13. The coniferous plantation is not to be removed until Phase 3 (approximately year 12 of the operation), at which time the reforestation on the berm will have achieved some size.
