# Evidence Book 15

## Township of Guelph/Eramosa Visual Impact Review Document Book

# Visual Information Package

## HIDDEN QUARRY

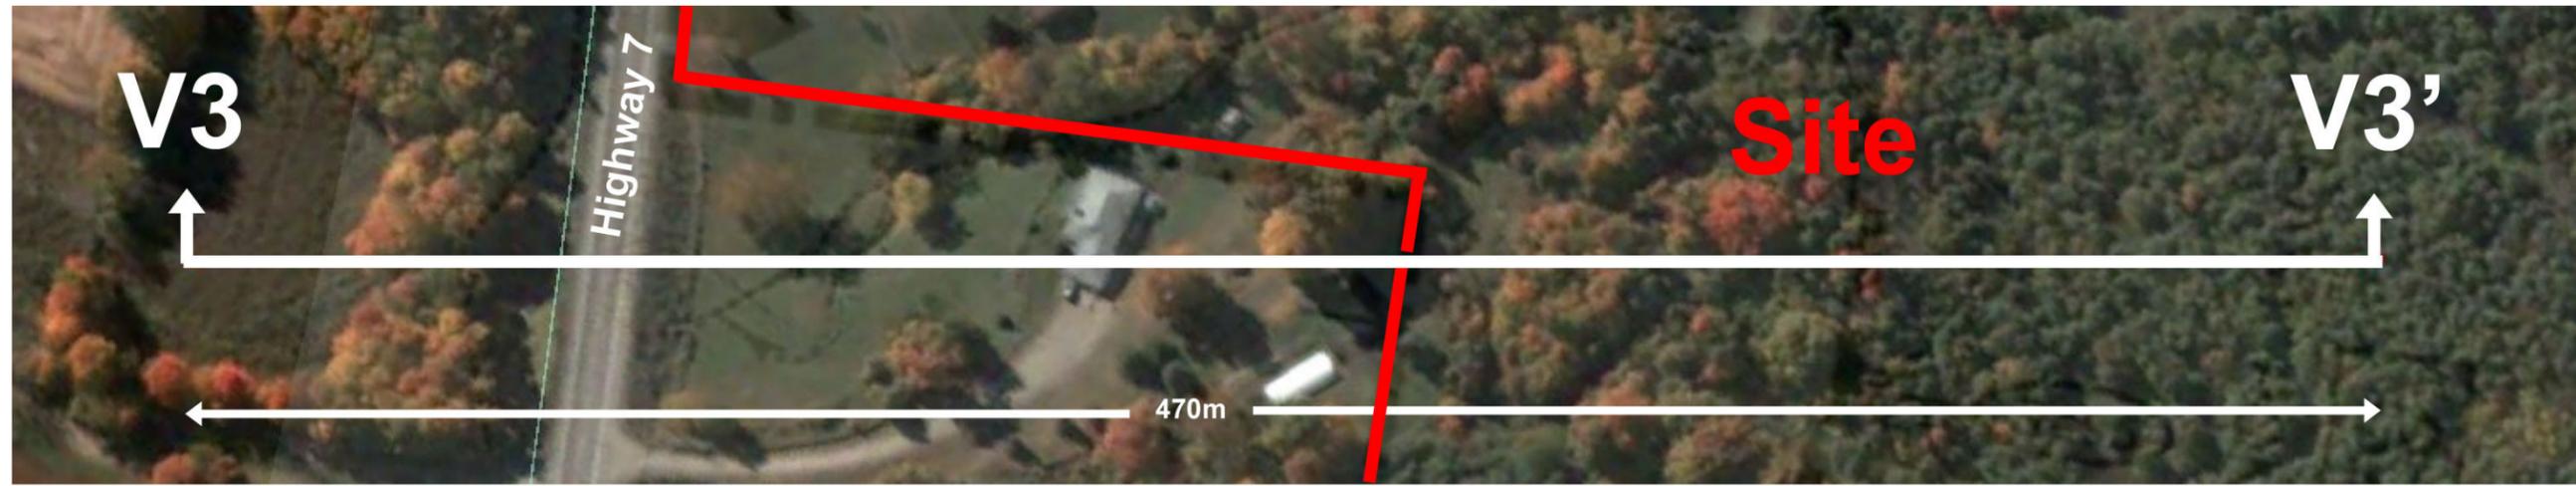
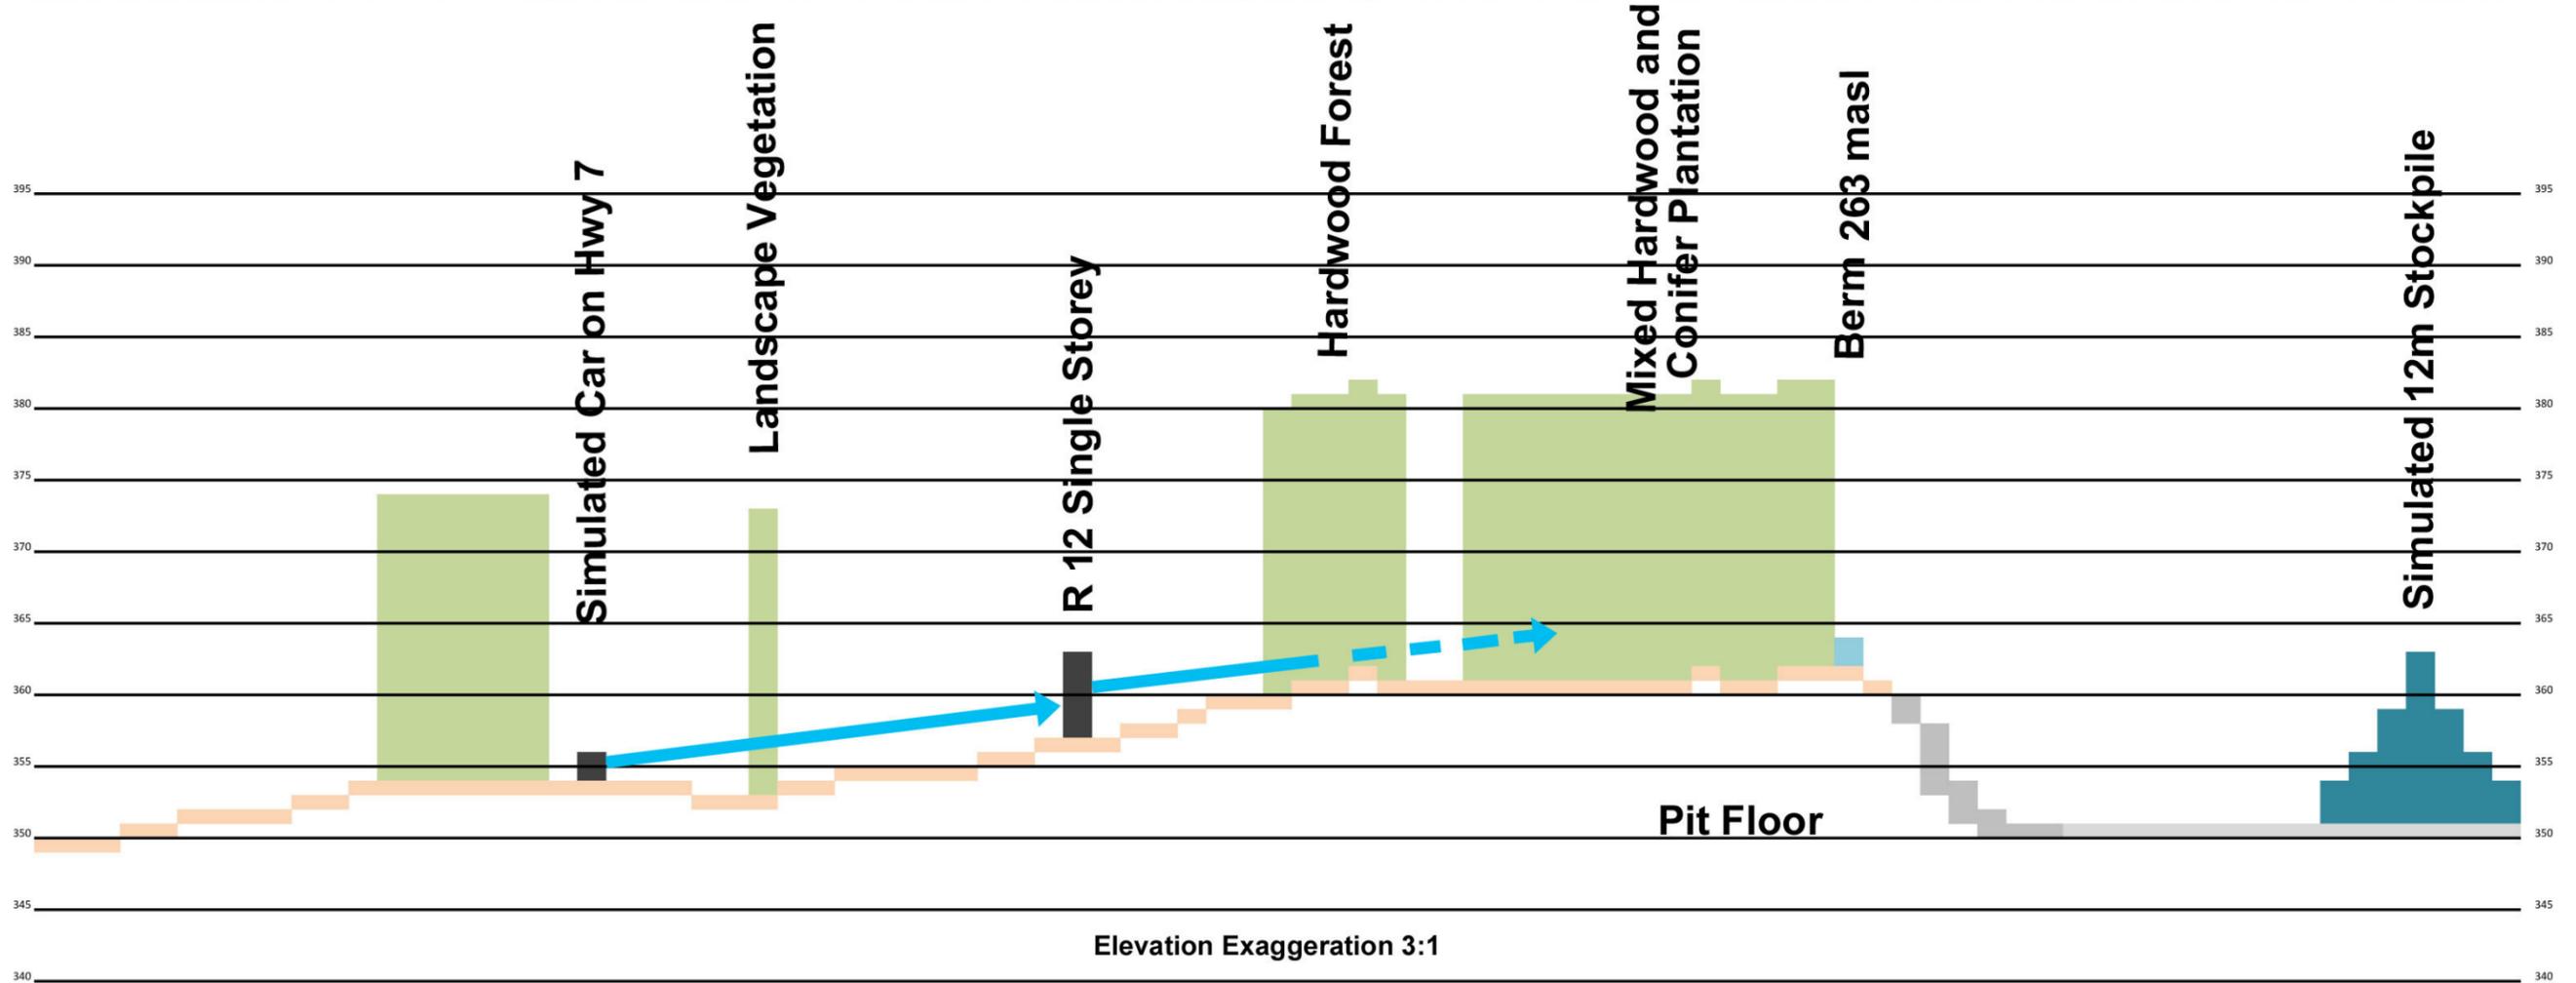
Figure 13- Cross Section V3-V3' Analysis- Quarry not visible from any receptor. Heavy existing tree cover in existing bush and large setbacks completely hide quarry. See Photo 5.
