Evidence Book 9

Township of Guelph/Eramosa Natural Environment Review Document Book

Natural Environment Review Document Book Index

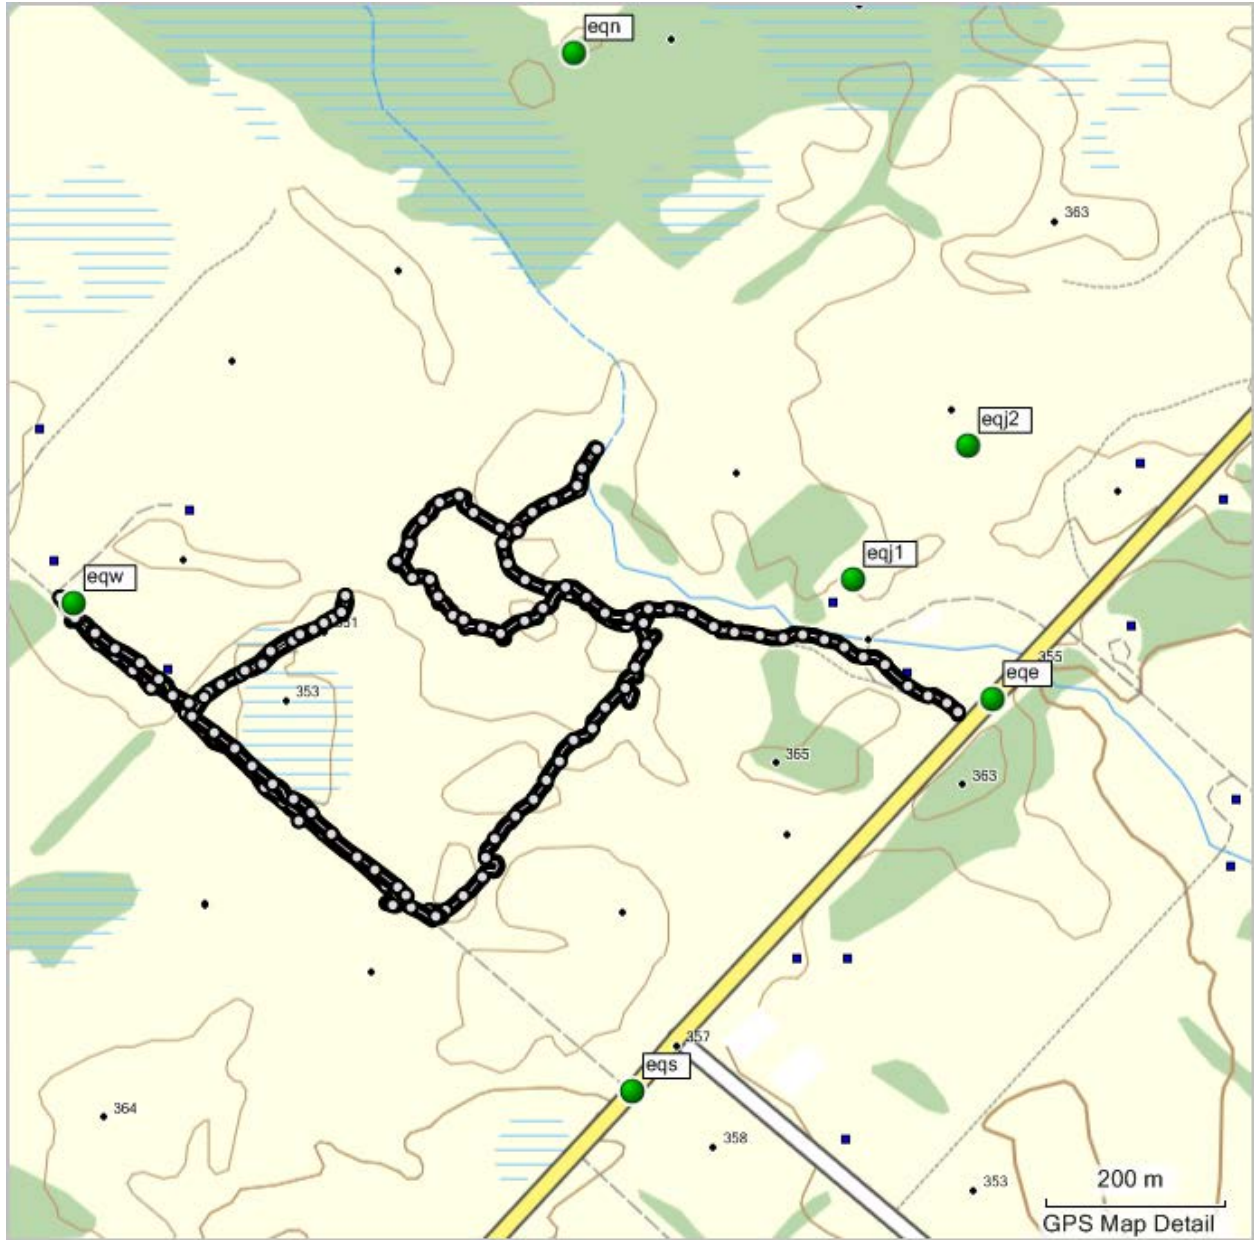
Figure 1: GPS tracks of route taken through the Hidden Quarry site. The route also included the Highway 7 frontage and 6 Line frontage from Highway 7 north to the track shown above. The green dots show the GPS coordinates of site corners. Source: 1:10,000 topographic mapping for Southern Ontario from TrakMaps.

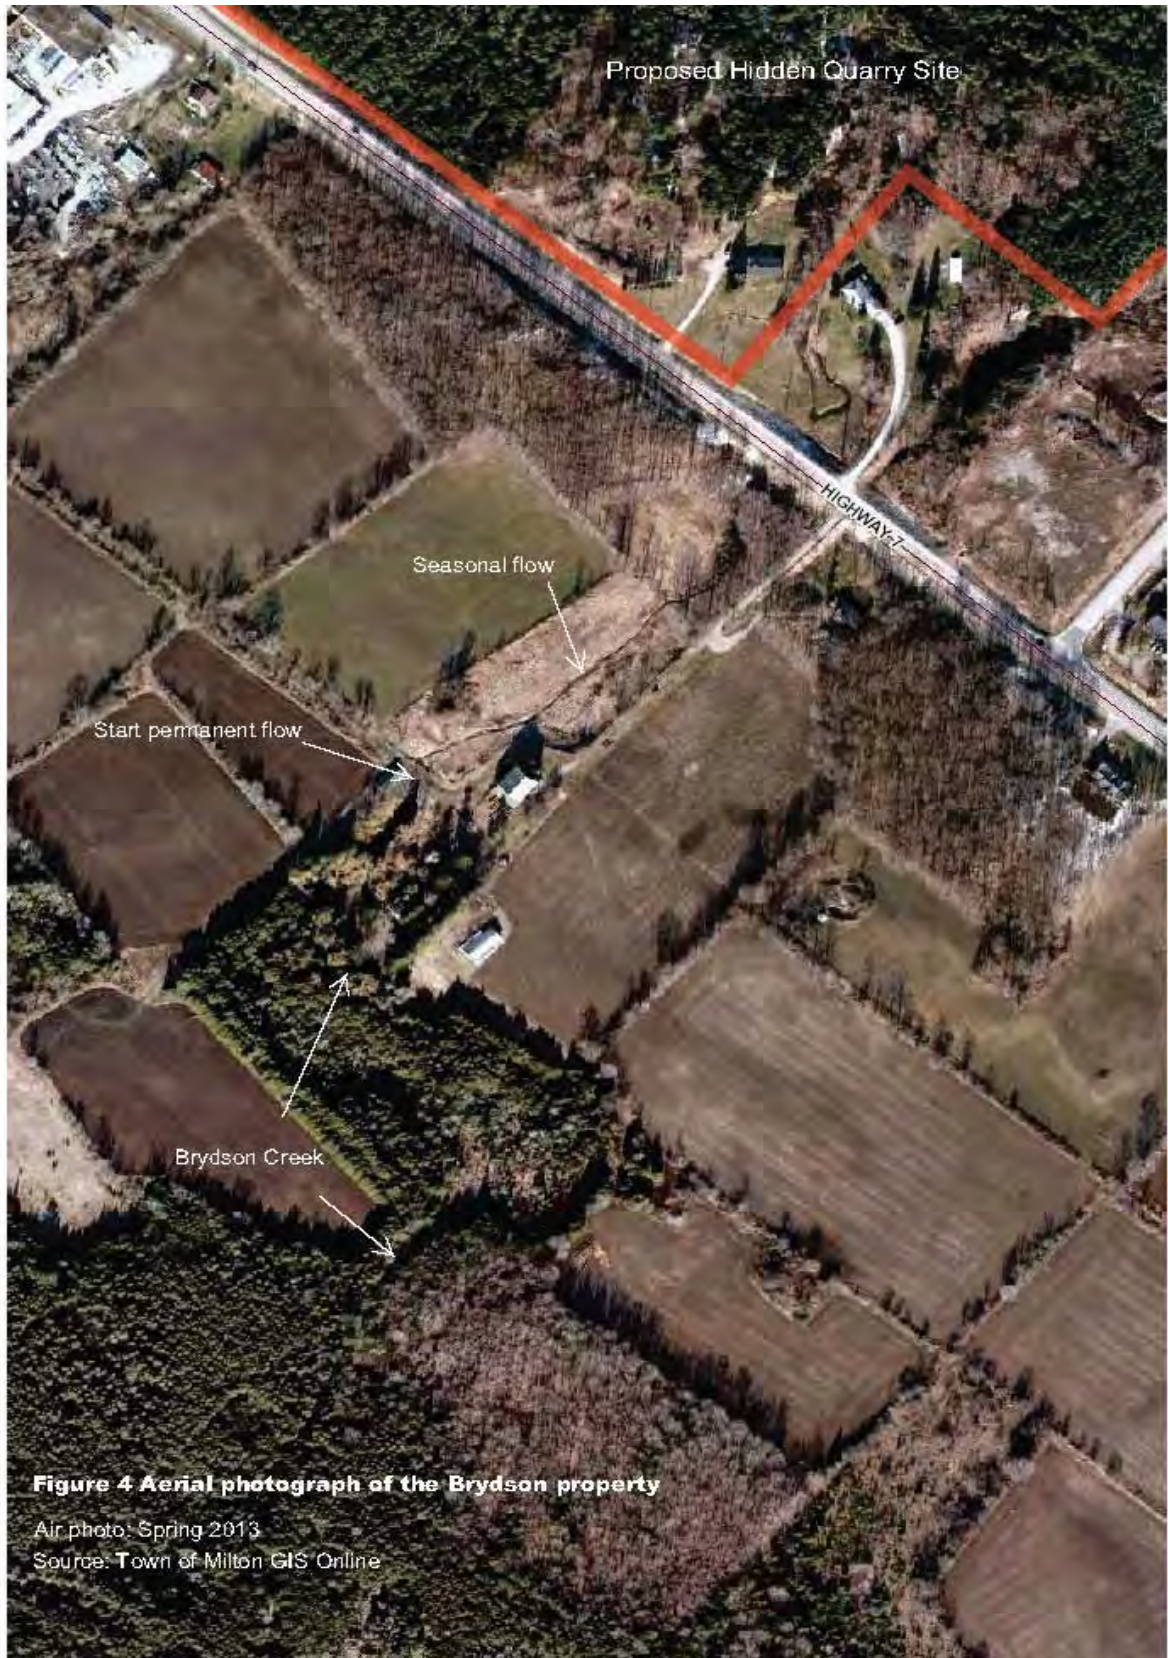
Figure 4 Aerial photograph of the Brydson property

Air photo: Spring 2013
Source: Town of Milton GIS Online

Figure 4 is an aerial photograph of the Brydson property and the stream flowing through it. The portion of Brydson Creek included in this survey only extended approximately 600 m downstream (south) from the Brydson pond.

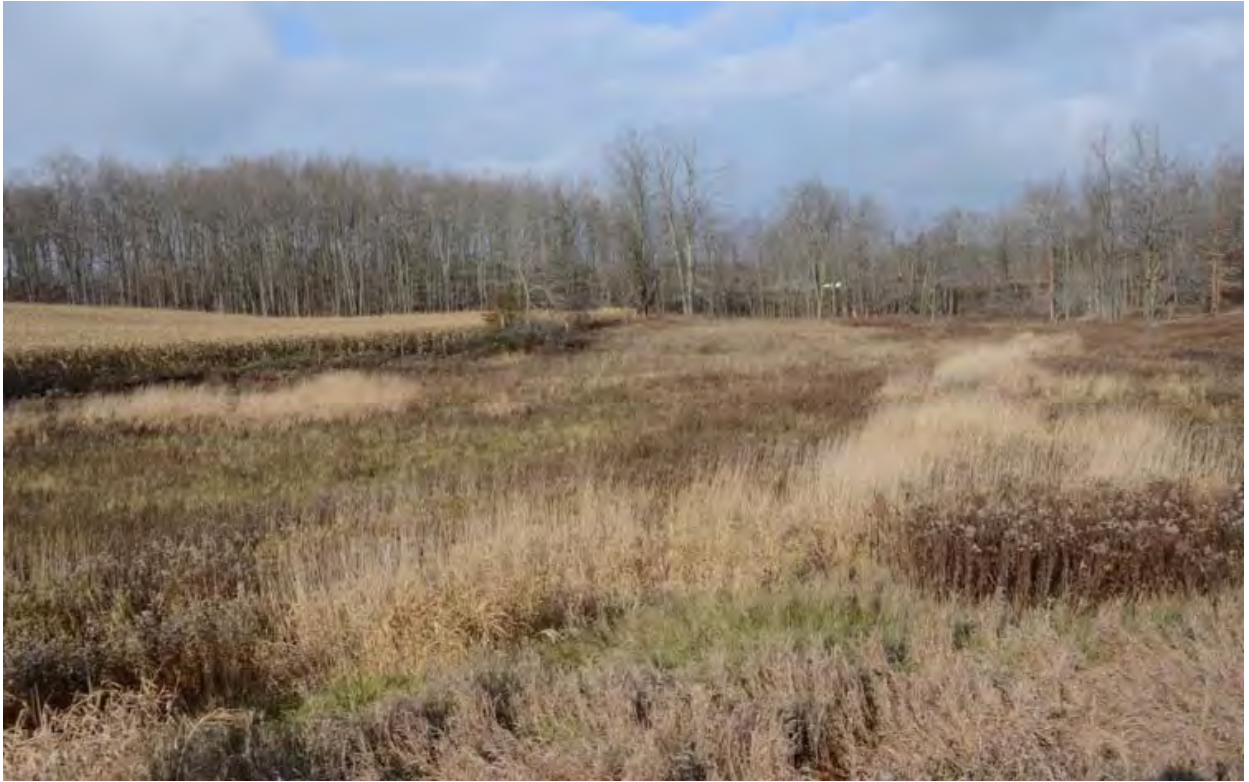
Photo 1

On the date of the site visit, the stream channel south of Highway 7 to the pond near the barn had no surface flow. This is seen in the center of **Figure 4** and indicated as an intermittent stream on **Figure 3**. **Photo 1** provides a ground level view of this dry channel from the pond north to Highway 7 seen in the background. However, historically this channel is not dry during other months of the year (Harden Environmental Hydrogeological report).

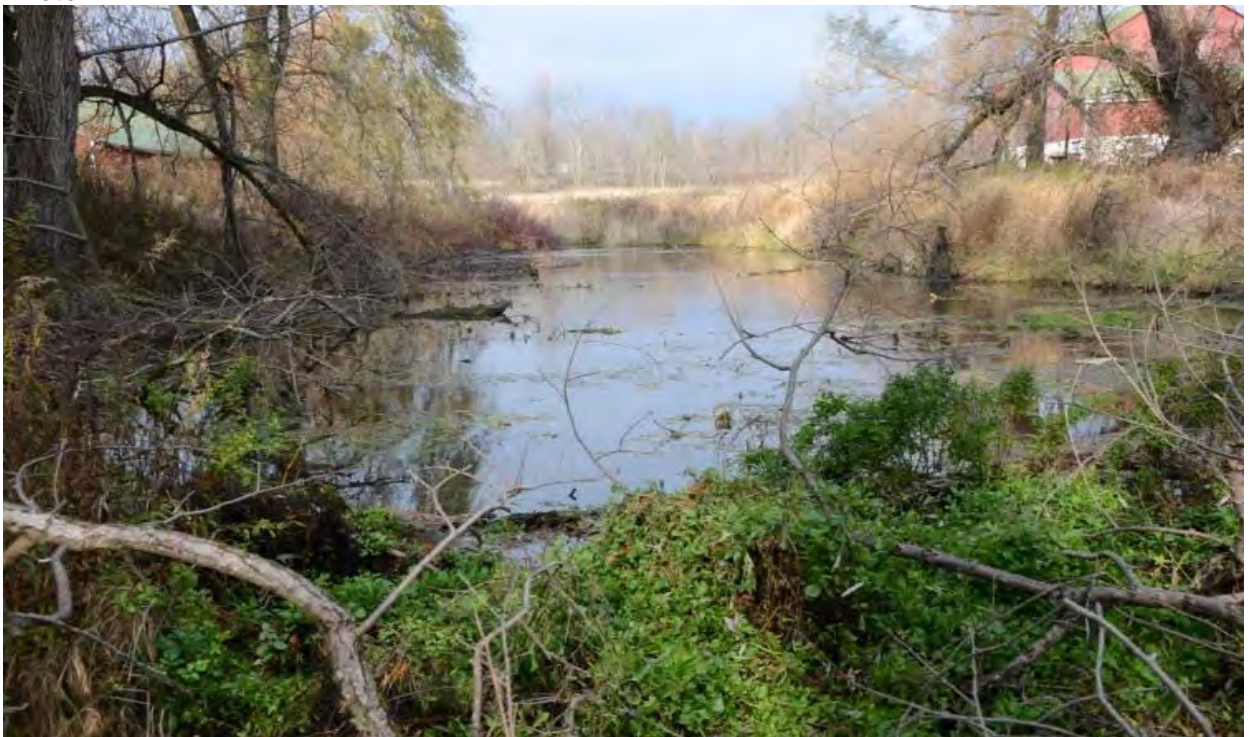
Photo 2 shows the Brydson pond from the south facing north to Highway 7 in the background. This pond and the area immediately south of it are the site of numerous major springs which join to form the permanently flowing section of Brydson Creek. From this point on, Brydson Creek flows through a continuously forested area, dominated by mature white cedar stands. This is shown in the centre and lower portions of **Figure 4** and the designated survey area shown in **Figure 3**.

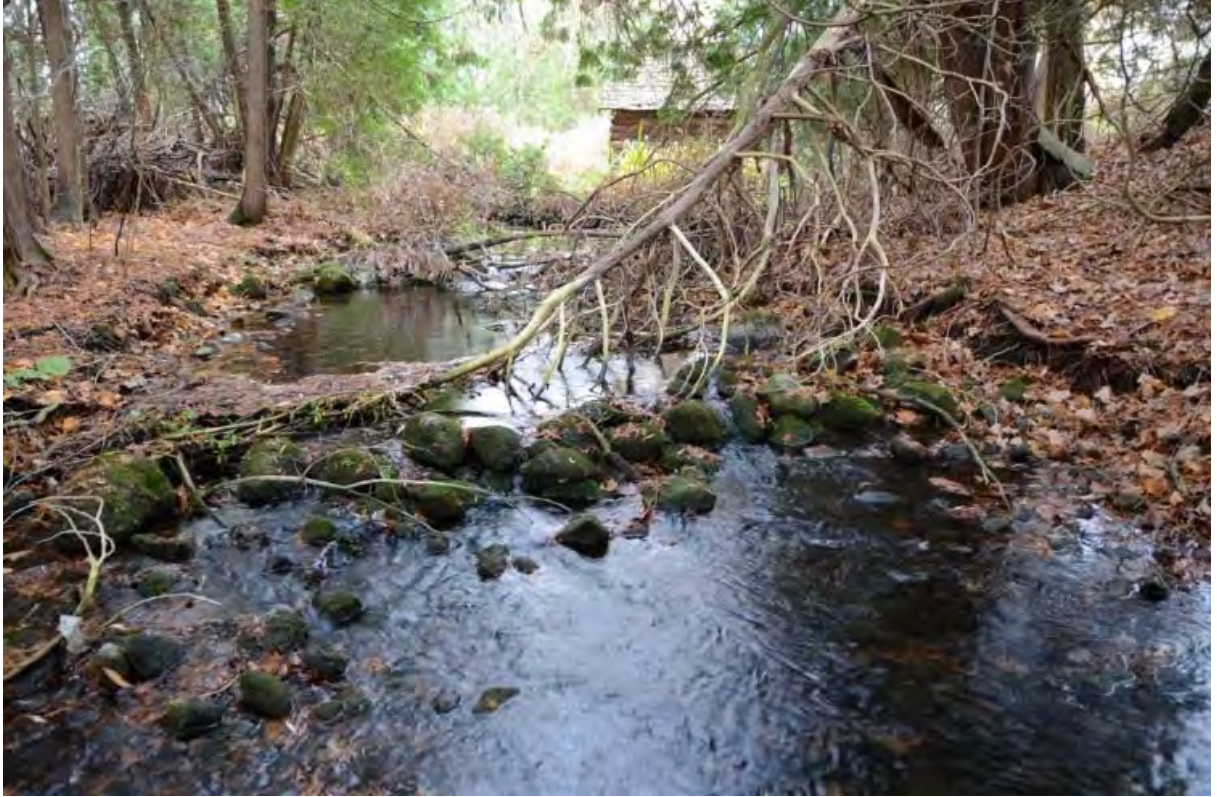
Photo 3 is taken approximately 50 m downstream of the pond and illustrates the quantity of water being discharged by the springs in this vicinity. The small log structure in the background of this photograph is near the south end of the pond and appears to be a former milk storage shed which is sited on a major spring source. The large and constant supply of cold, clean spring water provided natural refrigeration for raw milk once produced on this farm.

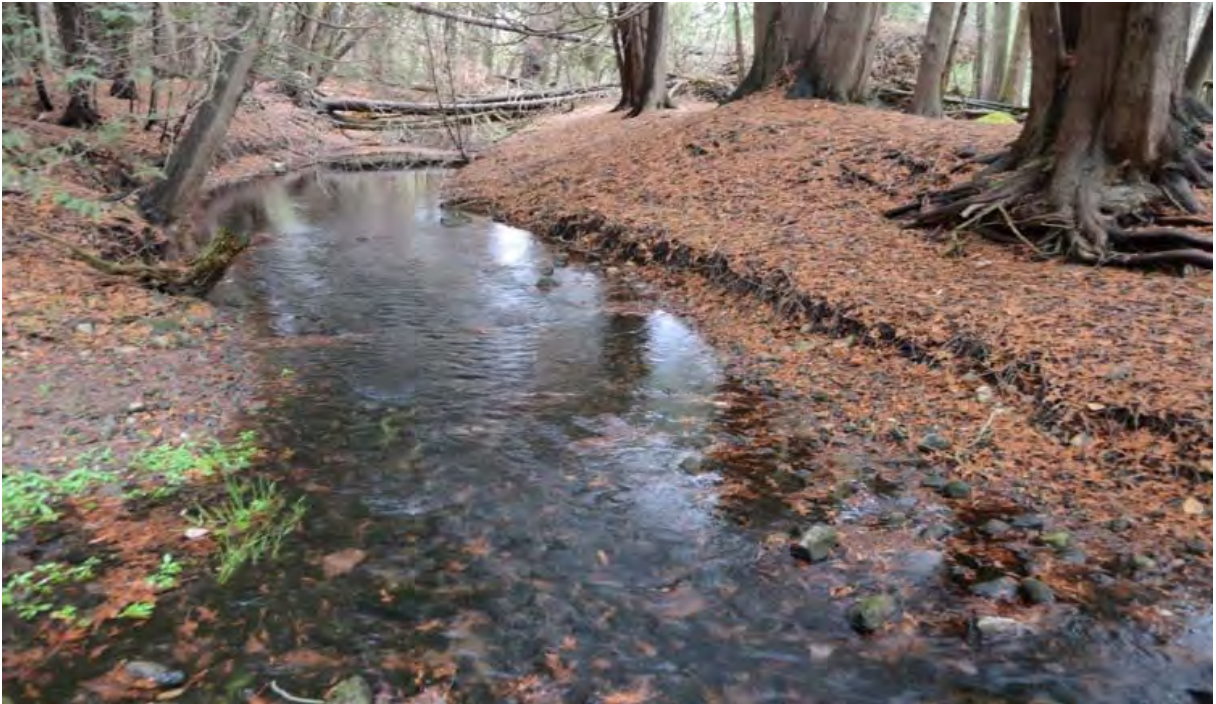
Photo 6 is a typical reach of rocky riffles found below the two weirs.

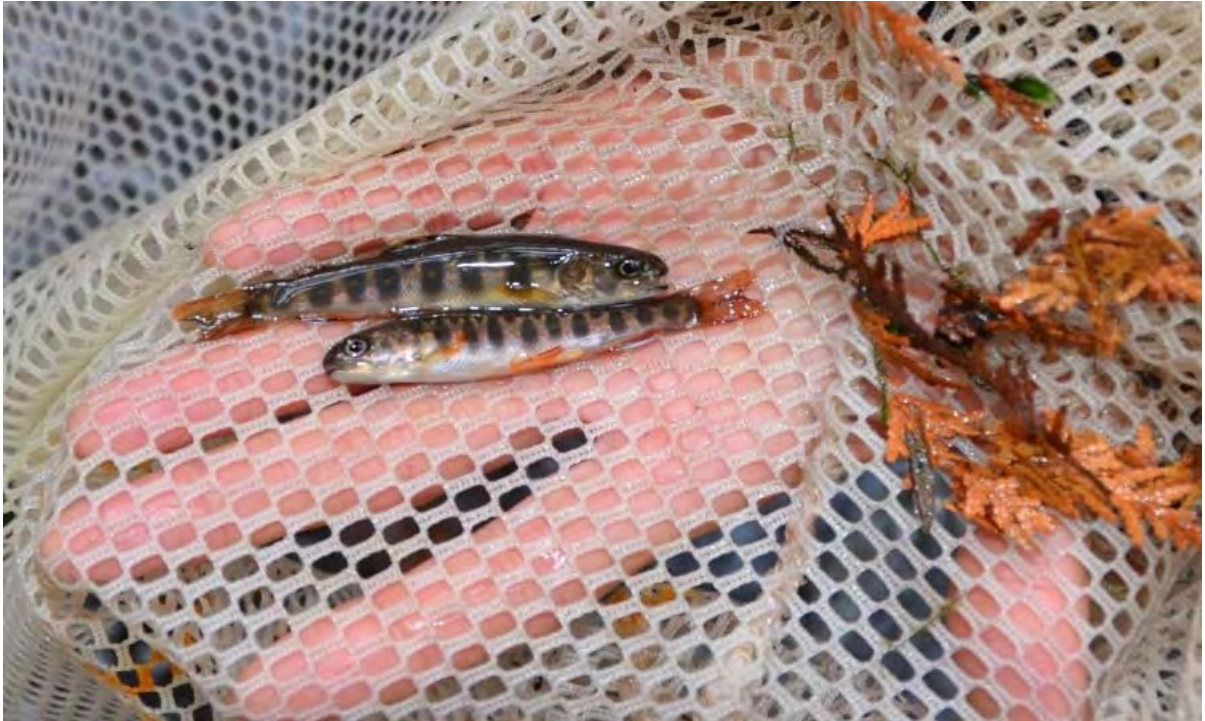
Photo 9

Because Brydson Creek provides high quality habitat for all of the life stages of brook trout, the population of brook trout appears to be near the carrying capacity for this habitat, with all age classes relatively abundant. **Photo 9** shows two brook trout fry (close to one year old) which appear to be in excellent physical condition. **Photo 10** shows a mature adult brook trout in full spawning colour. This fish also appears to be in excellent physical condition.
