ONTARIO MUNICIPAL BOARD

WITNESS STATEMENT FOR STAN DENHOED

This report describes in detail the groundwater and surface water resources around the site, the potential effects of the mining process on water resources and recommends actions that will minimize impacts to water resources. Features and properties discussed in this report are shown on Figure 1.4. This report has been written to satisfy the requirements of Level 2 hydrogeological reports as required under the Aggregate Resources Act. This Level 2 hydrogeological report includes a discussion of the following items:

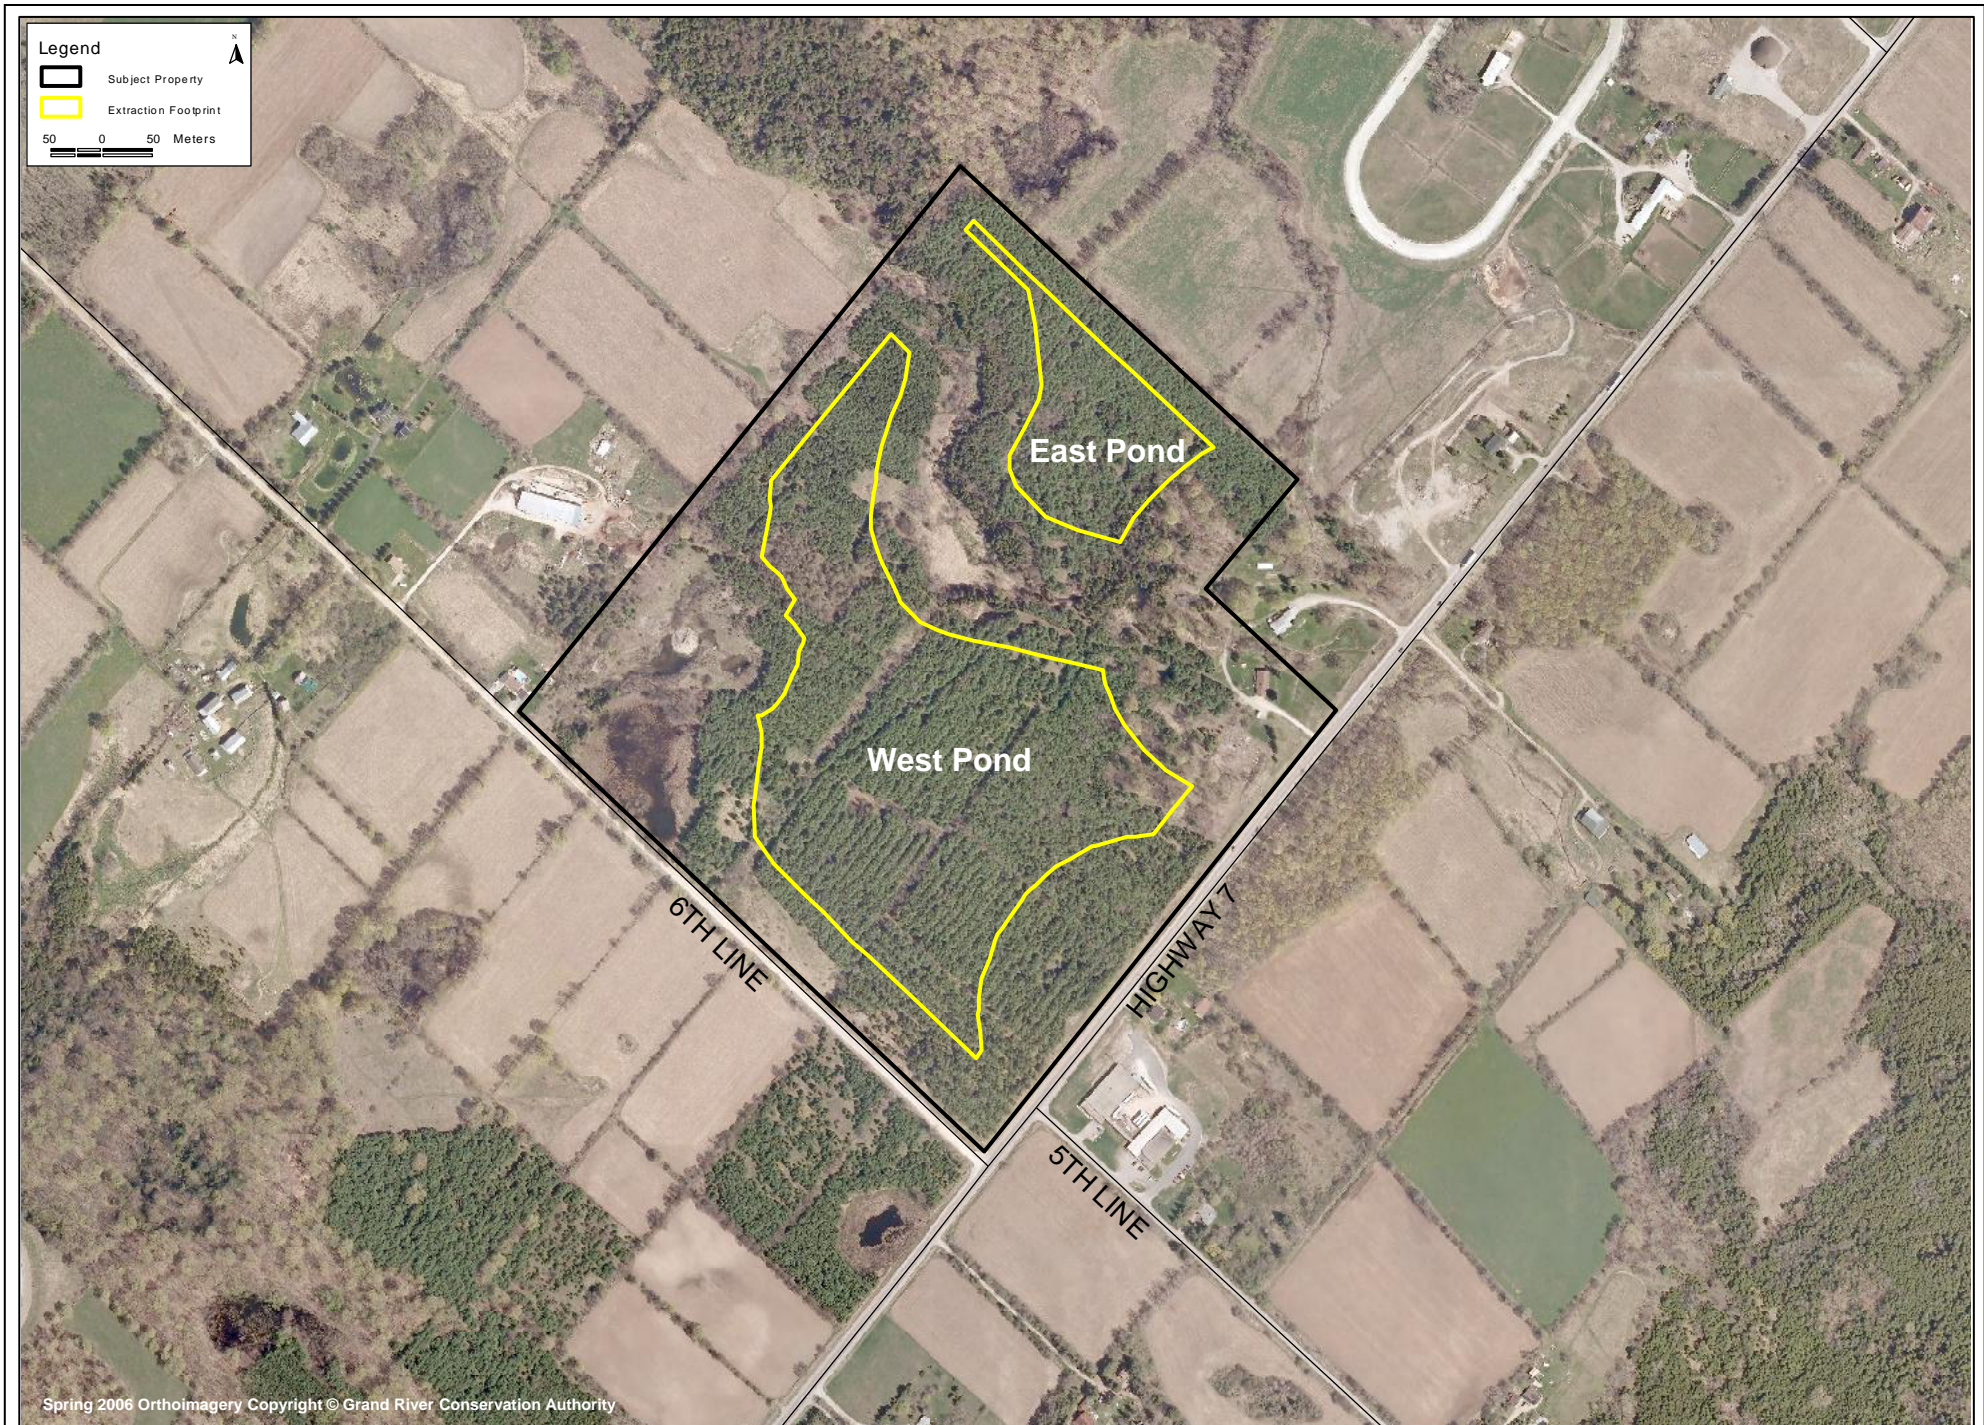
Figure 3.20: Simplified Geologic Cross-Section

The elevation of the wetland is between 360 and 363 m AMSL. The elevation of a depression in the Allen farm field adjacent to the wetland is 358.19 m AMSL based on a site level survey conducted by Harden Environmental on December 21, 2011 (Figure 3.20). The elevation of Tributary C, east of the wetland is 359 m AMSL (GRCA, 1 metre contours) and is thus also below the wetland elevation. These observations confirm that the only potential source of groundwater for the wetland is from the north. At the southern edge of the wetland (at the JDCL property) groundwater occurs below an elevation of 355 m AMSL (at TP8), several metres below the wetland.

With respect to potential groundwater contributions, we have attached Figure 3.20 from our original December 2012 report. This is a cross section through the Allen Wetland (location shown on Figure 2). It can be seen that it is not possible for groundwater to contribute to the wetland given the superior elevation of the wetland compared to low ground elevations to the east and west. Ground elevations to the south also decrease. In addition, the nearest groundwater monitors being M2 (bedrock) and TP8 (overburden) on

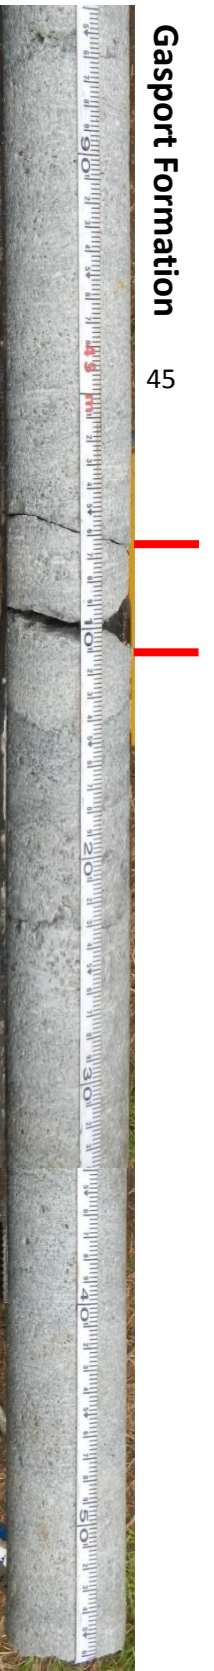
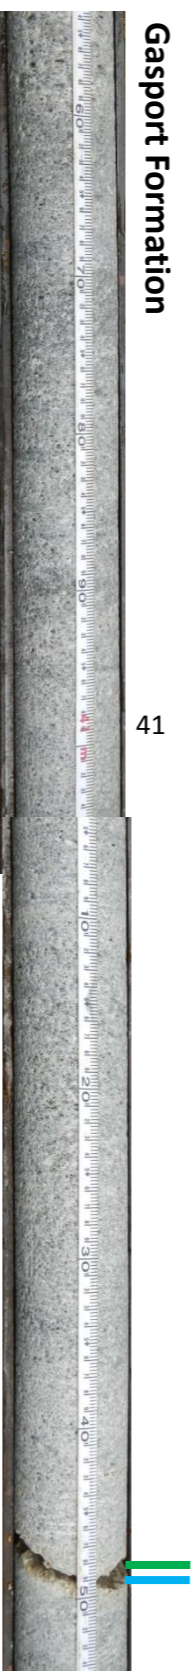
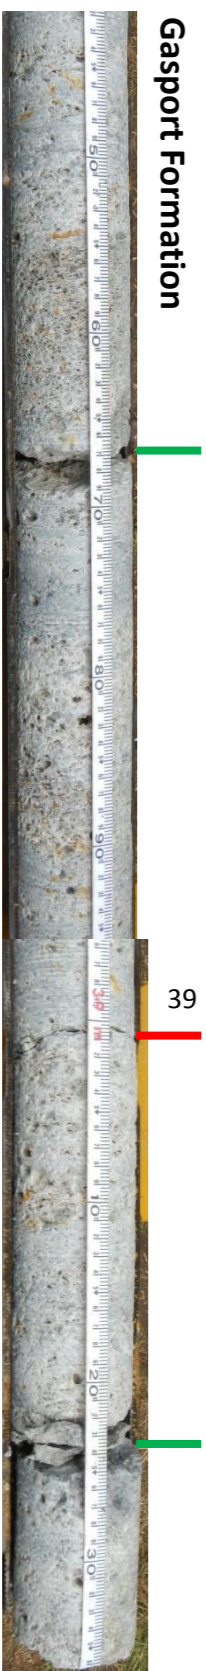
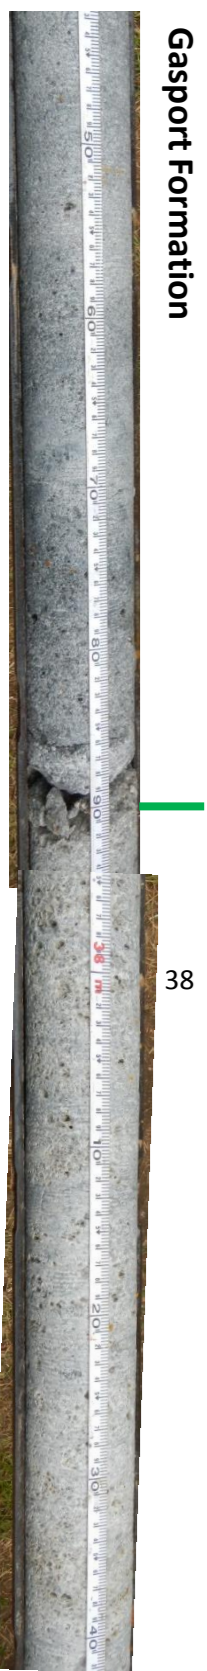
ARDEN Harden Environmental Services Ltd.	Project No: 9506	Hidden Quarry Summary of Drilling and Testing New Well M15	Appendix B: Core Log Photos (28.94m-37.44m)
	Date: May 2013		
	Drawn By: JD	Part of Lot 1, Concession 6 Township of Guelph/Eramosa, County of Wellington

Legend	
	Open Fracture
	Closed Fracture
	Impact Fracture From Drillers
	Significant Water Bearing Fracture
