Re: Proposed Spencer Pit (Guelph 635.06-4586)

Our Project # 10-47

Further to your email dated January 13, 2014, we are pleased to provide clarification on the following details regarding the proposed Spencer Pit site plans.

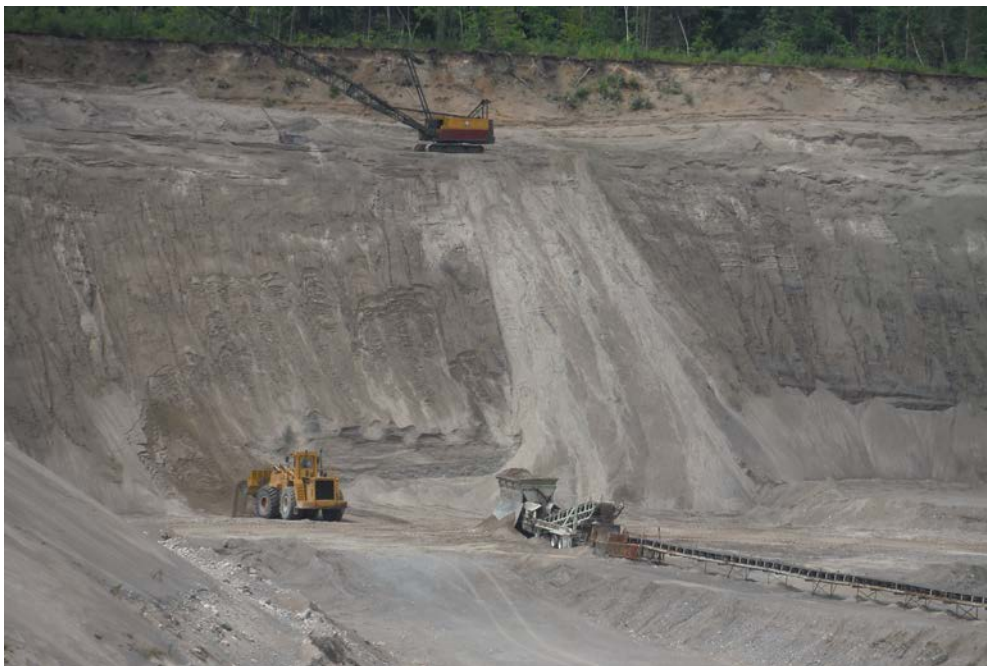
Figure 1. Vertical sand and gravel face (+/- 30m) during active extraction.

Sand and gravel laid down by melting glaciers retains a vertical face when extracted and for years if left. We have seen extraction faces of 30 m remain stable. This is in part due to the nature of the material and its deposition, but also because vertical faces are not subject to surface runoff as a slope would be. We have enclosed photos of vertical faces.

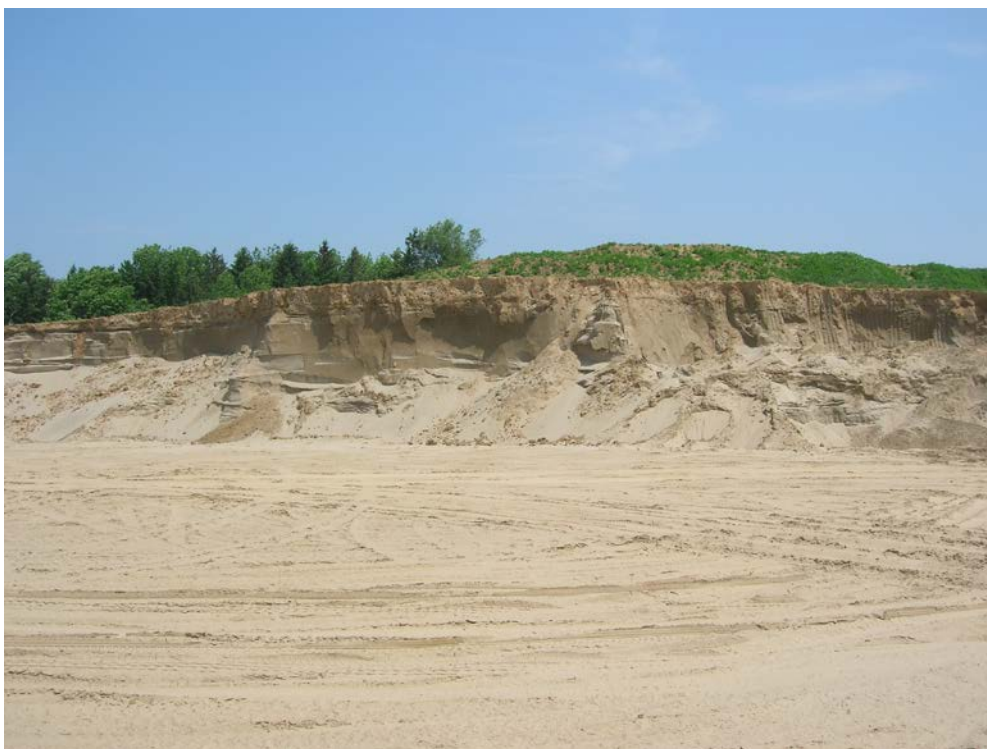
Figure 2. Vertical sand face (+/- 8m) during active extraction.

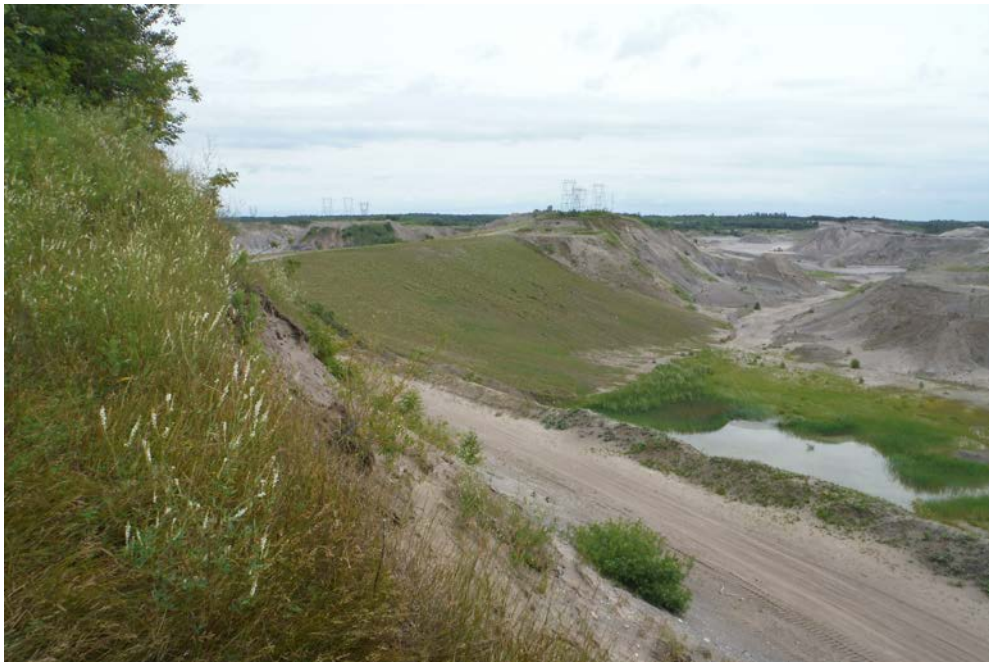
Figure 3. Rehabilitated pit face in close proximity to hydro towers.

Excavation will proceed to the setback 15m from the base of the tower. Even at the maximum face height of 9m, this is well beyond the bearing area of the towers (45° from footing). When excavation is complete, the slope will be backfilled to 3:1, top-soiled, and revegetated. We have enclosed photos of existing pits with hydro towers within the license which have existed without incident for many years.
