Harden Environmental Services Ltd.
4622 Nassagaweya-Puslinch Townline Road
Moffat, Ontario, L0P 1J0
Phone: (519) 826-0099 Fax: (519) 826-9099

Our File: 9506

Date: June 7, 2013

Re: Summary of Drilling and Testing of New Well M15 at Hidden Quarry Site

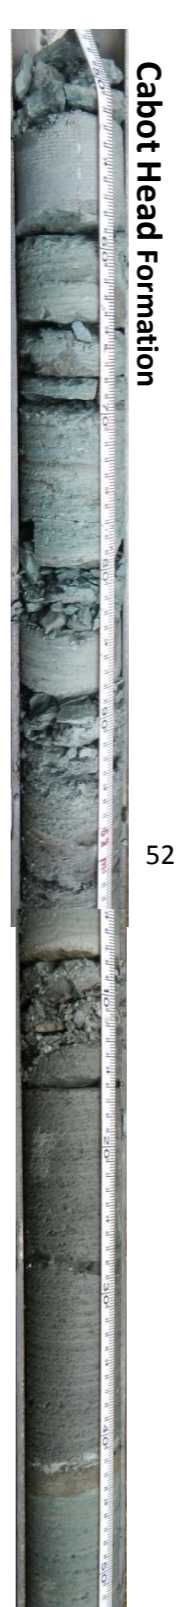
53

Cabot Head Formation

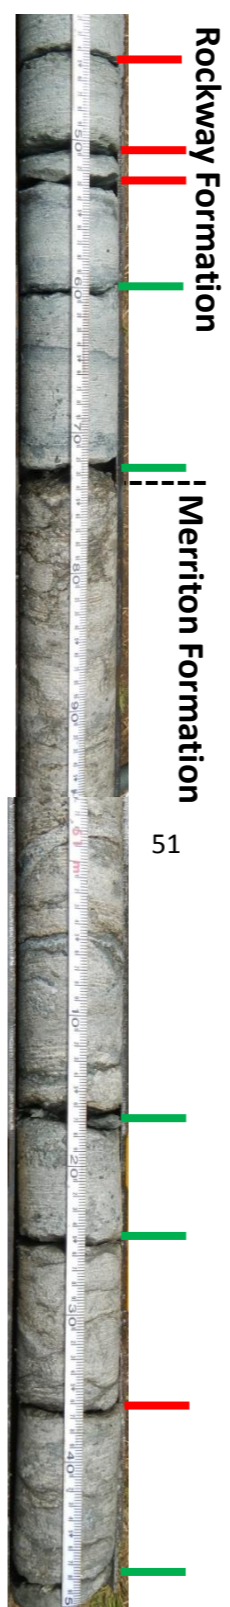
52

Cabot Head Formation

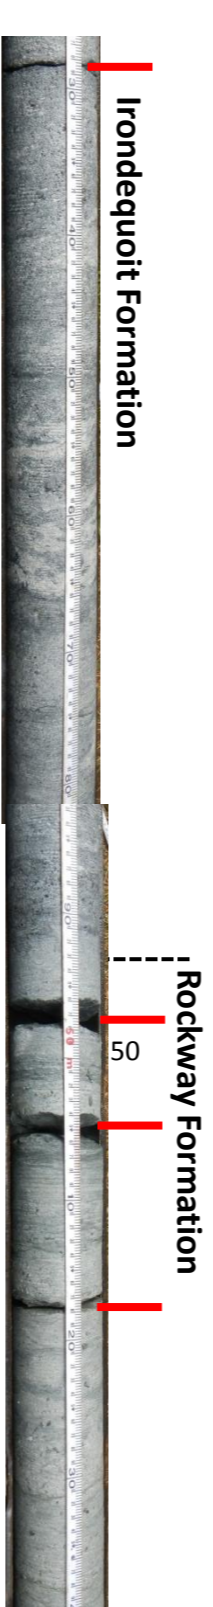
51

Rockway Formation

Merriton Formation

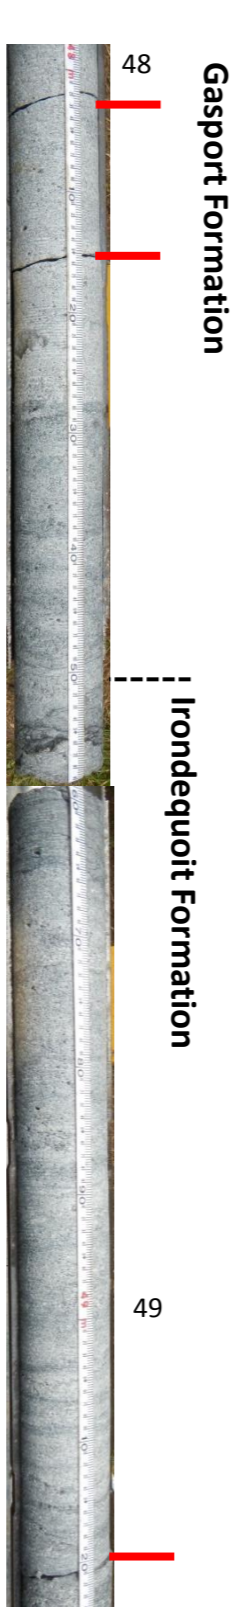
50

Irondequoit Formation

Rockway Formation

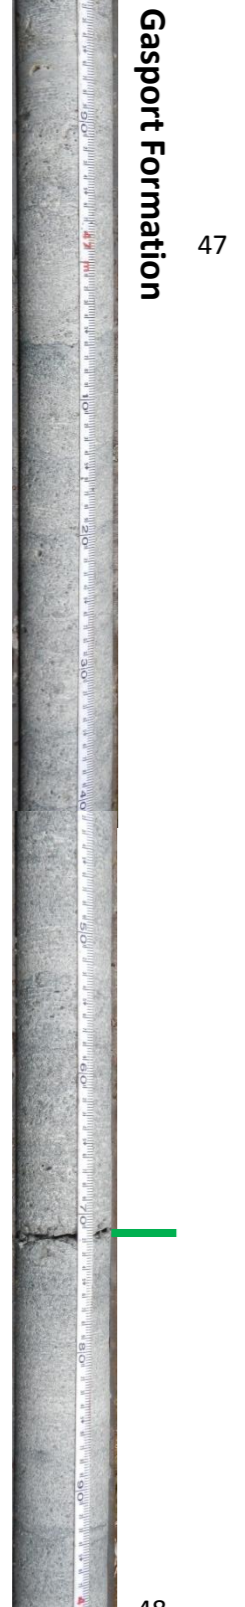
49

Gasport Formation

Irondequoit Formation

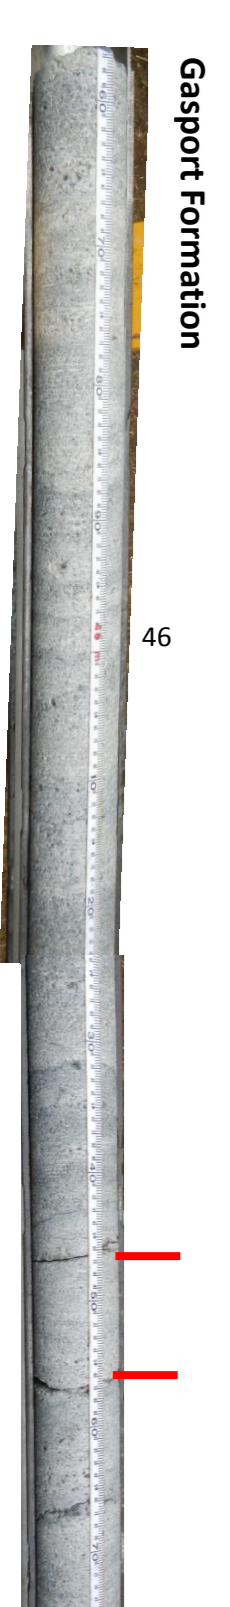
Gasport Formation
