**Hydrogeologic Assessment**  
*Groundwater Science Corp.*

**Hydrogeologic Assessment,  
Tri City Lands Ltd. Proposed Spencer Pit  
Part Lots 14, 15, 16, and, Lots 17 & 18,  
Concession B, Township of Guelph/Eramosa  
County of Wellington**

February 2014

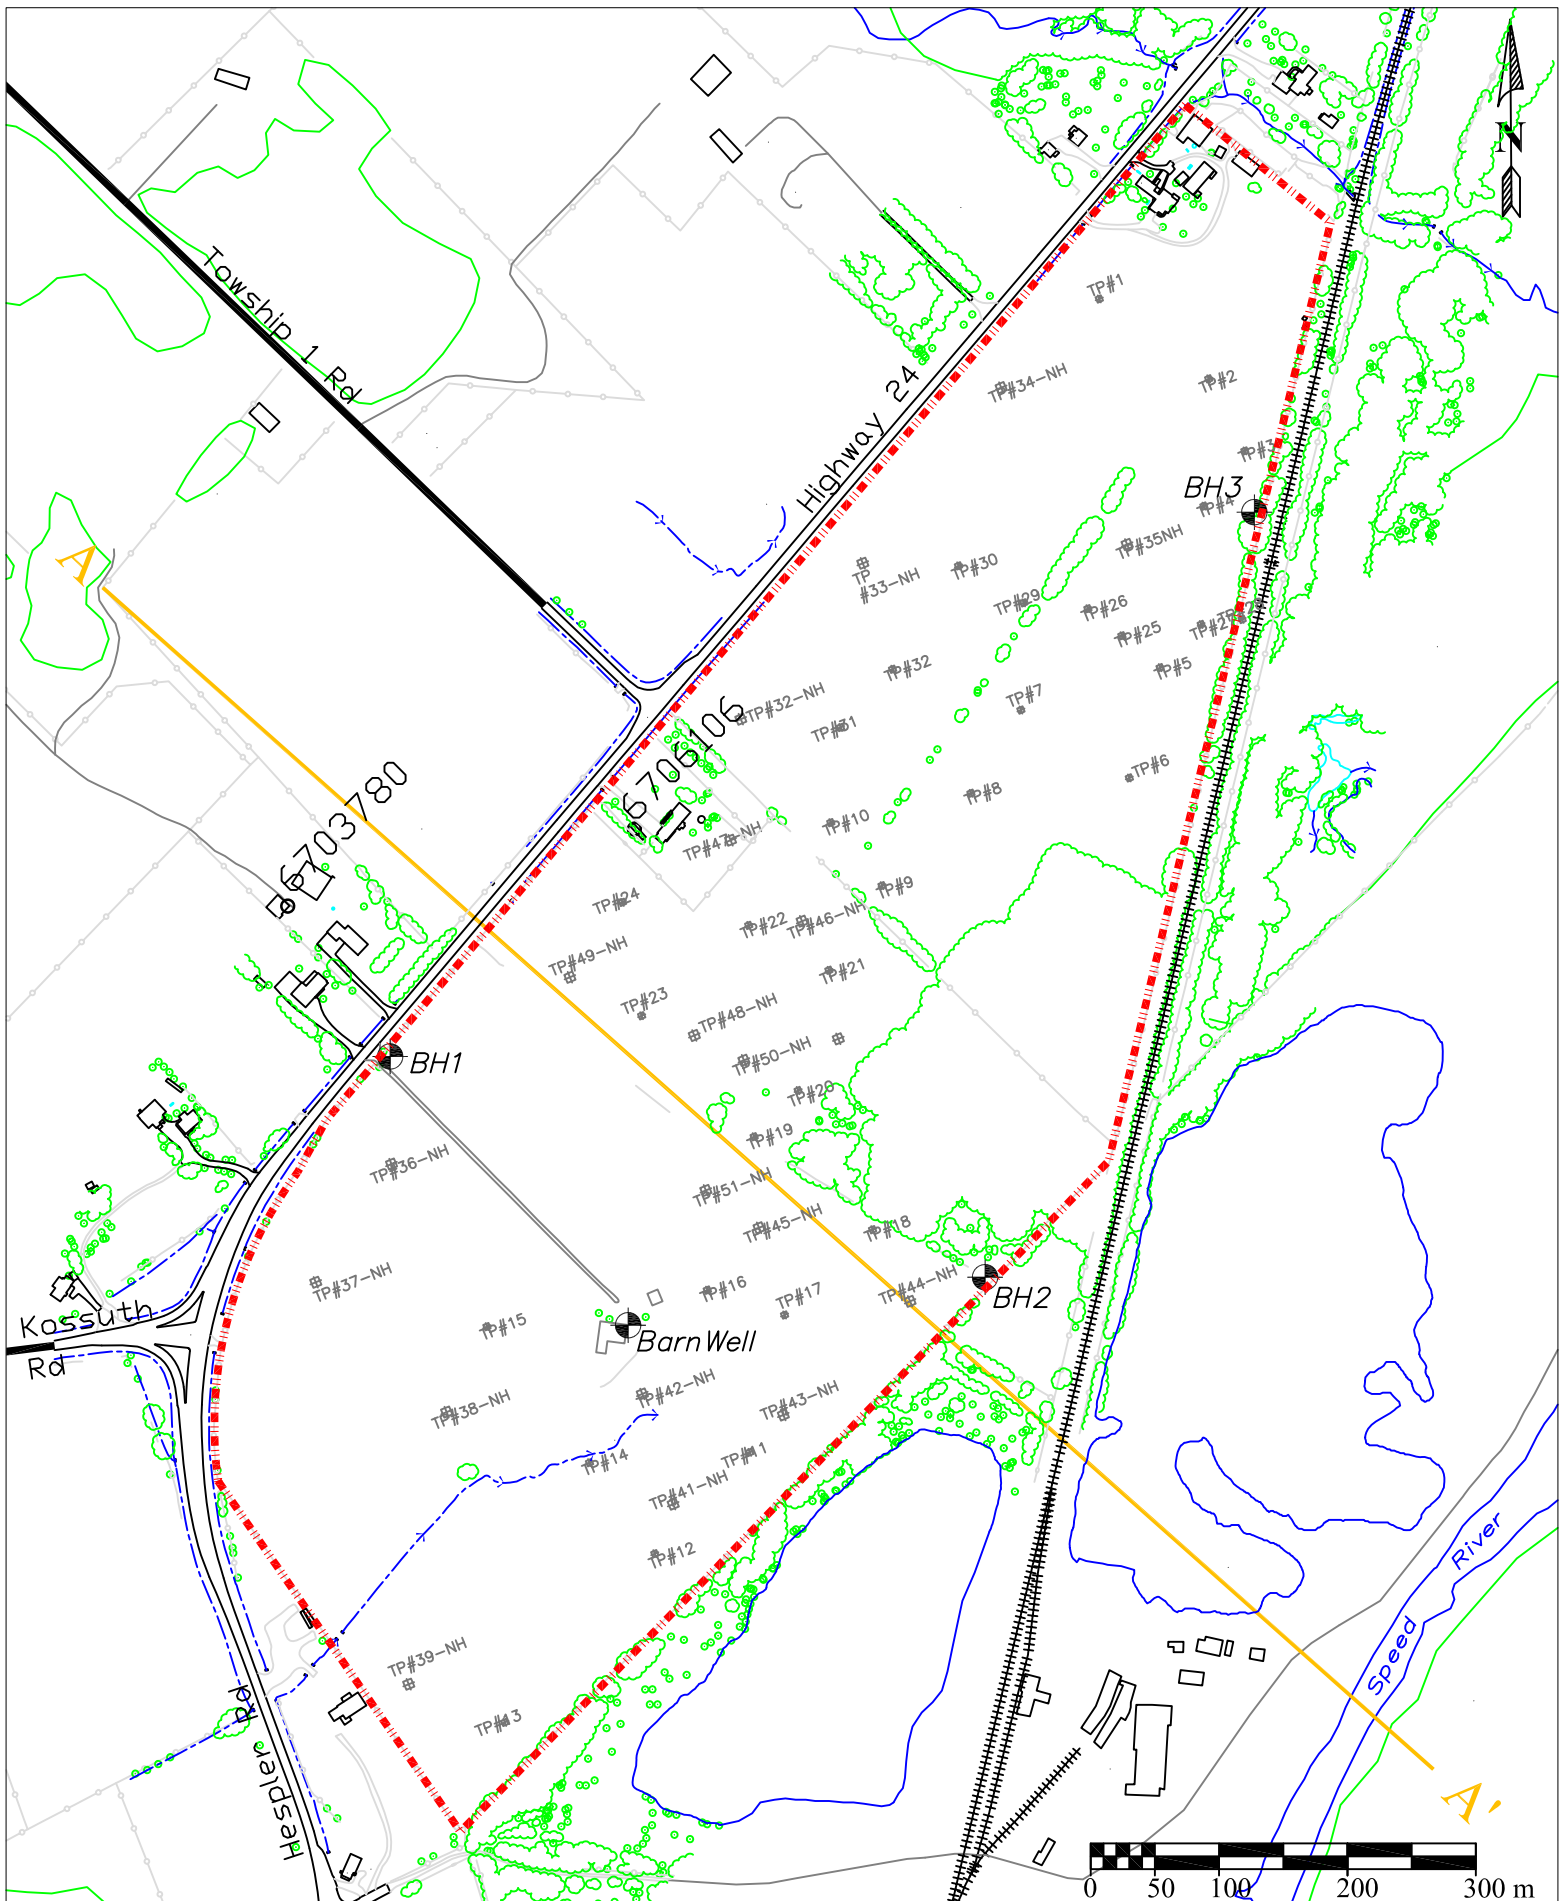
**Figure 3: Borehole Locations**

borehole location and reference
	test pit location and reference
	selected water well record location
	schematic cross-section location

Three (3) on-site boreholes (BH1, BH2 and BH3) were drilled and groundwater monitoring wells installed at the site. Drilling was completed by Knoll Drilling Ltd. (Maryhill, Ontario) from August 27, 2013 to September 6, 2013. The monitoring well locations are shown in **Figure 3** and the borehole logs are included in **Appendix B**.

Conditions on-site are illustrated on a cross-section developed through the site, as shown in **Figure 6**. The cross-section location is shown on **Figure 3**. The section is based on available topographic mapping, MOE water well records, on-site drilling results and water level monitoring results. The section illustrates: the overall topographic variation and existing quarry depth; on-site occurrence of sand and gravel and till units; the underlying bedrock formations; and, water table slope.

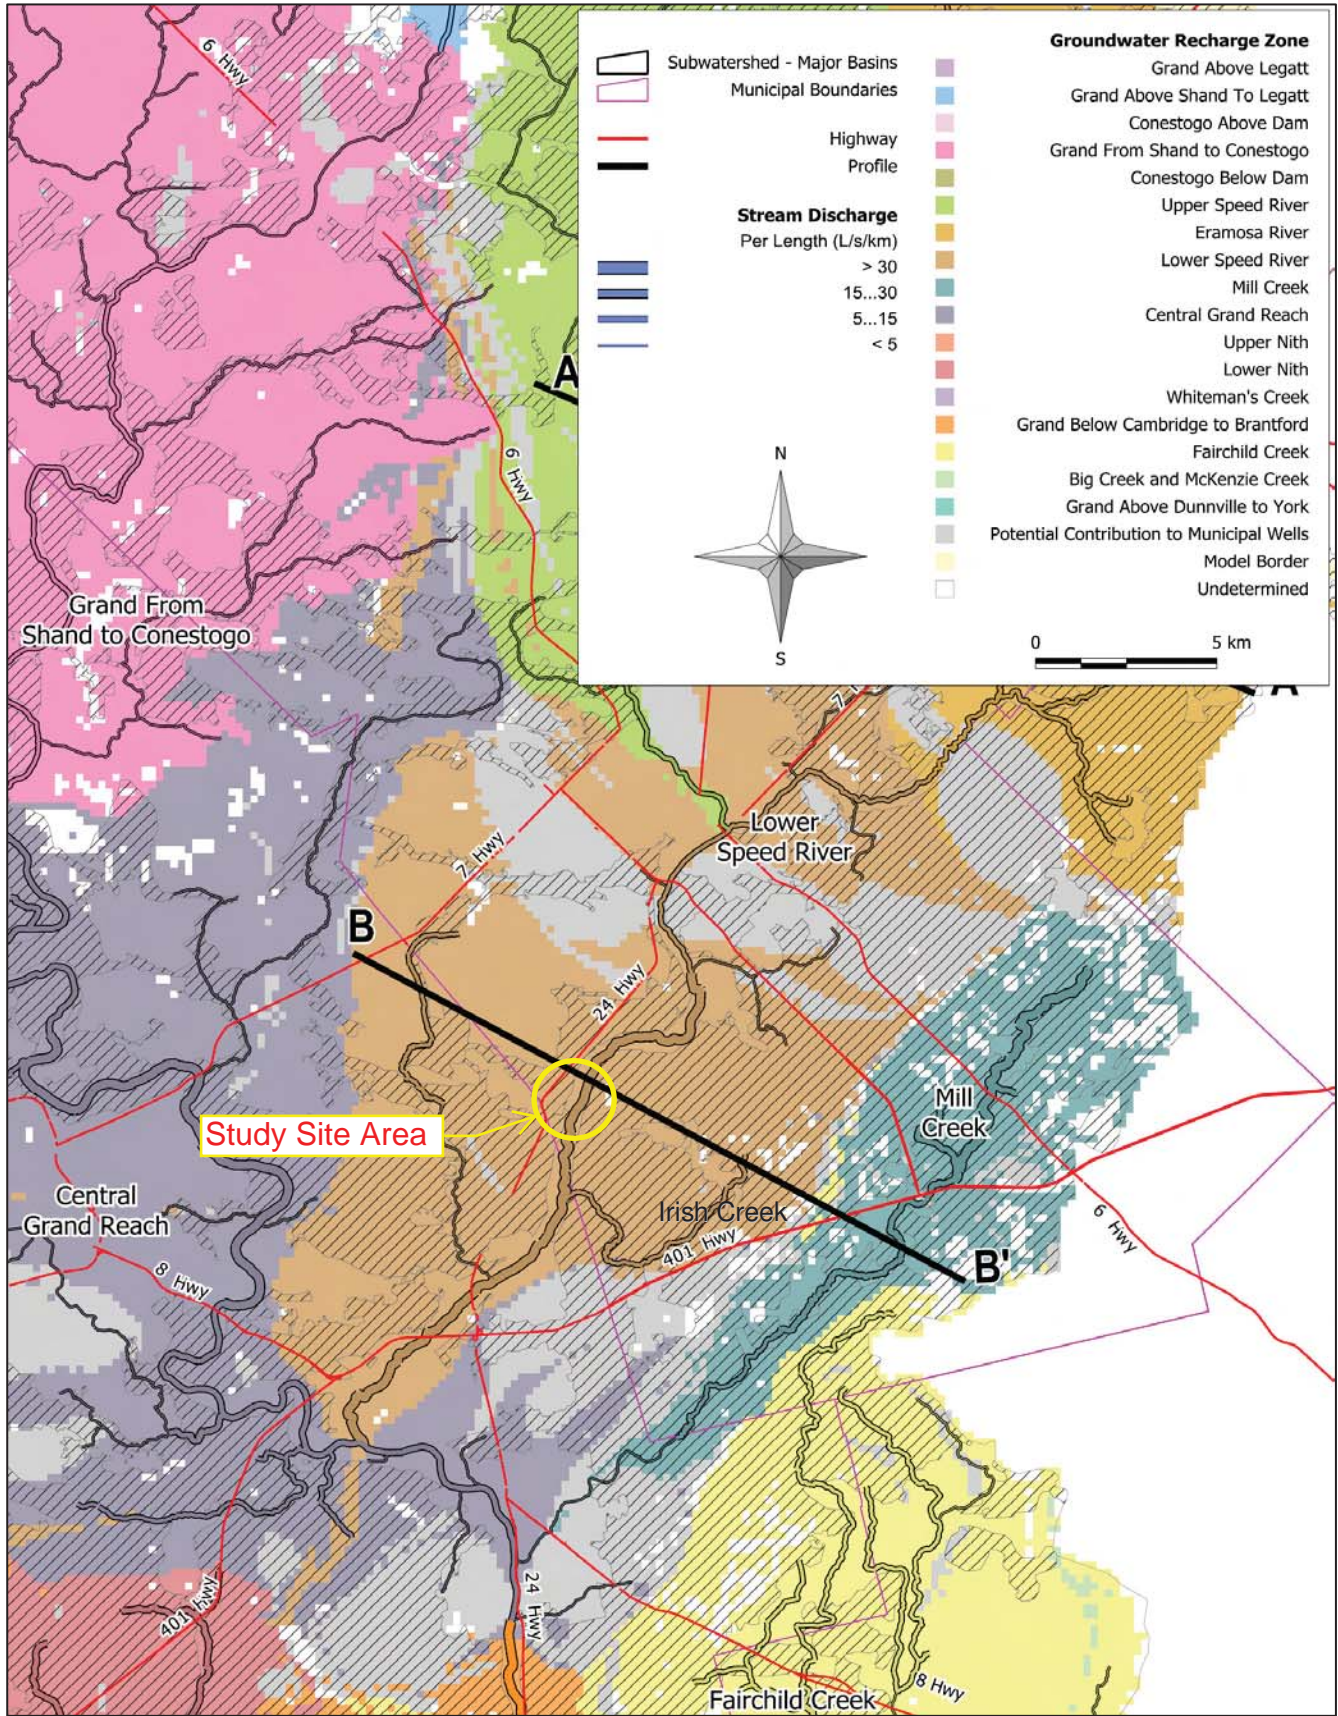
**Figure 77**  
**Speed and Mill – Recharge and Discharge**

Modified from:  
 Integrated Water Budget Report  
 Grand River Watershed  
 Final Report, June 2009

The site is a recharge area, which contributes to a large regional scale groundwater flow system moving eastward toward the existing quarry and river (see **Appendix A**). Based on the Integrated Water Budget report, recharge rates of approximately 0.355 m/yr and runoff rates of 0.008 m/yr (GAWSER derived average recharge rate 1980 to 1999 for sand and gravel with medium vegetation not within an area of hummocky topography) are expected at the site. Given a total proposed Licenced area of 51.16 ha, the site annual groundwater recharge volume contribution to the regional flow system is calculated to be 5.8 L/s on average (or about 0.2% of the Speed River normal summer low flow). As expected given the scale of the regional flow system moving toward the Speed River, on-site recharge comprises only a small component of the overall water volume reaching the river and wetland system. Similarly, the calculated annual average site runoff of 0.1 L/s (only half of which would flow directly toward the valley) is also considered minor with respect to both the river and associated wetland system adjacent to the site.
